AIRCRAFT ACCIDENT REPORT

OCCURRENCE NUMBER 01/44

BELL 204 (UH-1F)

ZK-HVY

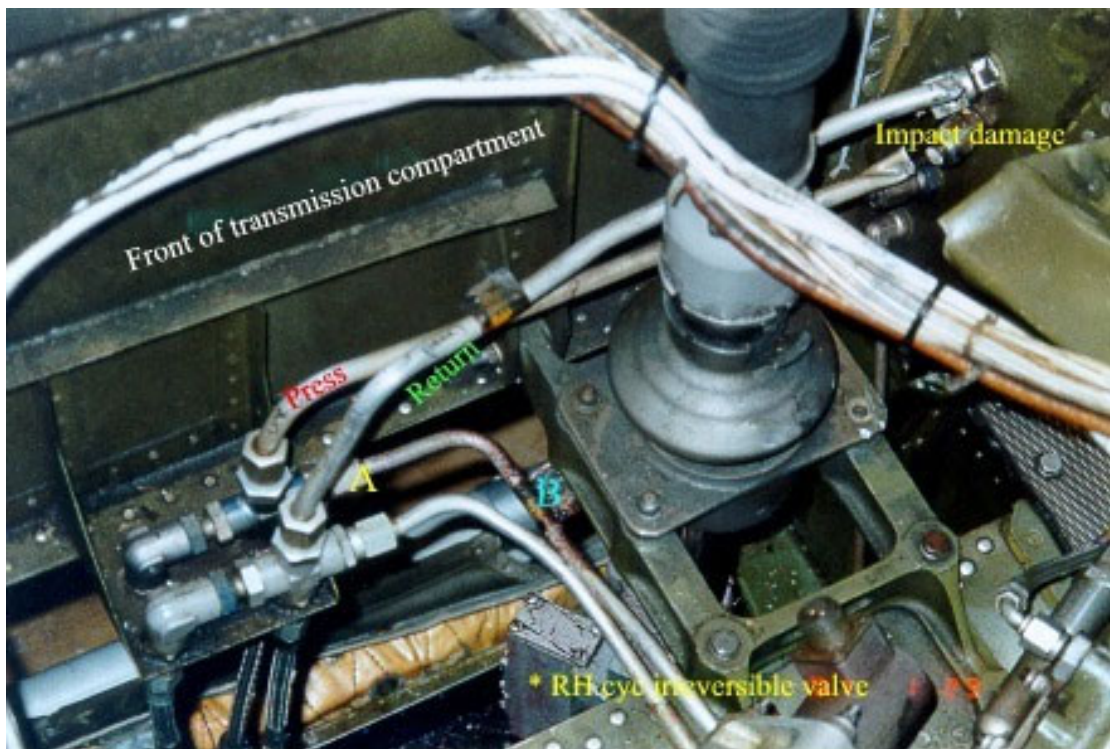
- 1.16.8 In general appearance, the pipe had had a long service life, and at the end where the leak occurred, had tarry deposits of dried hydraulic oil over about 170 mm of its length. The pipe was not readily visible or accessible with the main transmission in place. A general view is shown in Figure A5.

- 1.16.9 The pipe was sent for metallurgical examination, which found a fatigue crack at the end where the leak occurred. The crack ran circumferentially about halfway round the pipe, in the area of the MS21922 sleeve, adjacent to the slight deformation caused by the cutting edge of the sleeve. The pipe also exhibited bending in the area of the sleeve, and the result of this would have been to transfer bending loads to the end of the pipe where the cutting edge of the sleeve made contact. The fatigue crack had multiple origins and had propagated from the outside of the tube to the inside; it had developed over hundreds rather than thousands of cycles. This could indicate that the crack started developing relatively recently; alternatively, the movement of the tube leading to the cracking may have been present only occasionally, such as at a particular combination of aircraft load and speed, in which case it could have developed over a long period.

- 1.16.10 The associated MS21921 nut showed considerably more spanner marks on its surface than did the nut at the other end of the pipe. Additionally, file marks were present on the end of the nut, which had been shortened by 2.7 mm. The tube end also showed evidence of overtightening, being compressed and deformed between the tube end and where it emerged from the sleeve. Wear marks on the tube also indicated that the sleeve had been displaced about 1 mm towards the tube end from its original position at installation.

- 1.16.11 The evidence suggested that the nut had been repeatedly tightened in an attempt to eliminate a “weep” (indicated by the tarry deposits on the pipe) and eventually the nut had run out of travel, bottoming on the reducer. The whole tube assembly had then been removed and the nut filed to permit more travel. The maximum permissible tightening of these nuts on installation is one-third of a turn (two flats); further detail is given in 1.18.14.

Figure A5: Hydraulic lines in transmission compartment – transmission removed
A indicates the area of the leak; B indicates hydraulic fluid residue.
