CAA Safety Investigation Report
Collision with terrain
ZK-HWJ, Robinson R22 Mariner
Benmore Station, Canterbury
11 December 2013

CAA Final Report 13/6223
24 September 2018

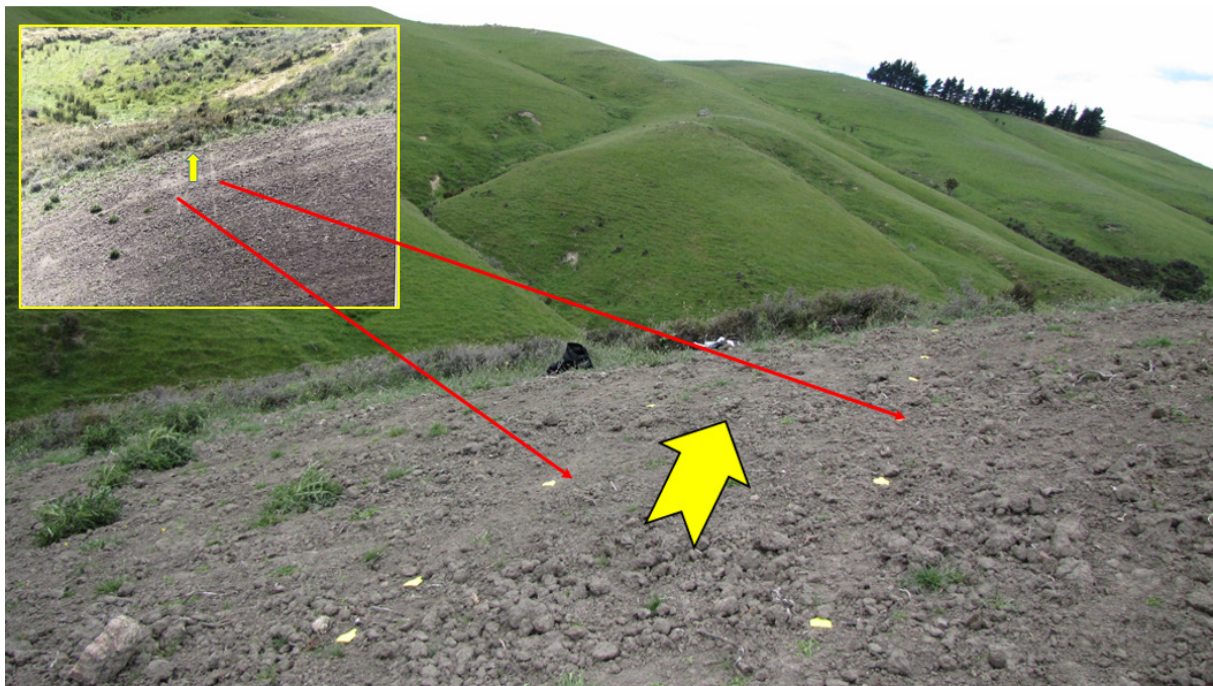
It was apparent from ground marks that the helicopter initially contacted rising terrain, on sloping ground, in a level yawing attitude. Significant depressions made by both the skids in the topsoil, were evident for a distance of 31 ft. It was also apparent that the landing gear skids had splayed from their normal dimension of 76 inches (at MAUW¹⁶) to 91.3 inches at the furthest point of ground contact (refer Figure 2 below and Figure 3 next page).

or fail in overload. The conditions of this accident indicate that once contact with the ground ceased, the tail boom oscillated and contact was made with the main rotor blades, severing the tail boom. The helicopter became uncontrollable, rolling over a downward slope approximately three times.

Figure 3. Ground marks shown with yellow arrow indicates direction of travel. (inset overhead view)

The parallel ground scars found along the hillside fall line, made after initial contact with the terrain, were likely attributed to the pilot levelling the aircraft and discontinuing the spray run after finding adequate clearance from terrain had been significantly compromised. The actions of the pilot to recover appear consistent with realising a problem existed then electing to fly out of the situation. An immediate jettison of the load may have been beneficial to avoid contact with terrain, however this did not occur. Having contacted terrain, the helicopter's tail boom flexed sufficiently to make contact with the main rotor blades which subsequently led to the total destruction of the helicopter.

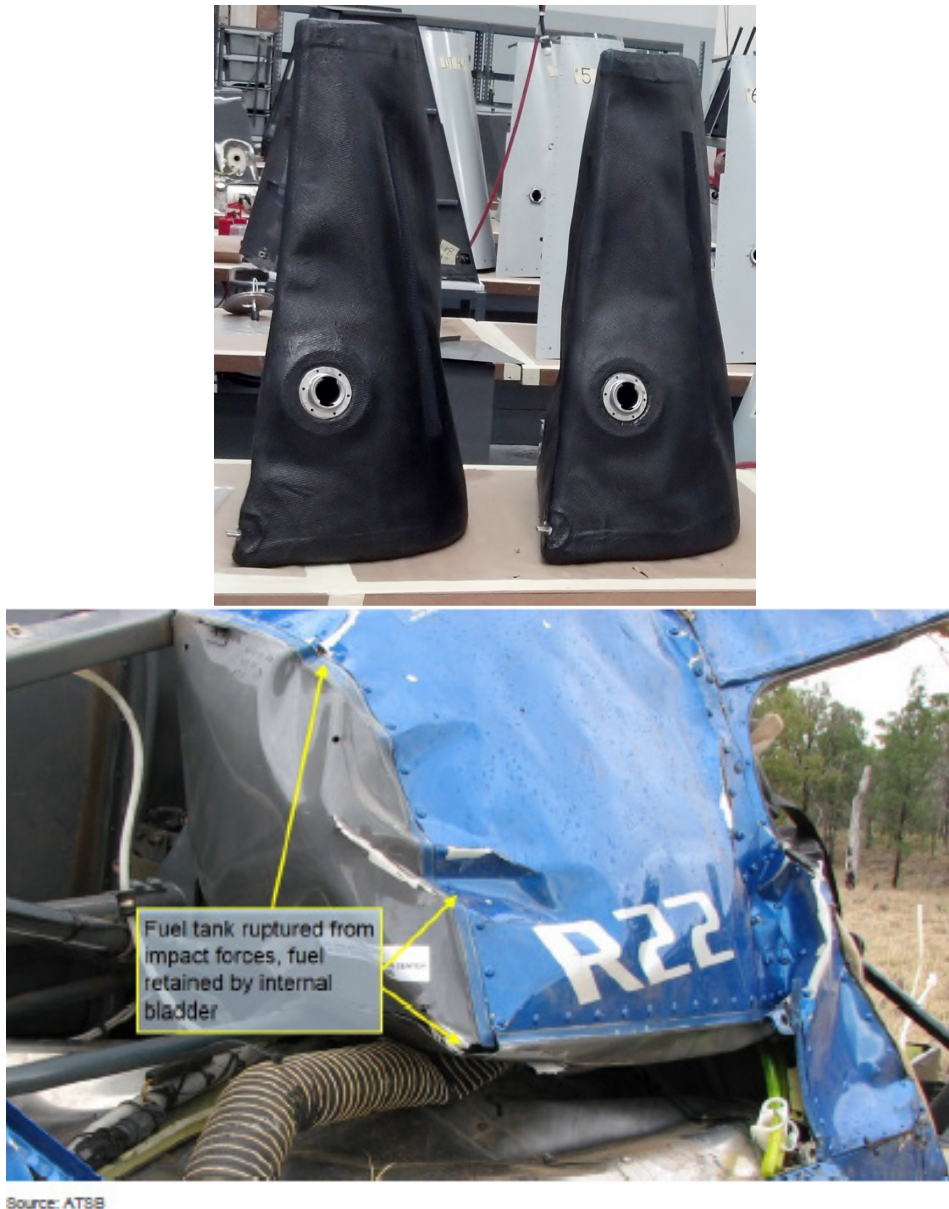
At the time of the ZK-HWJ accident a retrofit internal fuel bladder system was also being prepared for release for RHC R22 helicopters. Service Bulletin SB-109²³ was released by RHC on 8 January 2014 advising that the retrofit was now available and stipulating a compliance time frame of “*As soon as practicable, but no later than 2200-hour overhaul or 12-year inspection*”. It is conceivable that had the retrofit fuel bladders been installed, the risk of post-impact fire could have been reduced. An RHC R22 accident in Australia in 2015²⁴ demonstrated the effectiveness of the installation. In that accident the fuel tanks were ruptured but the fuel was retained in the retrofit bladders and no fire occurred. (Figure 4 next page).

Figure 4. Bladder fuel tanks for compliance with SB-109 and post-impact evidence.

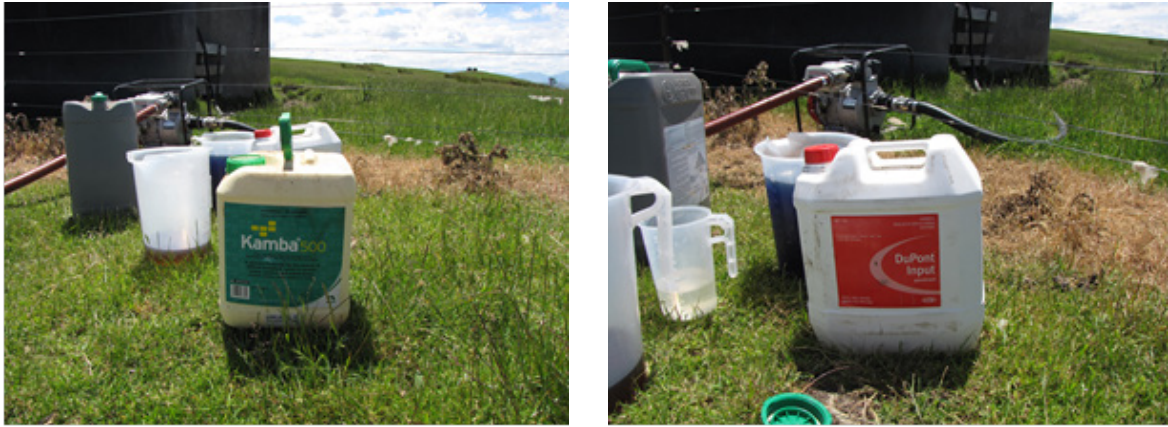
Evidence found at the loading site showed herbicide products measured out into three separate plastic jugs (Figure 5 overleaf). The herbicides were in two five L and a single one L jugs made up of the following: 5000 ml Glyphomax XRT (Glyphosate), 800 ml Kamba and 330 ml of penetrant. These measurements were identified by the ground loader as being identical amounts to those loaded into the Helipod III prior to the accident. These measured amounts varied considerably from those requested by the property owner and the higher concentration would have required a larger amount of water, and therefore a heavier load of water additive. (CAA Findings 18F579 and 18F580 refer.)

Figure 5. Measured quantities of herbicide found at loading site.

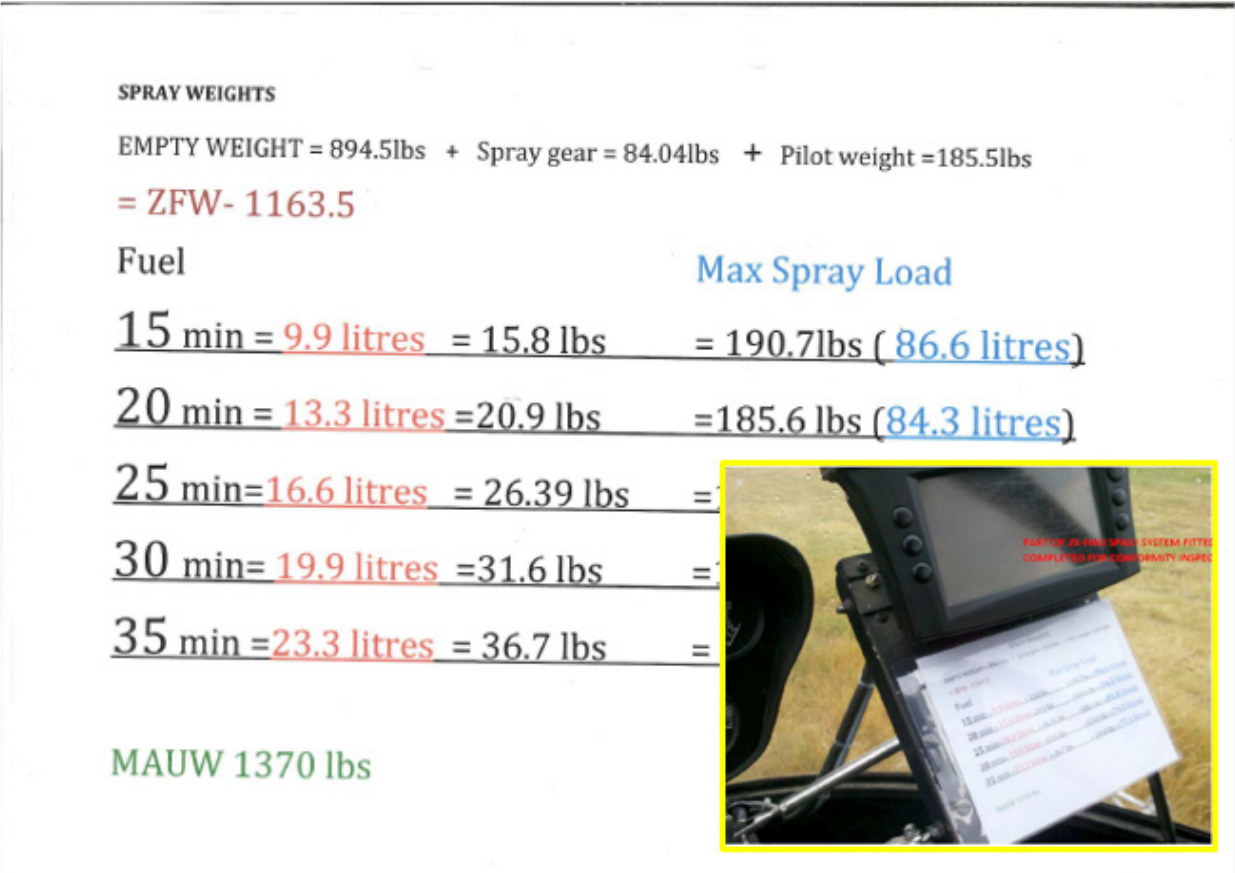
A "Spray Weights" information card (Figure 2 overleaf) was located in the debris trail and identified as belonging to ZK-HWJ. The card was a quick reference source used by the pilot when calculating fuel loads versus spray loads. This information was repeated in a number of other documents recovered from the company including the POH and Pilot Maintenance Records.

Figure 2. Spray Weights quick reference card found at scene (Inset: card pictured in ZK-HWJ).

The card shows the empty weight of the aircraft as 894.5 lb and the Helipod III as 84.0 lb (38.1 kg), a total weight of 978.5 lb. The safety investigation revealed that with the addition of the Helipod III and the GPS, ZK-HWJ would weigh 1013.46 lb.
