## CAA Safety Investigation Report Wire strike involving MD500E, ZK-ITJ 7 NM north of Wanganui 28 October 2014

## Wire strike involving MD500E, ZK- ITJ

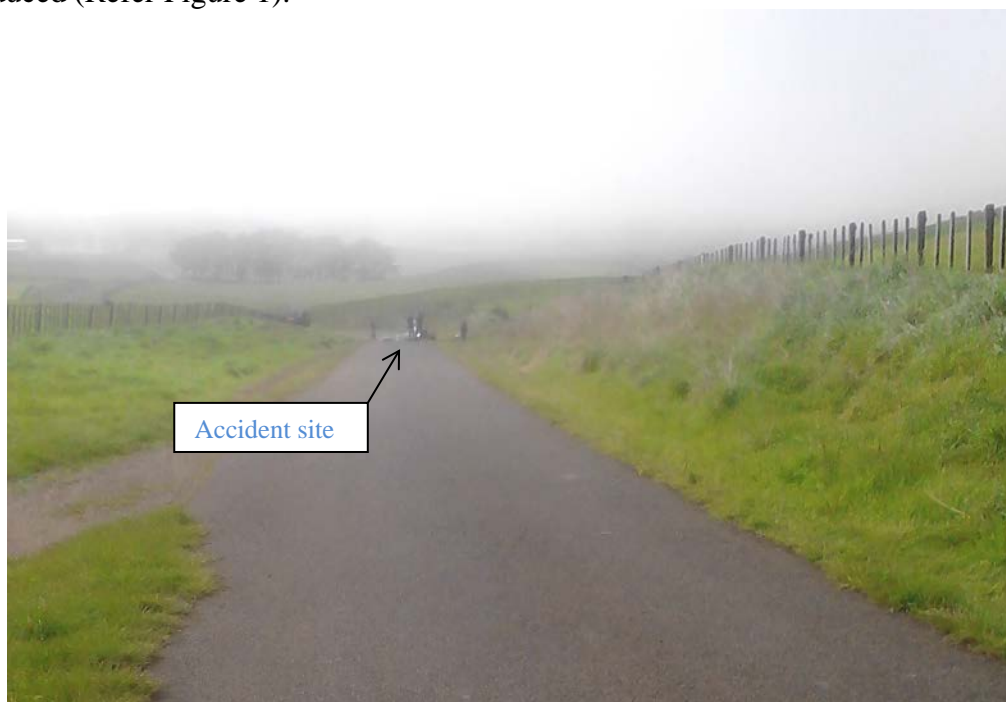
Early morning fog in the area had delayed the start of spraying operations at the farm. By approximately 0910 hours the weather conditions had improved sufficiently for the spraying job to commence. The farm manager indicated during the CAA safety investigation that there were still some patches of fog in low lying areas, however the paddock that the pilot had started to spray was free of fog. It was noted from a photo taken by a local resident as they approached the accident site, approximately 10 minutes after the accident, that the fog had not cleared completely. There appeared to be no distinct clear horizon and horizontal visibility was reduced (Refer Figure 1).

Figure 1: Weather conditions 10 minutes post-accident

As shown in figure 2, there was some fog present in the vicinity of the paddock being sprayed which gave a reduced forward visibility and a poor reference to the horizon. The reduction in visibility and the grey/white background of the horizon would have made the visual detection of the electric fence feeder wires more challenging for the pilot.

The remnants of the early morning fog may have hindered the pilot's visual recognition of the electric fence feeder wires.

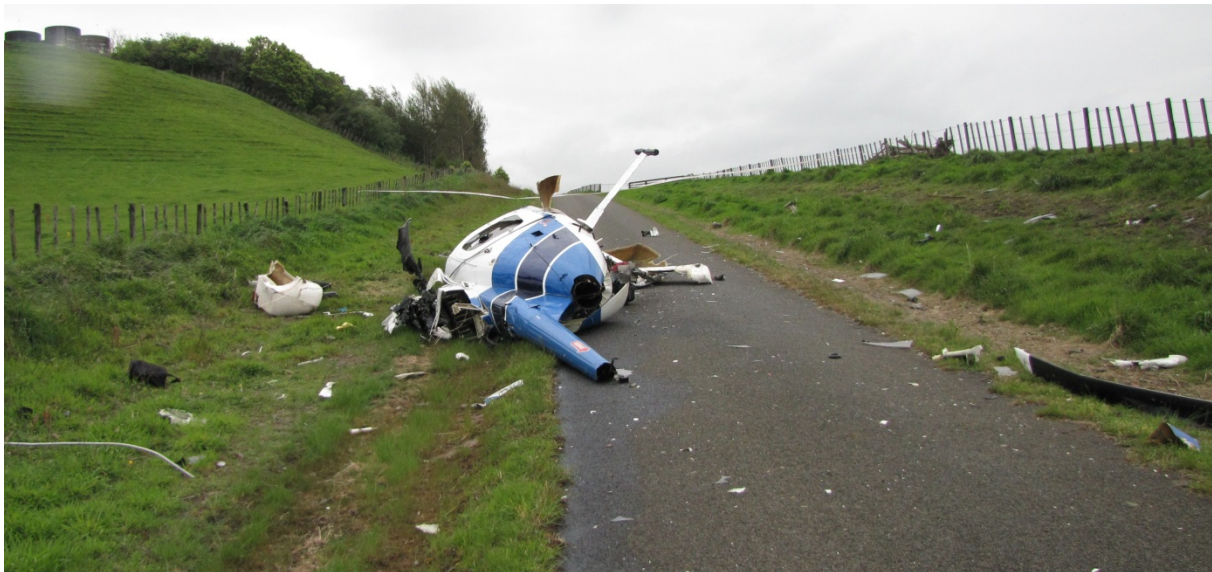
Following a brief climb, the helicopter descended and the witnesses observed it strike the ground initially with the right skid. The helicopter then rapidly rolled over to the left landing heavily on its left side. The helicopter was largely intact and all parts were accounted for at the accident site apart from the aft stabiliser assembly and tail rotor. Signatures indicated that the main rotor system was under power at the time of ground contact.

Figure 2: Accident site

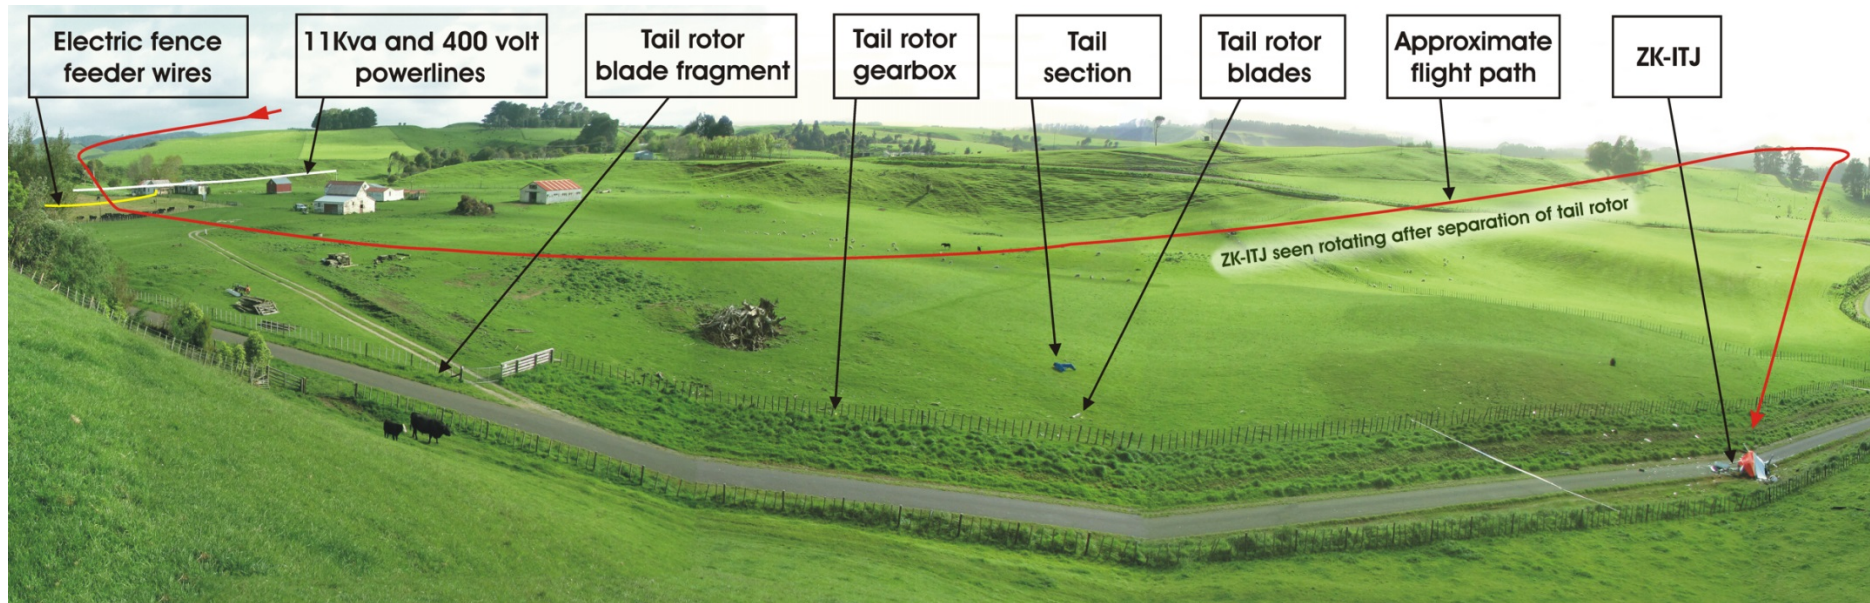
The aft stabiliser assembly was located along the helicopter's flight path, approximately 80 metres prior to the main wreckage. The tail rotor gearbox and tail rotor blades were located nearby, the tail rotor blades were found to have separated from the gearbox. One tail rotor blade was missing a 10 cm section which was later found embedded in the ground. Refer to Figure 3 for an overview of the accident site and approximate flight path.

Figure 3: Accident site overview and flight path

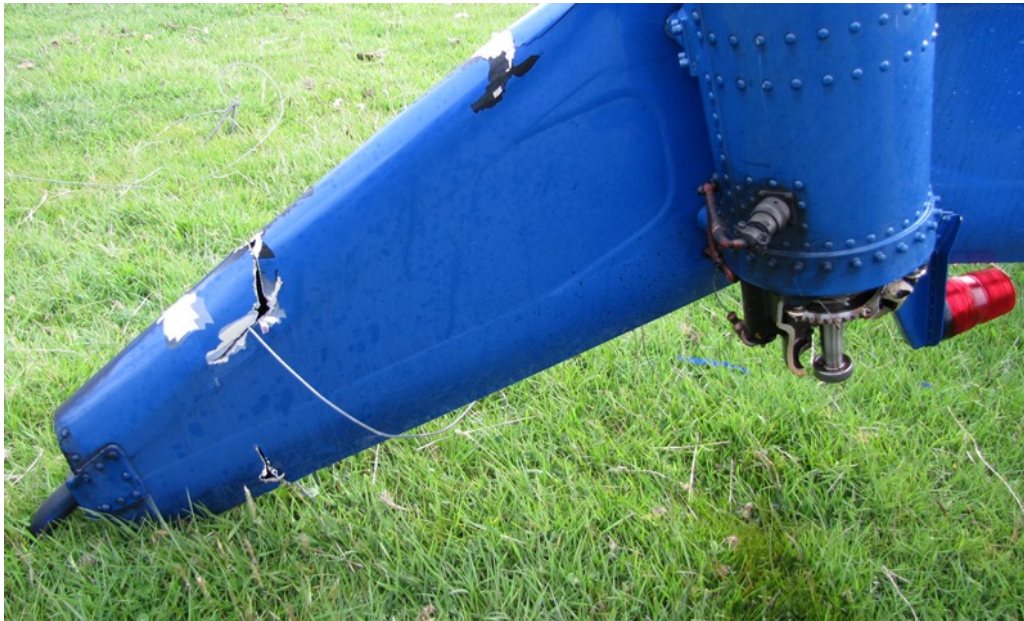
The lower vertical stabiliser was found to have a length of wire embedded in the leading edge of the stabiliser (Refer Figure 4).

Figure 4: Electric fence feeder wire embedded in lower vertical stabiliser

The suspended electric fence feeder wires had been disused for a long period of time. Removal of the wires by the property owners would have eliminated this wire hazard to aerial operations on the property.

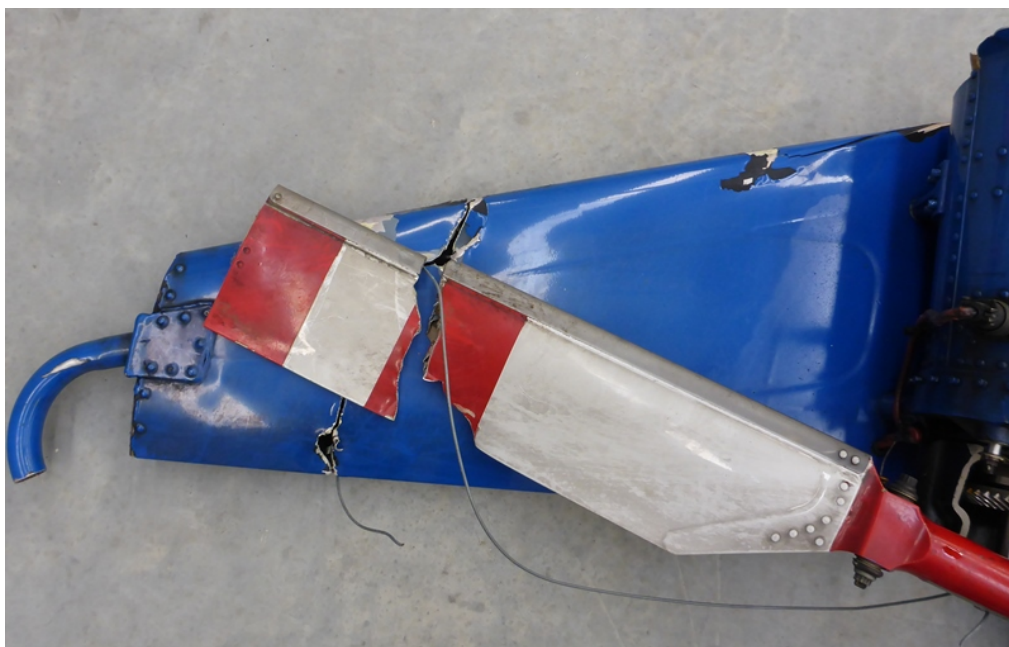
Witness marks on the failed tail rotor blade indicated that the blade failed after having contacted the wire. The position of the length of wire embedded in the lower vertical stabiliser coincided with the position of where the tail rotor blade had failed. (Refer Figure 5).

Figure 5: Tail rotor blade failure
