**AIRCRAFT ACCIDENT REPORT
CAA OCCURRENCE NUMBER 13/365
MICRO AVIATION BANTAM B22S
ZK-MLF
Loss of Control,
Due to Spatial Disorientation
CARTERS BEACH, WESTPORT
30 JANUARY 2013**

Aircraft type, serial number and registration:	Micro Aviation (NZ) Ltd Bantam B22s, s/n 97-014, ZK-MLF
Number and type of engines:	1 Bombardier-Rotax GmbH 582 (65 hp)
Year of manufacture:	1997
Date and time:	30 January 2013, approximately 2120 hrs ³
Location:	Carters Beach, Westport Latitude ⁴ : S41° 44' 55.6" Longitude: E171° 30' 47.8"
Type of flight:	Private
Persons on board:	Crew: 1 Passenger: 1
Injuries:	Crew: 1 Fatal Passenger: 1 Fatal
Nature of damage:	Aircraft destroyed
Pilot's licence:	Advanced Local Microlight Pilot Certificate (RAANZ)
Pilot's age:	58 years
Pilot's total flying experience:	Approximately 765 hours total flight time (logged)
Information sources:	Civil Aviation Authority Field Investigation
Investigator in Charge:	Mr M R Harris

Synopsis

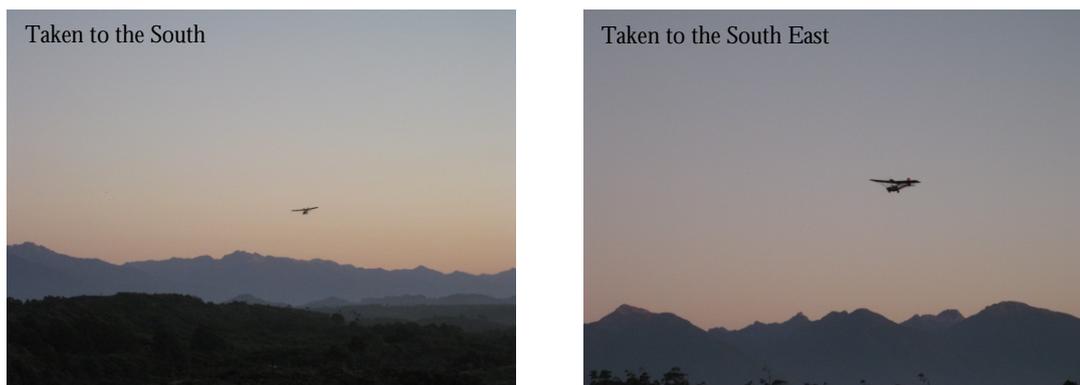
Figure 3:

1.1.4 At approximately 2100 hrs ZK-MLF was photographed over the Okari Lagoon by a hunter in the area. Figure 3 shows two of the photographs taken.

ZK-MLF photographed over Okari Lagoon area

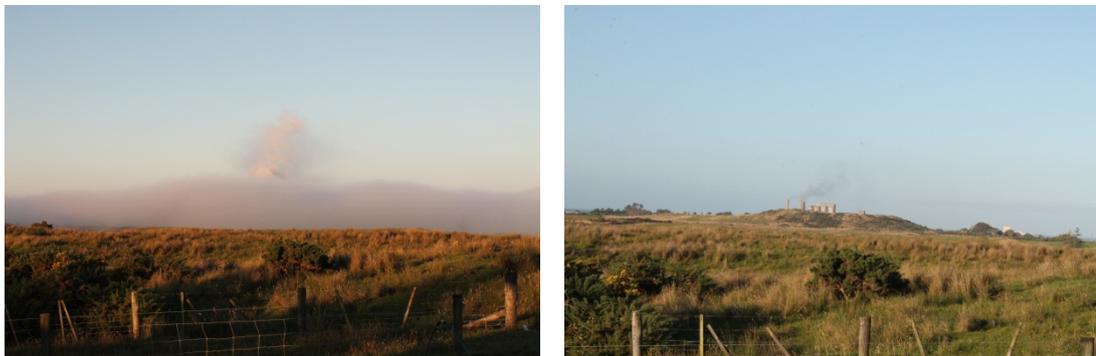
Figure 4:

- 1.6.3 Several witnesses interviewed during the safety investigation stated that the region of Cape Foulwind and Carters Beach was affected by thick fog around the time of the accident. Owing to the unusual nature of the weather conditions, an eyewitness situated approximately 3 km south west of the accident site, took a photograph of the fog that had formed over the area of the Cement Works and Carters Beach. This photograph was taken at approximately 2045 hrs. As part of the safety investigation the eyewitness was asked to take a second photograph from the same location, looking in the same direction on a clear day to provide a comparison. Both photographs can be seen in Figure 4.

photographs of weather conditions over the Cement Works

(Note - Left photo taken on the evening of the accident and right on a clear day.)
