**AIRCRAFT ACCIDENT REPORT**

**CAA OCCURRENCE 20/4164**

**SONEX**

**DEPARTURE FROM CONTROLLED FLIGHT DURING EMERGENCY LANDING**

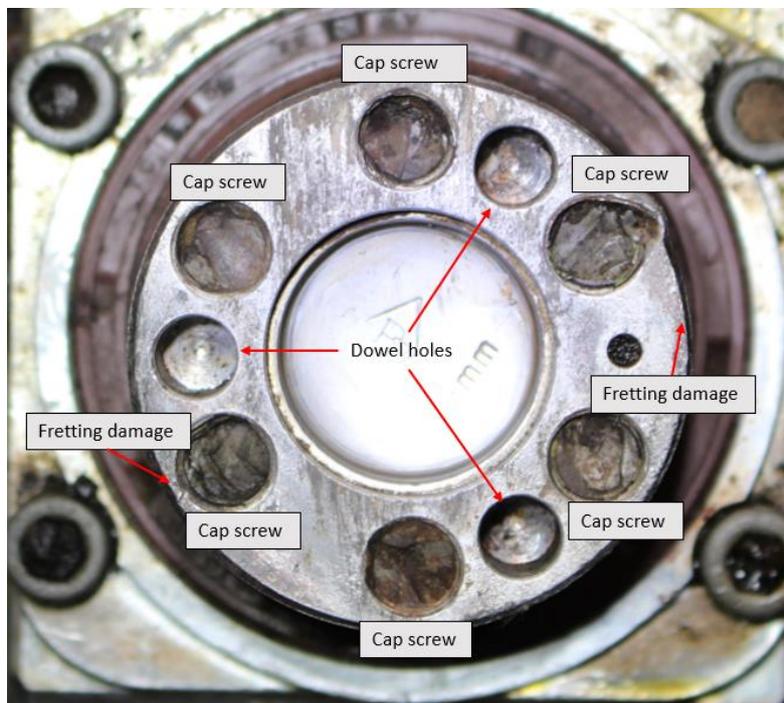
**Figure 1:** Crankshaft to propeller flange face detail (CAA photo)

1.16.2 The examination found that four of the six crankshaft to propeller flange attachment cap screws exhibited beach marks, consistent with fatigue crack propagation. The remaining two screws were consistent with overload failure. Ageing of the fracture surfaces suggested the fatigue cracking had been occurring for some time prior to the accident.

- 1.16.3 There was no evidence of positive location dowel pins being fitted.
- 1.16.4 Green thread compound was found in four of the screw holes. Further disassembly would have been required to examine the remaining two. However, it was likely the compound would have been present.
- 1.16.5 The examination also found fretting damage on the crankshaft to propeller flange mount face. It was determined that some of the clamping force imparted to the six securing cap screws had been lost prior to the accident. The loss of clamping force allowed slippage between the crankshaft and propeller flange, resulting in fretting of the crankshaft mounting surface (refer Figure 1).

- 2.12 The forensic examination of the failed cap screws identified beach marks, consistent with fatigue crack propagation. It was determined the aging of the fracture surfaces suggest the fatigue cracking had been occurring for some time prior to the in-flight departure of the propeller.

- 2.13 Finally, investigations of other instances of propeller separations found that the lack of crankshaft positive location dowel pins fitted to the crankshaft was significant, in that they weakened the crankshaft to propeller flange joint. Without them, all the stresses were on the crankshaft to flange cap screws. This lack of strength and the fitting of unapproved propeller types to ZK-NAF, likely contributed to the failure of the cap screws and detachment of the propeller on the day of the accident.

2.14 As a result of this accident, the CAA issued Continuing Airworthiness Notice (CAN) 61-001 on 27 August 2020. Jabiru engines manufactured before July 2011 have reduced strength and reliability of the crankshaft/propeller flange joint, compared with the later design that incorporated positive location dowel pins. The CAN, in line with the Jabiru 2200/3300 Engine Overhaul Manual, strongly recommends that engines manufactured prior to July 2011 are updated during the next full overhaul or bulk strip, to include propeller flange positive location dowel pins between the crankshaft and the propeller flange.

Jabiru 2200 / 3300 Engine Overhaul Manual (document JEM0001) now includes a strong recommendation that operators update their engines during the next full overhaul or bulk strip to include propeller flange dowels between the crankshaft and the propeller flange.
