## **Preliminary Report**

### **ZK-NPI Collision with terrain 40km west of Te Kuiti**

**21 July 2009**

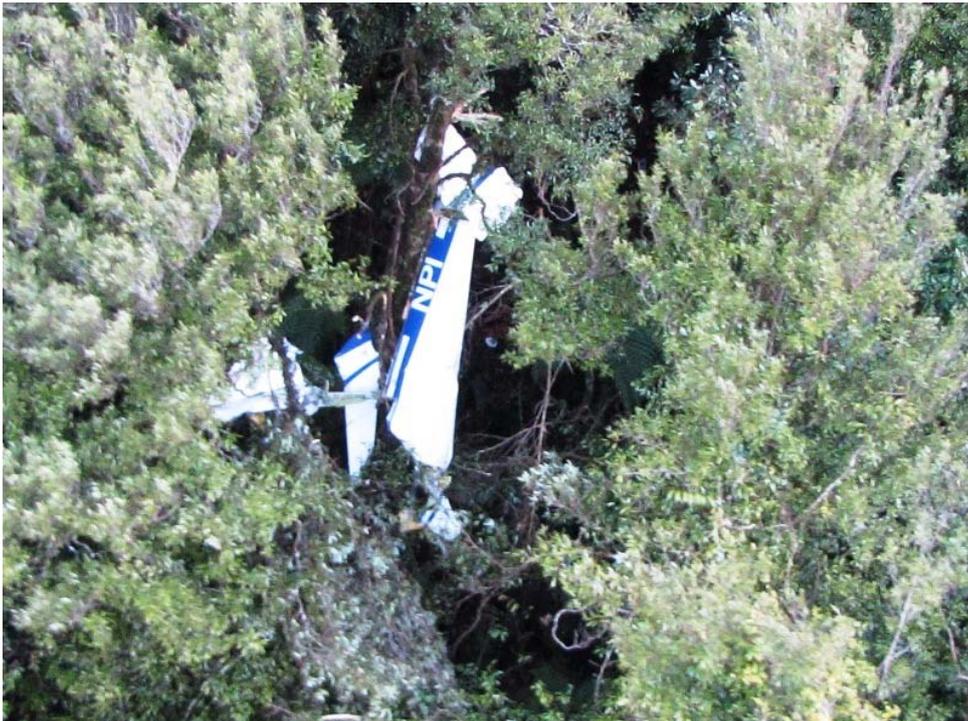
**Figure 1: Accident Site**

The aircraft was destroyed by impact forces (Figure1). The aircraft struck a tree on a ridge at approximately 1800 feet while on a south-easterly heading. The wreckage trail went for about 300 metres down a steep slope with sections of both wings and elevator being caught in tree branches. The fuselage was jammed between two trees with the engine on the ground 30 metres further down the slope at the end of the wreckage trail. There was no fire. The impact was not survivable.
