# Departure from controlled flight

## Montgomerie Bensen B8MR Gyroplane ZK-00Z

Near Piopio, Waikato

09 April 2017

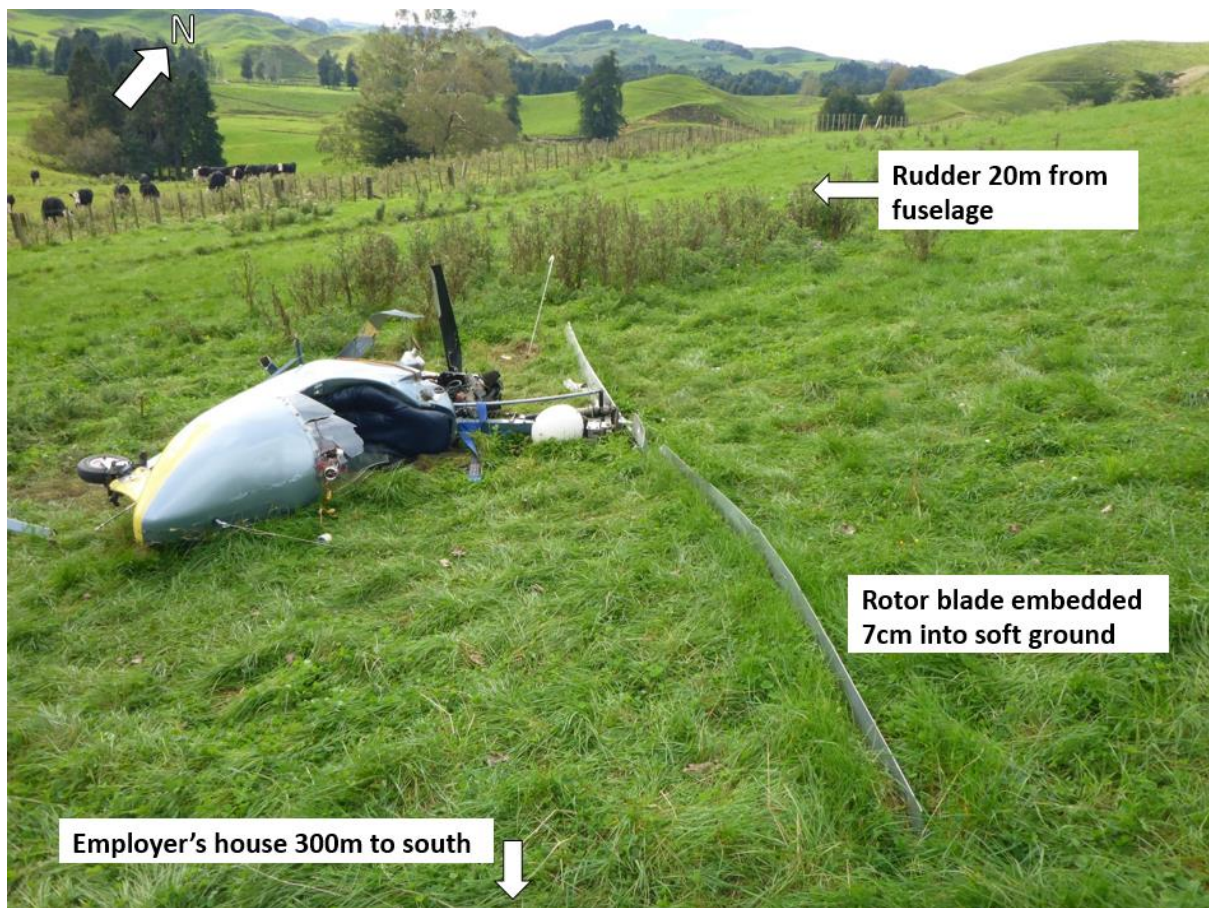
During the site examination, no mechanical defects which may have contributed to the accident were identified.

Wreckage signatures, together with eyewitness reports, indicated the gyrocopter departed controlled flight following a reduction in rotor rpm. The left side of the fuselage sustained the most impact damage. The rotor blades had minimal damage and were still attached to the rotor mast. The blades were deeply embedded in soft ground, indicating there was minimal, or no rotation on impact. The rudder and right wheel separated from the fuselage during the accident sequence. Integrity of the control systems was established.

A witness reported hearing the gyroplane's engine operating until it impacted the ground. Damage to the propeller and a subsequent engine inspection support the witness's account. Engine failure did not occur.

Figure 4: ZK-OOZ-Photograph taken during site examination looking north-west.

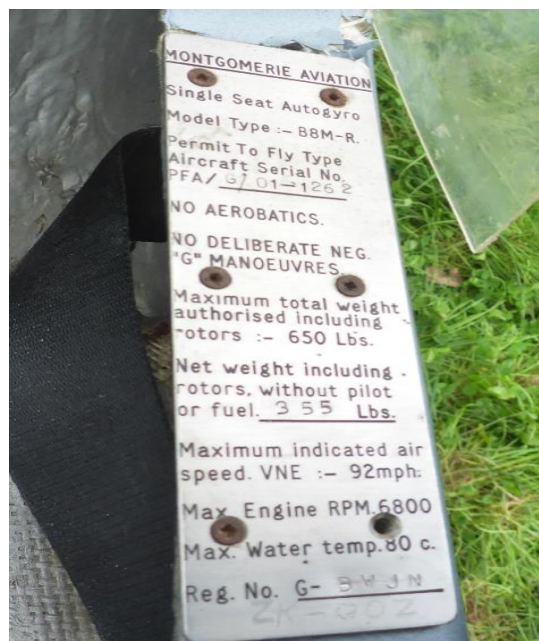
The aircraft limitations placard (refer to Figure 5) on the right side of the cockpit should have alerted the pilot to the hazards of performing the manoeuvres conducted in ZK-OOZ. There was, however, no specific warning about PPO.

Figure 5: ZK-OOZ/G-BWJN<sup>9</sup> limitations placard.

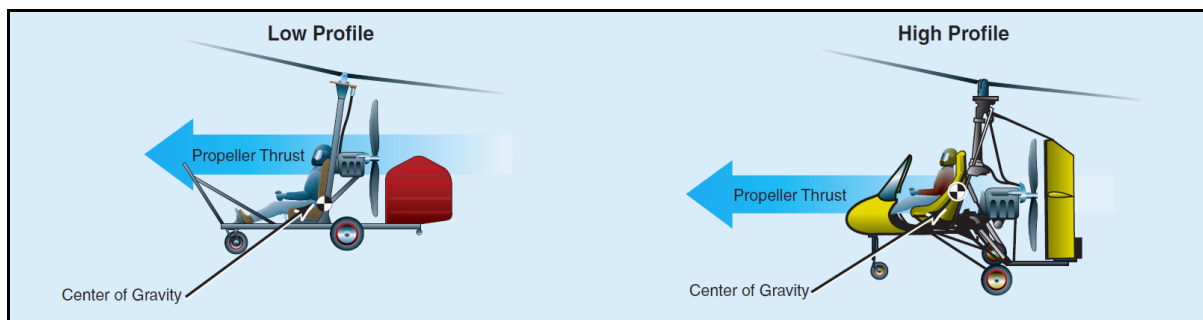
The Bensen B8MR gyroplane has an engine thrust line higher than the centre of gravity<sup>18</sup> so when power is applied, it has a tendency to pitch nose-down which further unloads the rotor (refer to Figure 6). In normal flight this tendency is countered by the lift or rotor thrust from the main rotor blades. However, if this balance is lost the nose will pitch down, known as a 'power push-over' (PPO). This rapidly becomes irreversible with a subsequent loss of lift and the gyroplane will 'tumble', unless immediate corrections are made by the pilot. This phenomenon occurs rapidly and without warning.

Figure 6. A low profile gyroplane has the propeller thrust line above the centre of gravity (CG). The high profile gyroplane has the thrust line at or below the CG and is more stable. (Source: FAA Rotorcraft handbook p16-6)
