**AIRCRAFT ACCIDENT REPORT**  
**OCCURRENCE NUMBER 10/885**  
**CESSNA U206G**  
**ZK-SKT**  
**COLLISION WITH VEHICLE**  
**MARSDEN POINT**  
**12 MARCH 2010**

## AIRCRAFT ACCIDENT REPORT

<b>Aircraft type, serial number and registration:</b>	Cessna U206G, S/N U20606609, ZK-SKT
<b>Number and type of engines:</b>	One, Continental IO-520-ECF
<b>Year of manufacture:</b>	1982
<b>Date and time:</b>	12 March 2010, 1557 hours <sup>1</sup> (approximately)
<b>Location:</b>	Private Airstrip, Marsden Cove Latitude <sup>2</sup> : S 35° 50.39' Longitude: E 174° 27.78'
<b>Type of flight:</b>	Private
<b>Persons on board:</b>	Crew: 1
<b>Injuries:</b>	Crew: 1 fatal
<b>Nature of damage:</b>	Aircraft destroyed
<b>Pilot-in-command's licence:</b>	NZ Private Pilot Licence (Aeroplane)
<b>Pilot-in-command's age:</b>	27
<b>Pilot-in-command's total flying experience:</b>	186 flight hours approximately <sup>3</sup>
<b>Information sources:</b>	Civil Aviation Authority field investigation
<b>Investigator in Charge:</b>	Mr S.J. Walker

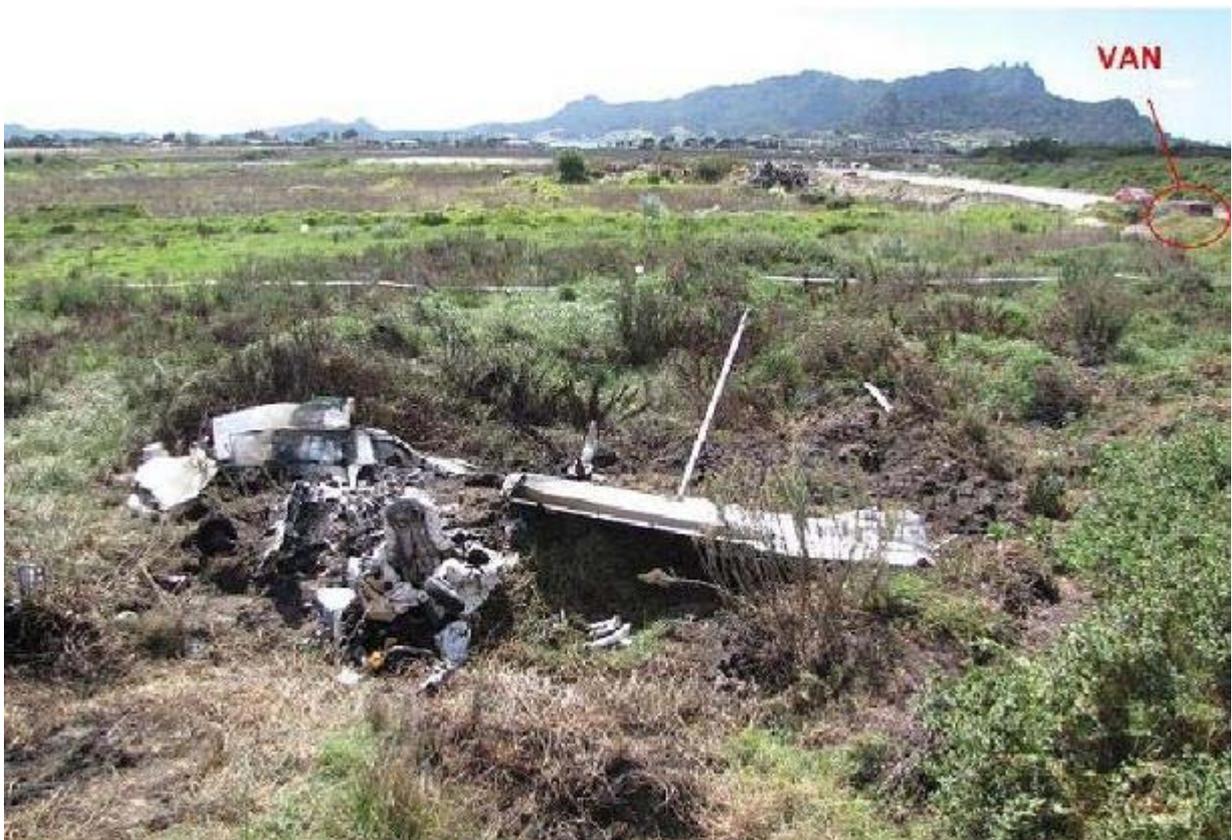
**Figure 1: Main Wreckage.**

1.12.2 The second point of impact was where the right wing struck the earth bank at approximately 46 metres beyond the van. The third and final point of impact was the main impact with the ground, approximately 65 metres beyond the van, where the aircraft came to rest inverted.

1.12.3 Both of the wings, the engine and the propeller had separated from the fuselage during the impact sequence. The centre fuselage had been consumed by an intense fire (see Figure 1).

**Note – the van parked in the top right of the picture.**

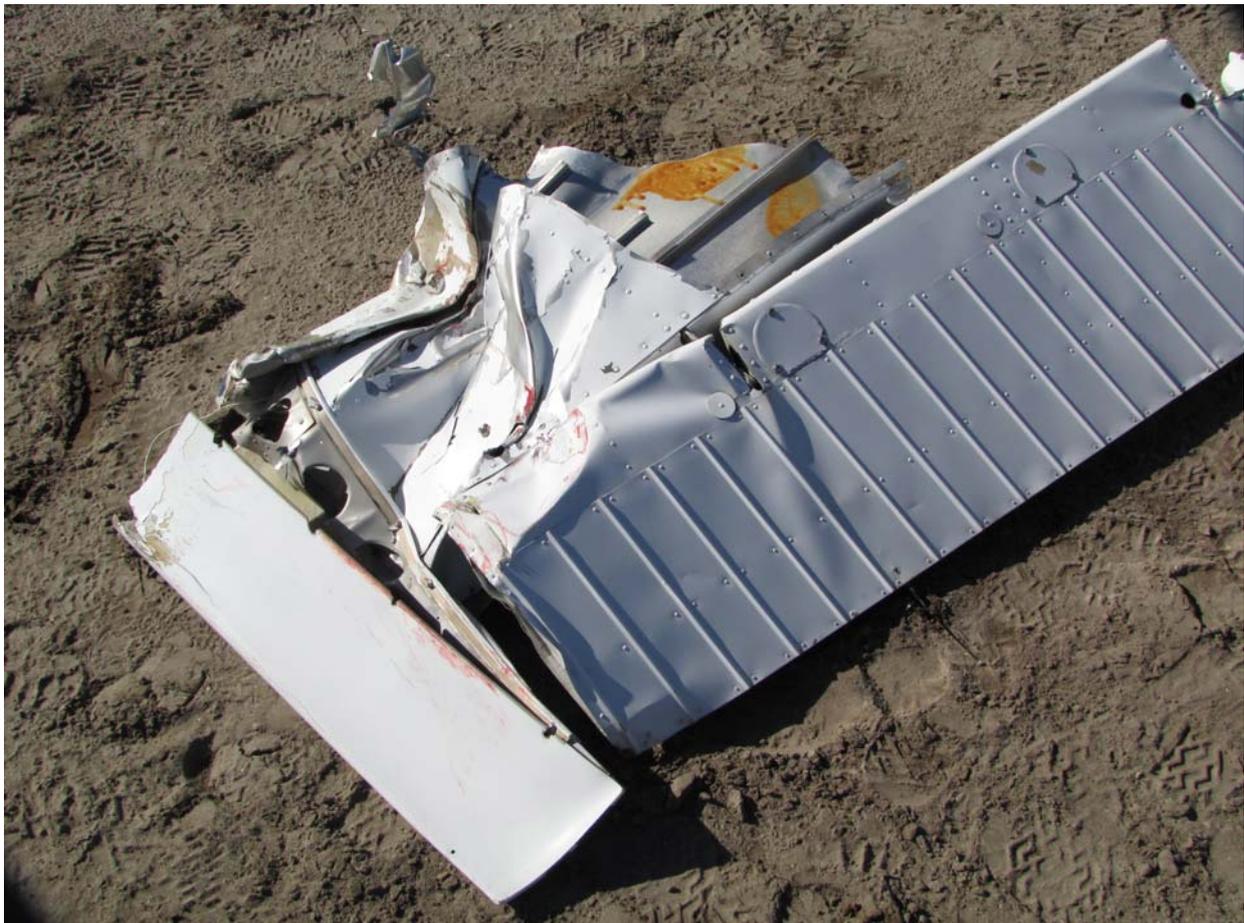
**Figure 2: Damage to Right Wing tip and Aileron.**

1.12.4 A section of the right wing was located on the track, six metres from the van. It consisted of the outboard end of the wing, a portion of wing spar and the complete

right aileron still attached by its outboard hinge (see Figure 2). Information about the aircraft attitude and the magnitude of the aileron deflection at the instant the wingtip struck the van was captured by deformation of the wing structure and paint transfer.

- 2.1 The separation of a large section of the right wing and right aileron from the aircraft reflected the severity of the collision with the van. It was established that the aircraft still had significant forward airspeed at the time that it arrived at the main impact site.

- 2.3 When correlated with the damage to the van, the damage to the wingtip revealed that the aircraft attitude, in relation to the ground at the time of the collision, was approximately 20 to 25 degrees nose up with 20 degrees of right bank. The right aileron was deflected upward from the neutral position by approximately 20 degrees. The aileron deflection indicated that the pilot was commanding a right roll, resulting in a banked turn toward the van when the impact occurred.

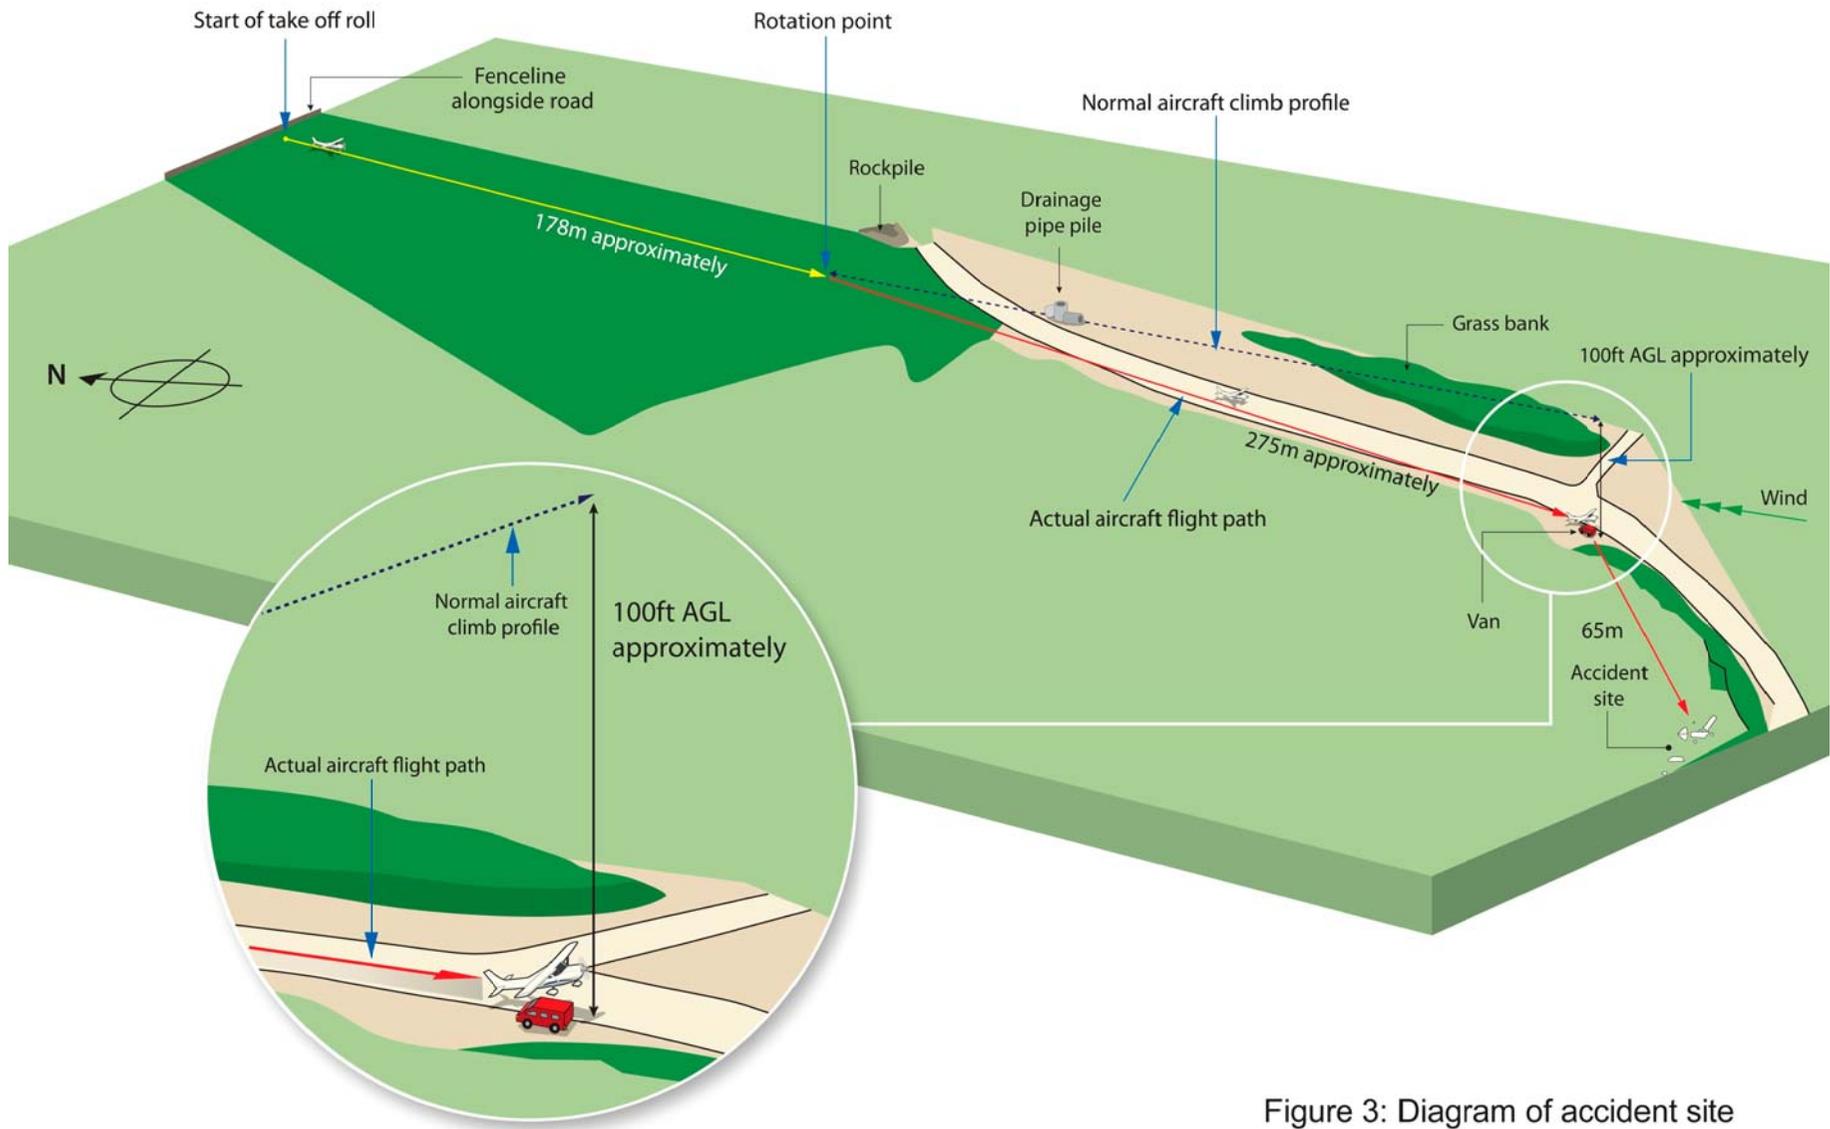
Figure 3: Diagram of accident site

- 1.1.2 At approximately 1550 hours the pilot was performing pre-takeoff checks. The Site Manager, who had given the pilot a lift to the aircraft in the company van, noticed that there was a large vehicle operating on the track in the vicinity of the end of the paddock used for aircraft operations. The Site Manager signalled to the pilot not to takeoff and then directed the tanker away from the track. Once the tanker had cleared the area the Site Manager parked the van to watch the takeoff. The van was parked facing the aircraft at a distance of approximately 450 metres from where the takeoff roll commenced, (see Figure 3 for further detail).
