Safety Investigation Report

ZK-RGB, serious accident during flight training, Glentui, North Canterbury

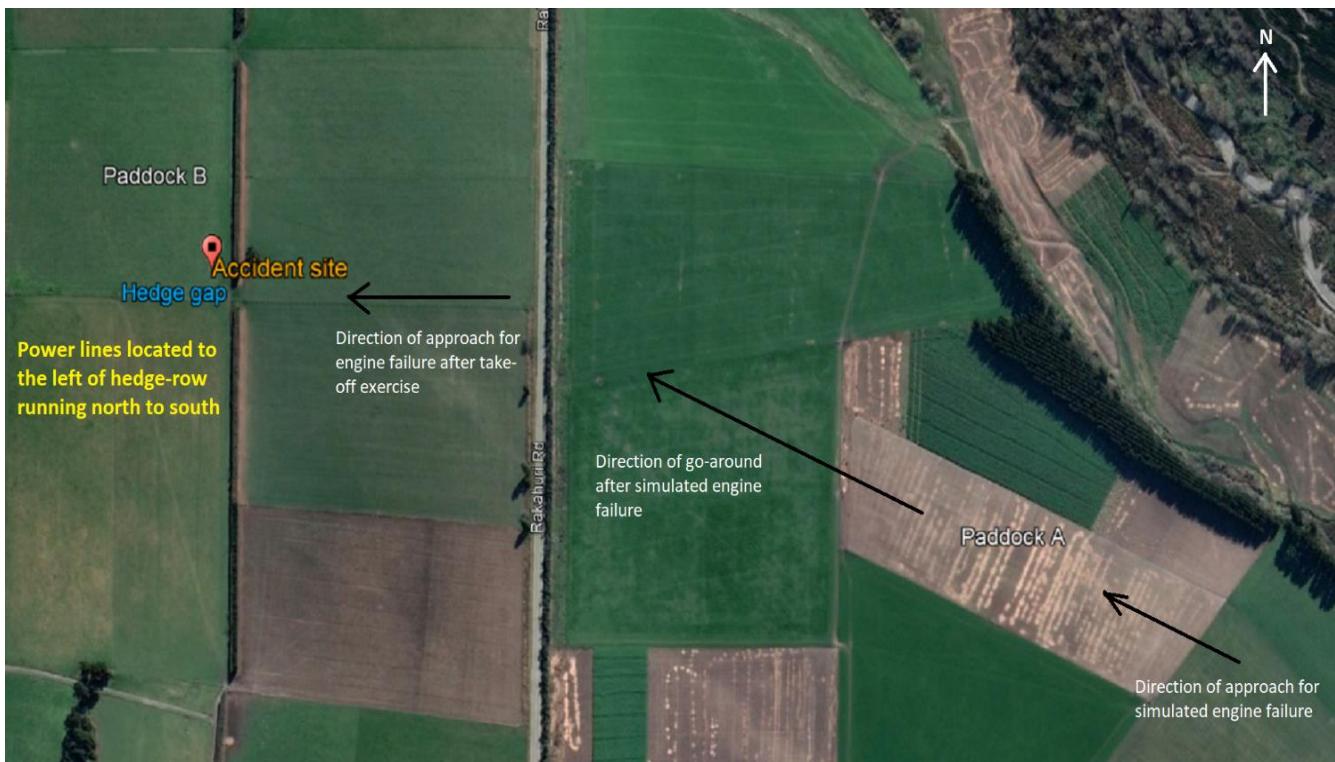
Figure 3. Simulated exercises diagram. Adapted Google Earth™ image.

The first part of the exercise was a simulated forced landing into Paddock A. The instructor reported having their hands on the control stick with the student ‘following through’ on the controls. The student was instructed to close the throttle to simulate the engine failure. On the completion of this simulation, the instructor then talked through a go-around.

At approximately 150 ft the student was instructed to close the throttle again to simulate an engine failure after take-off into Paddock B. During the simulation it was noted the aircraft did not have quite enough altitude to make it over the hedge. There was, however, a sizeable gap in the hedge and the instructor suggested aiming for that. As the aircraft glided towards the paddock over the gap, the instructor explained that landing diagonally across the paddock would increase the potential landing distance, and they initiated a small right turn. It was at this point the right wheel clipped unseen powerlines that were strung across the gap.

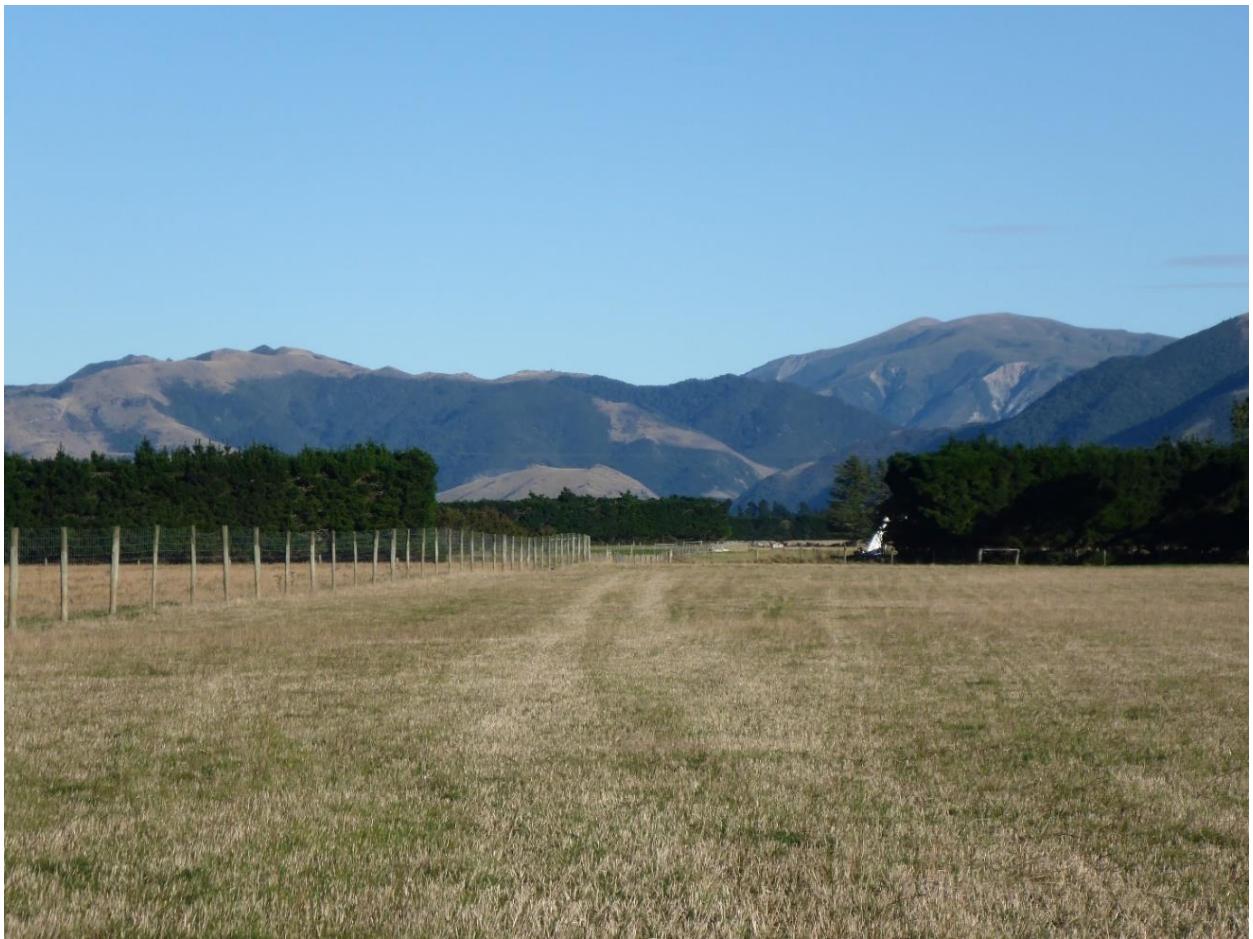
From the direction of approach, the power poles and lines were largely obscured behind the hedgerow. The tops of some power poles were visible along the length of the hedge. The power lines across the gap in the hedge, however, did not stand out against the green background of the paddock and hills. Without the visual cues provided by power poles, and with the powerlines obscured by, or blending into, background colours, neither the instructor nor the student could see the powerlines.

Figure 4. View from ground level of powerlines across gap in hedgerow

- The hedge largely obscured the power poles and lines and there were limited visual cues for the pilots to identify that powerlines were present.
- The instructor was not following lesson content guidelines as recommended by RAANZ and the CAA.

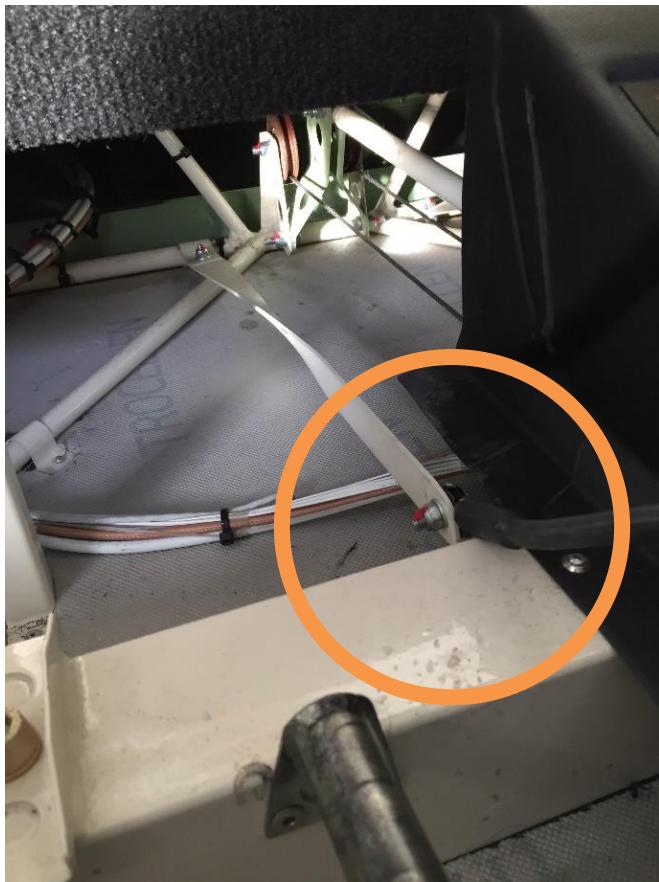
Anecdotally, several club members and instructors had reported issues with the original Tecnam seatbelt design. Some club pilots felt the original design (Figure 5) allowed the lap belt to ride up during flight. Concerns were raised that in an accident the seatbelt may not meet its design function to securely hold pilots in the seat, and that sliding out under the lap belt was a possibility. As a result of these concerns, the Chief Flying Instructor designed and modified the anchor point in conjunction with a local IA⁷ (Figure 6).

Figure 5: Original Tecnam seatbelt anchor design

Note: Seatbelt (buckle side) is connected to a metal strip, which is not anchored to the spar. This allows vertical movement of the seatbelt

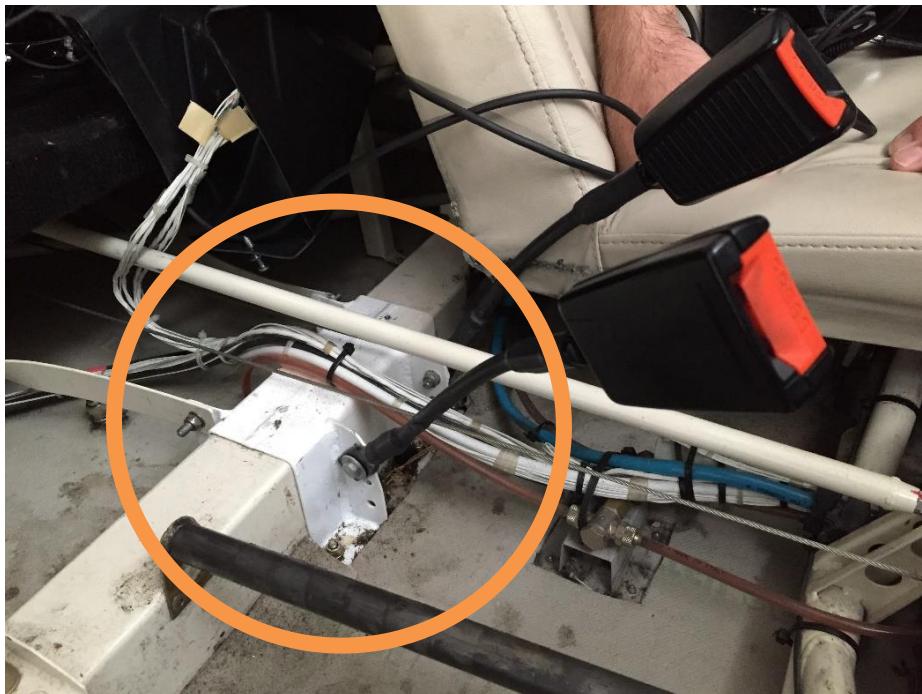
A review of the aircraft documentation found appropriate procedures were followed in introducing the modification.

Figure 6: Modified seatbelt anchor point. Seatbelt buckle unable to lift, holding seatbelt more securely across lap.

Both pilots had been firmly held in their seats during the accident sequence. The CAA was unable to state with certainty that the new seatbelt design led to a safer outcome for the aircraft occupants than the original design would have provided. However, after discussing the issues of the original design with the club's senior leadership, observing both the original and the new designs together, and consulting the New Zealand Tecnam representative, the CAA considers the modified design is worthy of consideration as a design improvement by owners and operators of the P92 Classic model.

- A combination of factors positively influenced accident survivability.
- Owners and operators of the P92 Echo Classic may wish to consider modifying the seat-belt anchor point.
