# Safety Investigation Report

## Fatal parachute accident Tauranga, 20 March 2021

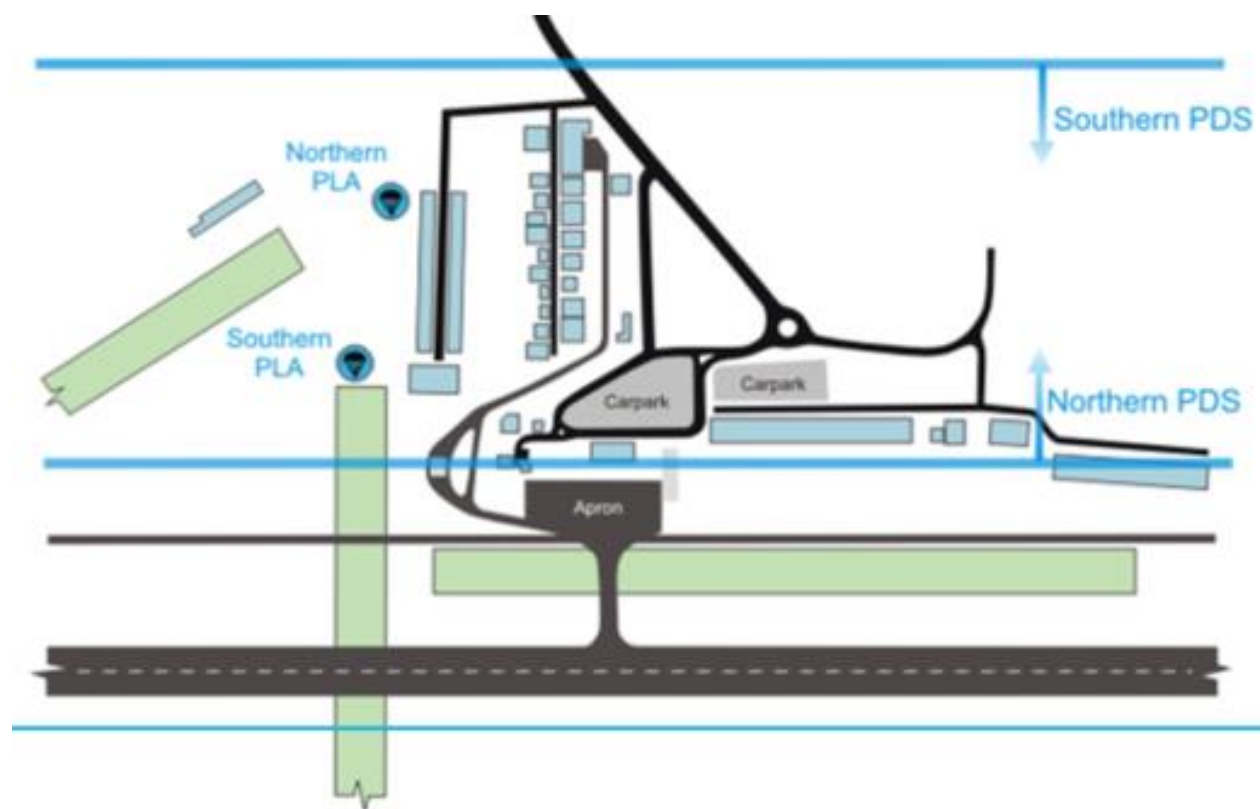
Figure 1 - Depiction of NZTG PLA.

The NZTG PLA is divided into northern and southern segments (refer figure 1), the use of which, is based on the local wind conditions and any glider operations taking place. The segment to be used is briefed prior to take-off. The wind conditions on the day were reported by the NZTG AWS<sup>5</sup> as favouring the southern segment with a 7-9 knot wind from 120°-140°<sup>6</sup>. The wind was also reported to have varied between 070° and 190° 30 minutes either side of the accident. The operator placed a windssock within the PLA for skydivers to observe the wind conditions during descent.

The skydiver's logbook did not record which segment was used during previous landings. However, witnesses reported that he had used both segments and was most familiar with the southern segment, which was in operation on the day of the accident.

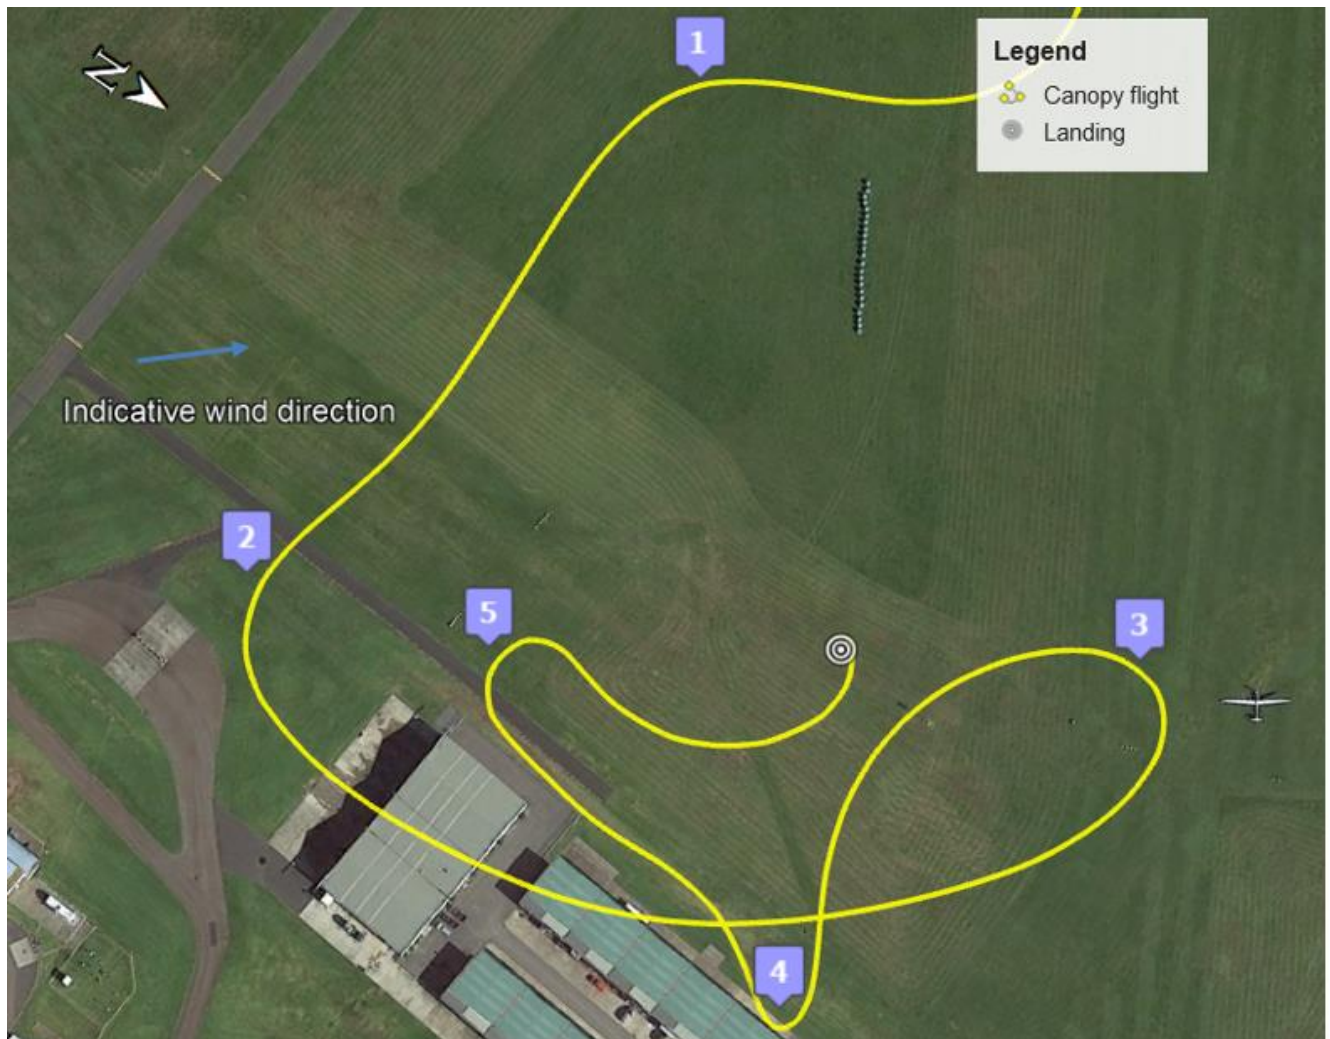
Figure 2 - Overhead perspective of final portion of descent. Adapted Google™ Earth image with altimeter data. (For illustrative purposes only).

Figures 2 and 3 display the last portion of the canopy descent from overhead and side-on perspectives, with the icons representing the same point in the descent in each figure.

<b>1024ft<sup>8</sup></b> – established in 25-30° descent gradient, passing slightly south of intended landing spot approximately into wind

<b>920ft</b> – initiates an approximately 90° left turn. Wind rear quartering approximately 4-5 o'clock relative position

<b>760ft</b> – continues a left turn for approximately 250°, with a descent gradient reaching 70°

<b>545ft</b> – initiates an approximately 110° right turn, with a maximum descent gradient of 82°. Wind approximately 9-10 o'clock relative position

<b>330ft</b> – initiates a 180° right turn before attempting a second 180° turn to the left at 164ft. This put him directly downwind just prior to contacting the ground in a near horizontal position, with a descent gradient of greater than 80°

it is likely that a safe and long landing could have been carried out had he continued straight ahead. Likewise, after completion of that right turn a safe crosswind landing would also have been possible.
