VECTOR

PA-31 Landing Gear

September / October 2003

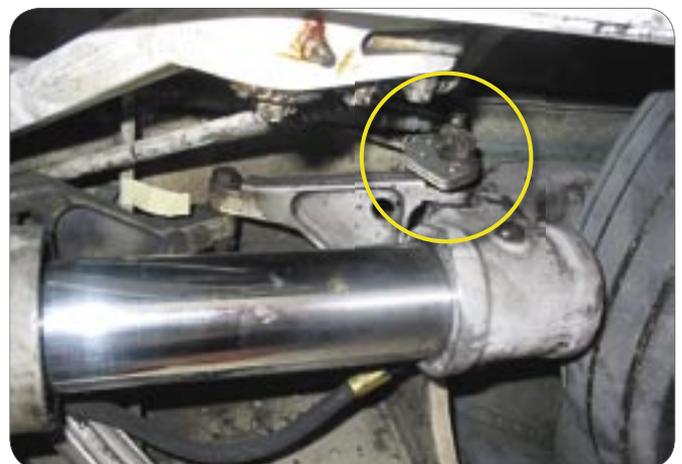
Landing gear retracted showing the up-lock hook holding the gear leg up.

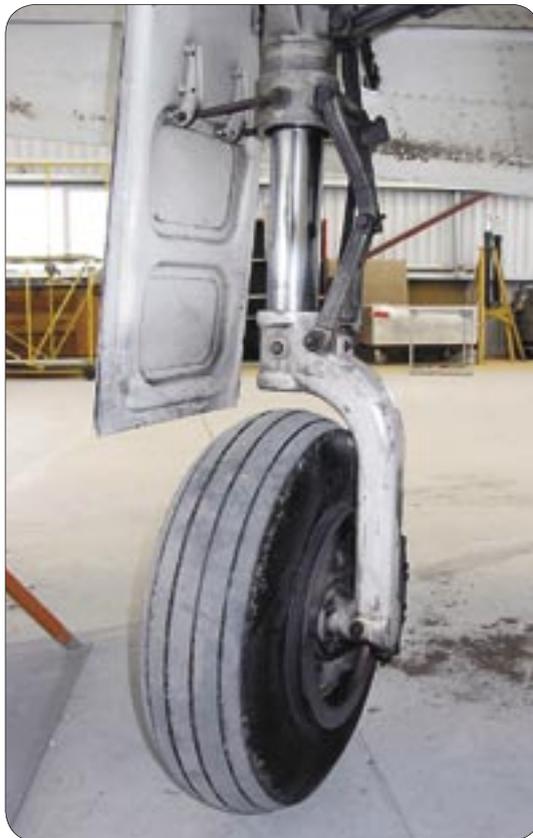
Landing gear extended – oleo strut inflated.

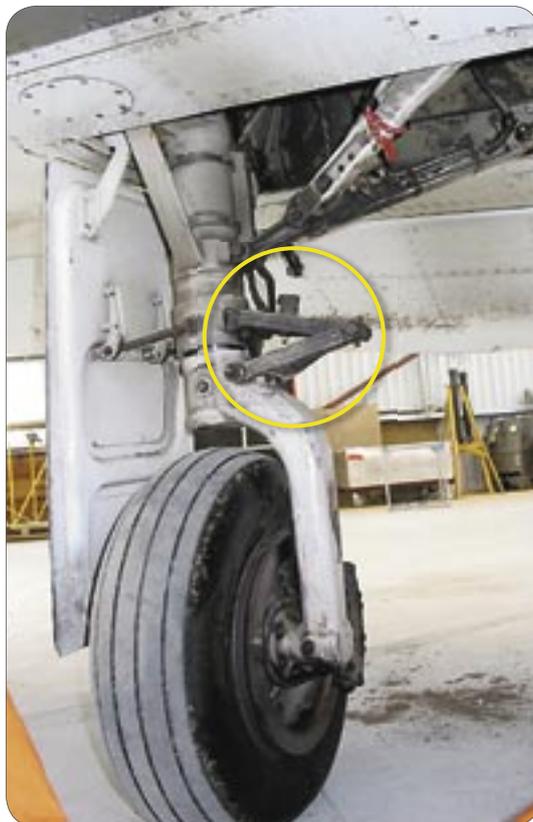
When the aircraft was jacked up, the righthand wheel assembly could be easily lifted, indicating that no pressure remained in the oleo strut. No fluid leaks were evident, except for the inboard door ram, which had a broken hydraulic fitting consistent with the damage incurred by the door on landing.

Detailed examination of the righthand landing gear components revealed two frames within the wing wheel bay had fresh marks and minor damage. Matching witness marks were found on the upper scissor-link (connecting the upper and lower leg parts to allow the strut suspension movement while preventing rotation) and on the lower leg casting.

The right gear leg was then removed for examination. It was first re-pressurised, and was found to hold pressure normally. Internal examination of the oleo strut generally showed components to be in good condition, but the O-ring seal in the lower bearing had rolled over within its groove, and was probably the cause of the loss of pressure in the strut. A quantity of oil (0.82 litres) was drained from the strut, whereas subsequent refilling on return to service, took 1.6 litres of oil.

During subsequent examination of the aircraft, the tests which replicated the compressed strut condition showed that this occurrence defeated the ability of the up-lock hook to release the leg during the landing gear extension cycle, unless the strut could be returned to its normal full length.

Landing gear extended – flat oleo strut. NB scissor link circled.

Internal examination of the oleo strut involved showed that the probable cause of the pressure loss was the O-ring seal in the lower bearing rolling over within its groove. It is possible that the low oil level contributed to the O-ring rollover, by allowing it to become dry.

- Any PA-31 pilot facing a similar landing gear hang-up problem could try climbing the aircraft back to cruise altitude or higher (where any negative internal pressure in the oleo strut would be cancelled) before again attempting to lower the gear.
- Should it be necessary to ferry a PA-31 aircraft to a maintenance base with a known flat oleo strut, then retracting the landing gear should be avoided.
- It is recommended that operators of PA-31 aircraft, and their maintenance personnel, give consideration to whether additional routine servicing might be warranted, to guard against the possible effects on landing gear extension of low oleo strut oil levels. ■
