Title: Rotor Blade Failure

Clients Name: Civil Aviation Authority of New Zealand
PO Box 31 441
Lower Hutt

Report Number: 31282.01

Part of a rotor blade from a Robinson R22 helicopter has been examined to determine the reason for failure. The blade failed due to fatigue cracking that initiated at the edge of a bolt hole in the blade root fitting. It was concluded that the primary reason for failure was that the helicopter had been operated in such a way that the loading on the blade was frequently higher than that expected by the manufacturer when the specified retirement life of these components was defined. No evidence that corrosion contributed to the failure was observed.

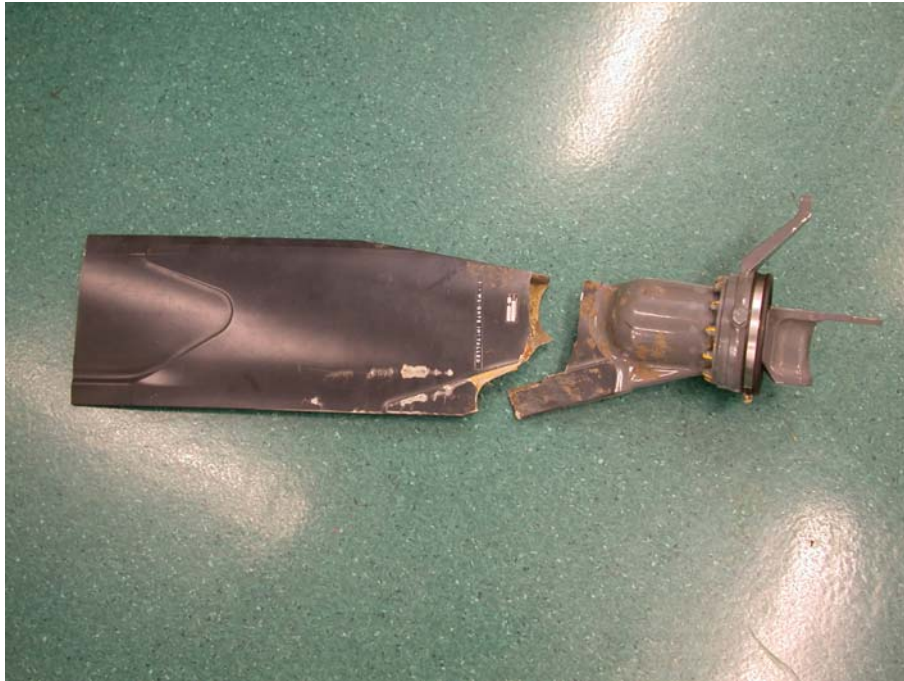
The samples as received are illustrated in Figure 1. The bulk of the blade had been cut away for convenience of handling before receipt by MPT Solutions. Both the blade and hub parts had an identification sticker. The information on these stickers is reproduced in Table 1.

The blade had failed approximately 20mm outboard from the end of the hub section. The fracture was approximately at right angles to the blade leading edge. At the trailing edge however, it had run along the blade away from the hub for a short distance before again running normal to the blade axis to the trailing edge (Figure 1).

Figure 1. Samples of rotor blade as received.

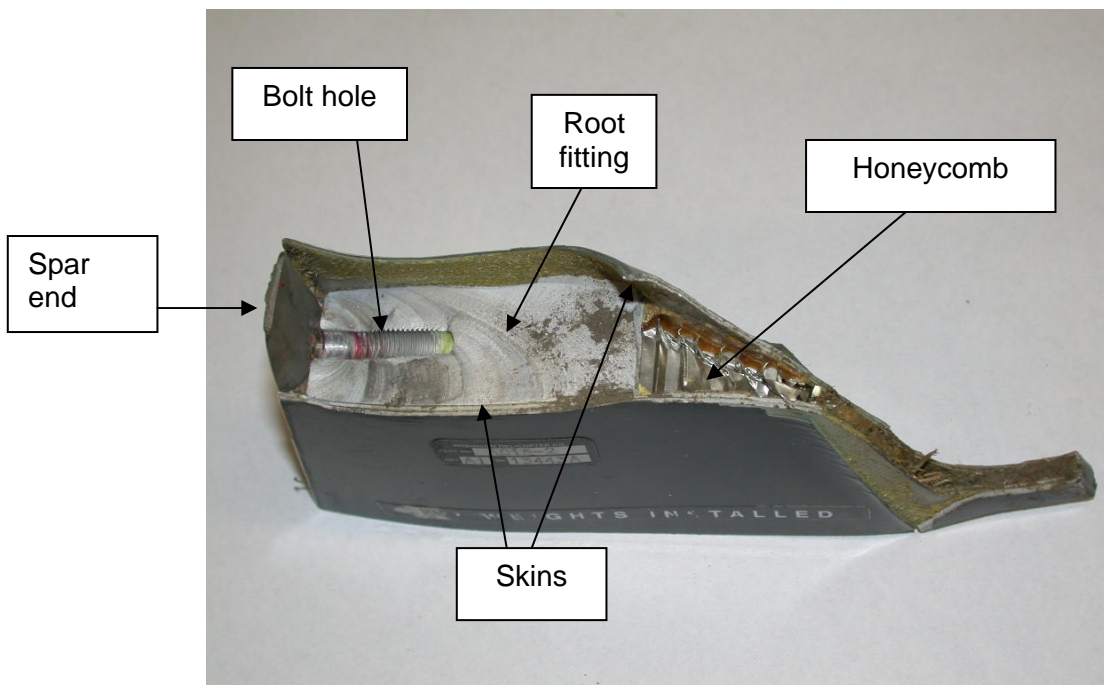
Various features of the fracture and the blade construction are illustrated in Figure 2. The fracture had run through the blade root fitting. This fitting appeared to be a solid aluminium component. A bolt hole was present at the position of the fracture. This bolt hole ran from the leading edge of the blade into the blade root fitting which had been drilled and threaded. The bolt attached the stainless steel spar to the root fitting (Figure 2). Behind the root fitting, the blade had a honeycomb filling between the skins. At the location of the fracture, there were 2 skins on either side of the blade. On one side of the blade (the black convex face), the skins had failed flush with the fracture surface through the root fitting. On the other side (the white concave face) of the blade, the skins had not fractured. Rather the glue joint

Figure 2. The fracture through the root fitting, the location of the bolt hole, the skins on either side of the root fitting and the honeycomb construction behind the root fitting.

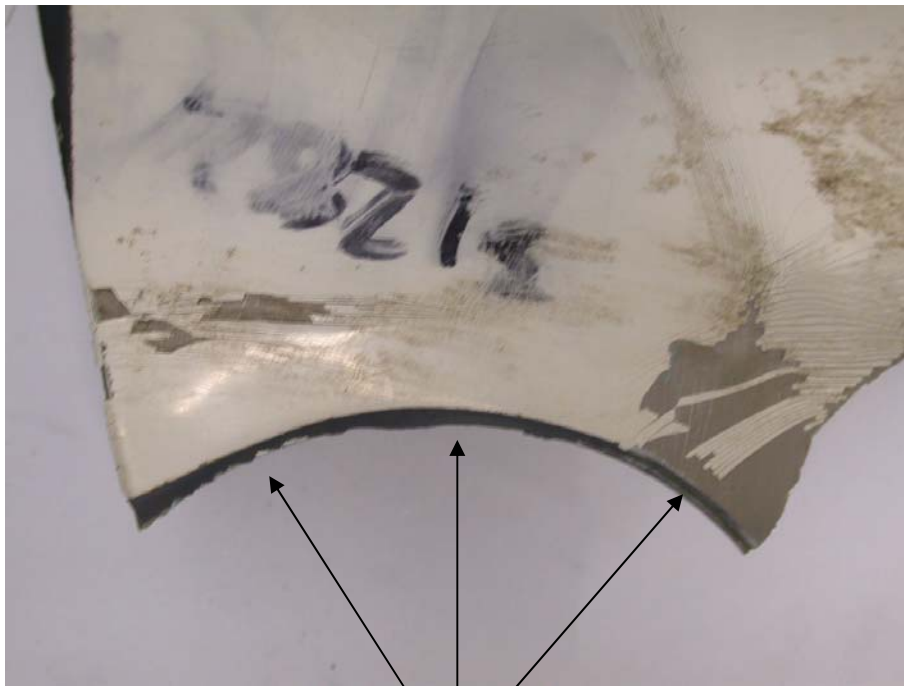
between the skin and the root fitting had failed and the circular shape of the skins where they originally butted up against the hub were revealed (Figure 3).

End of skin as manufactured

Figure 3. The "circular" end of the skins on the white concave side of the blade.

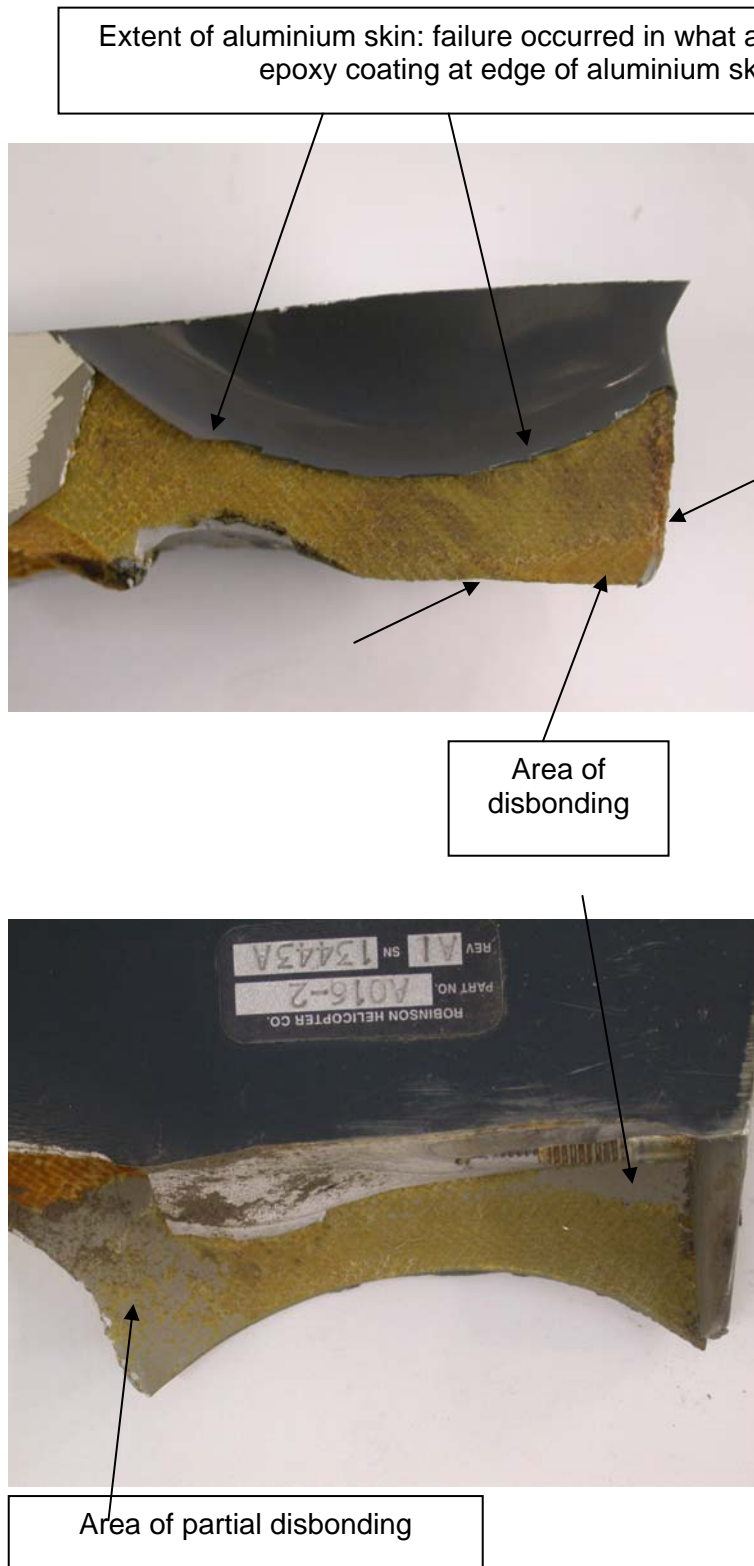
The failed glue joint between the skin and root fitting on the white concave side of the blade is shown in Figure 4. The upper illustration in Figure 4 shows part of the hub after it had been cut from the main part of the hub. The lower illustration shows the underside of the skin still attached to the blade root fitting. These two photographs therefore show the two faces of the original glued joint between the skin and the root fitting. Glue was present over most of the skin to fitting surfaces on both sides indicating that the glue joint had mostly been sound prior to the failure ie the glue was well attached to both surfaces. There was some minor disbonding where the failure had occurred at the glue to metal surface as illustrated in Figure 4.

Figure 4. The glue joint failure of the skin on the white, concave side of the blade.

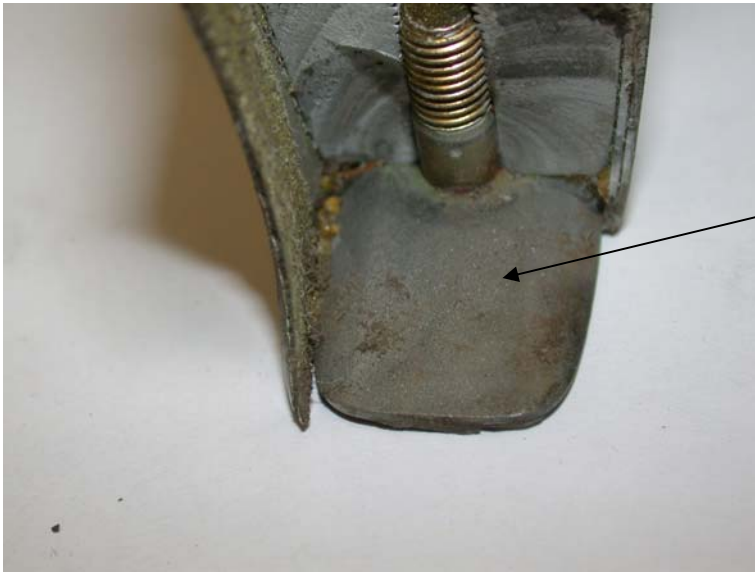
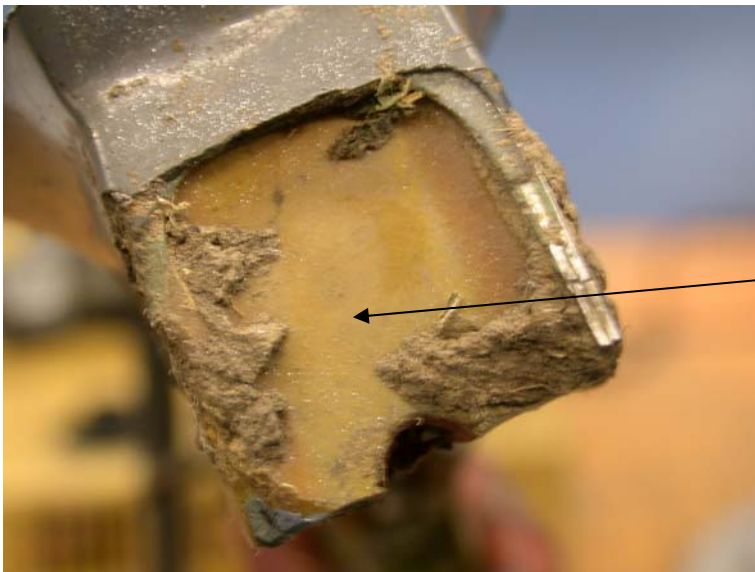
The part of the blade as received contained part of the spar through which the bolt passed. The end of the spar that projected beyond the fracture position in the main root fitting had no apparent trace of glue on the surface (Figure 5, upper picture). The opposite face to which the spar had originally been attached however, was completely covered in glue (Figure 5, lower picture). This particular joint therefore failed at the glue to metal interface rather than within the glue itself. It is possible that a poor glue joint existed at this location.

The front of the spar through which the bolt passed attaching it to the root fitting had separated from the fitting during the failure (Figure 5). The separation occurred along the glue joint between the glue and the root fitting. It is possible that this glue joint was poor or ineffective. It is not known how this glue joint would influence the failure. In principle at least, the joint would provide reinforcement against those stresses that acted to initiate and propagate the fatigue cracks in the root fitting. However, the total area of this glue joint is not great compared to the cross sectional area of the root fitting and it would be surprising if a sound joint at this position would sufficiently strengthen the assembly to prevent failure. The manufacturer has stated that the adhesive bonding helps transfer load between the spar and the root fitting. They further state however, that the bolts can handle the entire load.

5. Visual examination of the various components suggested that the glue joints were sound EXCEPT for the joint between the leading edge spar and the root fitting (Figure 5). The manufacturer has stated that this joint is not necessary for satisfactory performance of the blade.

Spar end: no apparent glue of this face

Opposite face: all glue.

Figure 5. The joint faces between the leading edge spar (top picture) and the main part of the root fitting. (lower picture)

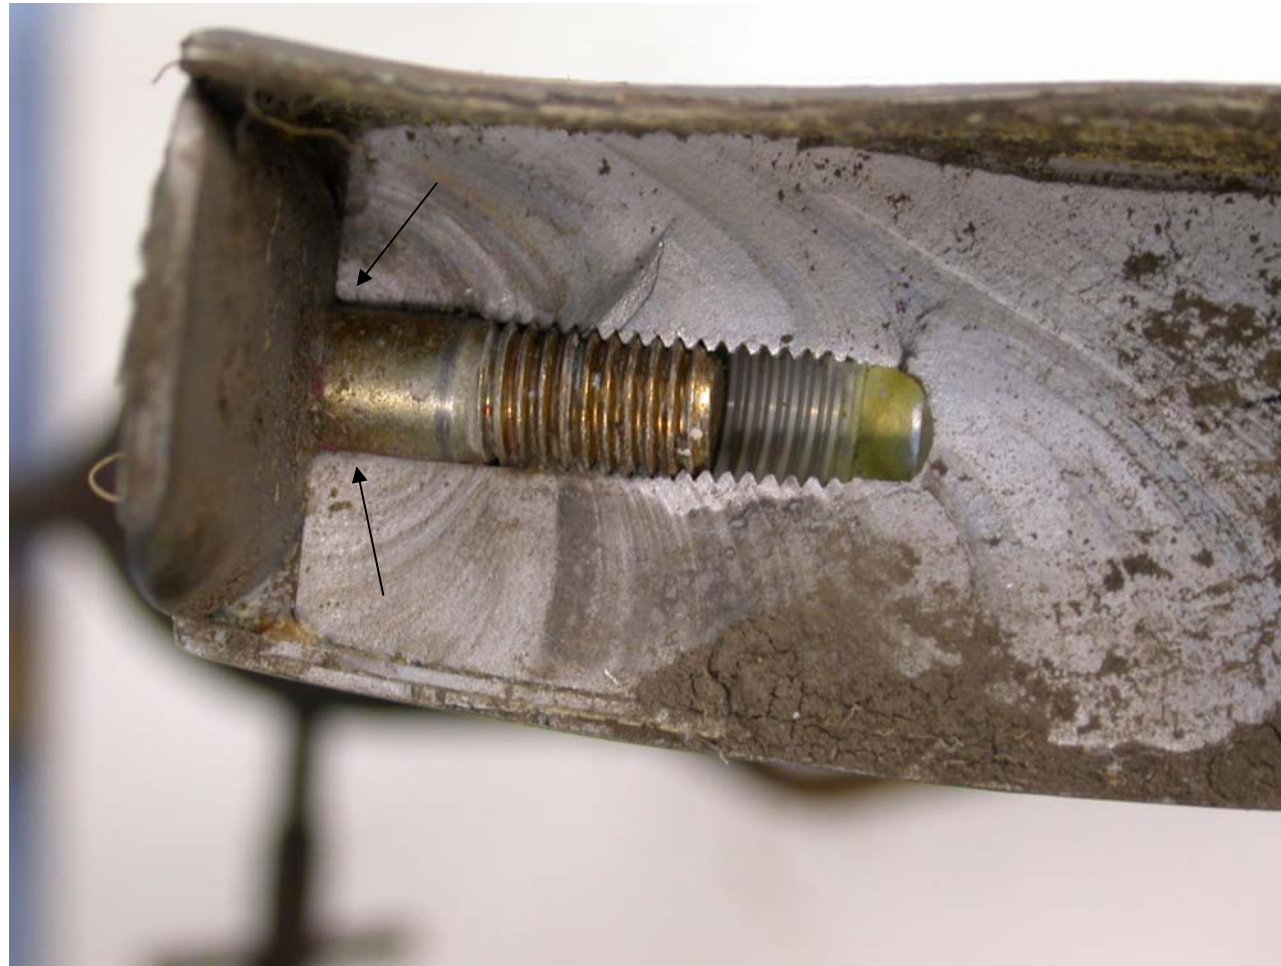
The fracture surface of the main root fitting is shown in Figure 6. The fracture was typical of a fatigue, almost a text-book example in fact, showing the characteristic “beach marks” spreading from the fracture origins as the crack propagated. These beach marks are produced by the crack arresting and re-starting. The number and distribution of these marks suggest that the crack propagated over a reasonably long period of time probably involving a number of take-off and landing cycles. There were two distinct fracture origins and these were on either side of the bolt hole approximately 1 to 2 mm from the leading edge of the root fitting (arrowed positions in Figure 6). The fracture propagated by fatigue through almost the entire depth of the root fitting before final failure occurred. Initially, the crack propagated outwards from the bolt hole towards the skin of the blade implying that the principal driving load was bending of the blade in the vertical plane (relative to the helicopter). The cracking then propagated to the rear of the root fitting. The pattern of beach/arrest marks indicate that the crack first initiated on the “black” side of the blade and may have propagated for some time prior to the crack forming on the other side.

The location of the fracture origins (Arrowed in Figure 6) were examined in some detail on both sides of the fracture and before and after removal of the bolt. The threads on the bolt had been of slightly greater diameter than the hole into which it screwed. Before the threads commenced there was a parallel section of the hole. Within this parallel section, the original threading tool had cut a shallow helical groove. On one side, the fracture origin appeared to coincide with this groove but on the other side it did not (Figure 8).

Figure 6. The fracture through the root fitting. The arrows indicate the location of the fracture origins on both sides of the bolt hole very close to the leading edge.

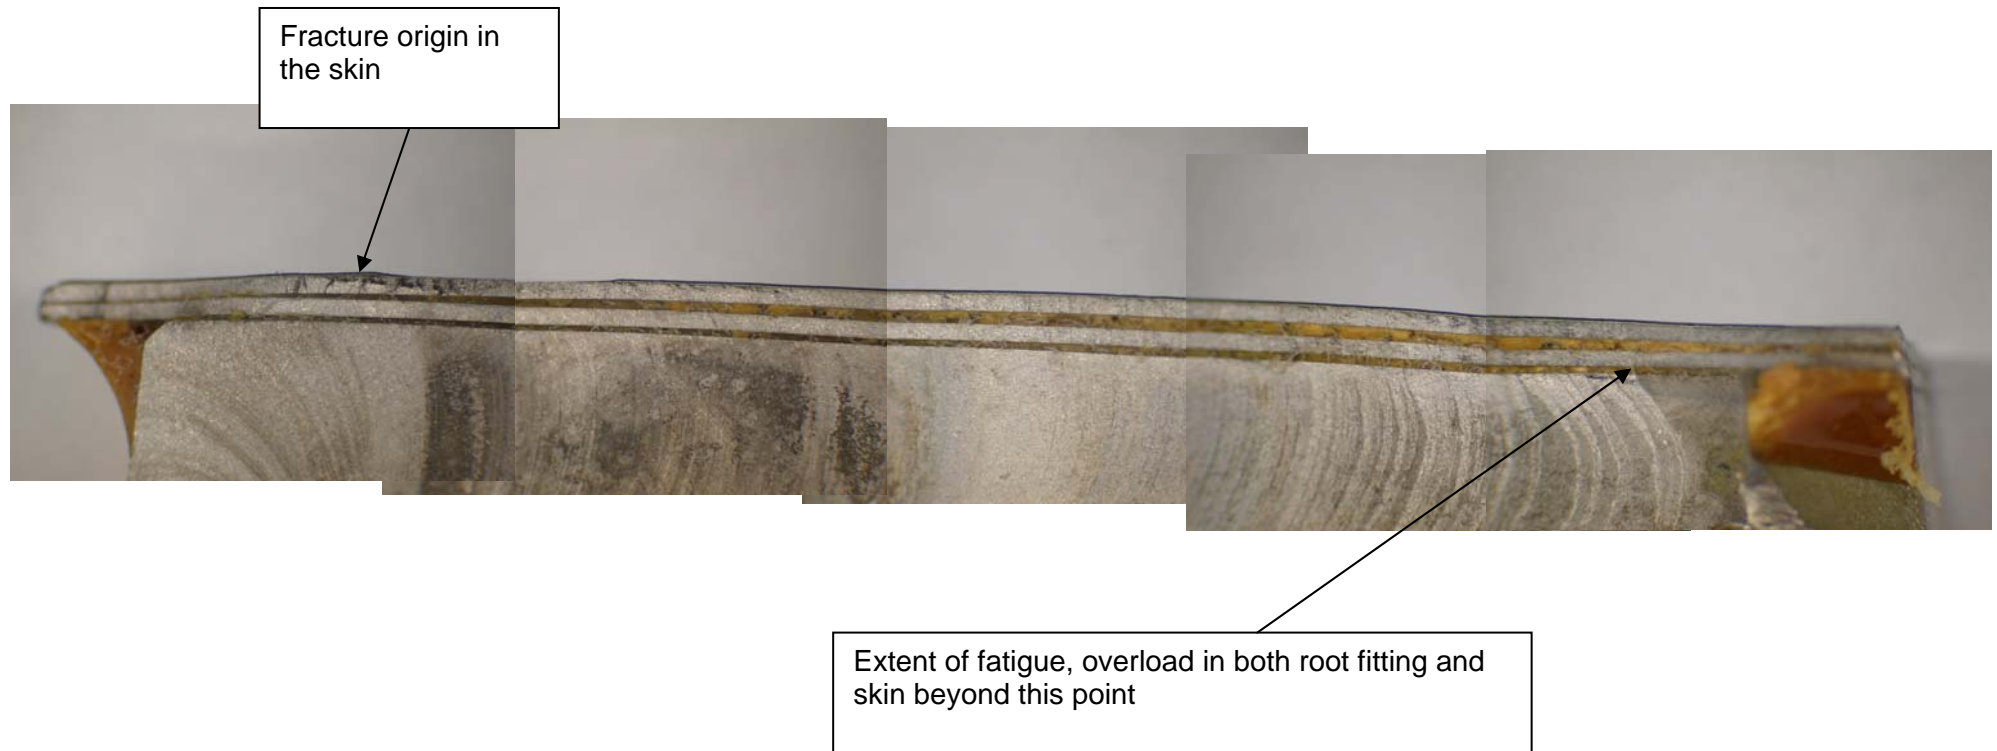
The skin failed by failure of the glue joint on the white concave side of the blade as described above. The failure of the skin on the black convex side of the blade is illustrated in Figure 7. The fracture in the black-side skins was fatigue originating at the indicated position in Figure 7. Also shown in Figure 7 is the position to which the crack had propagated by fatigue prior to final overload failure of the remaining section. The glued joint between the skin and between the inner skin and the root fitting appeared to be intact and in good condition along this joint.

Figure 7. The failure of the skins on the black convex side of the blade.

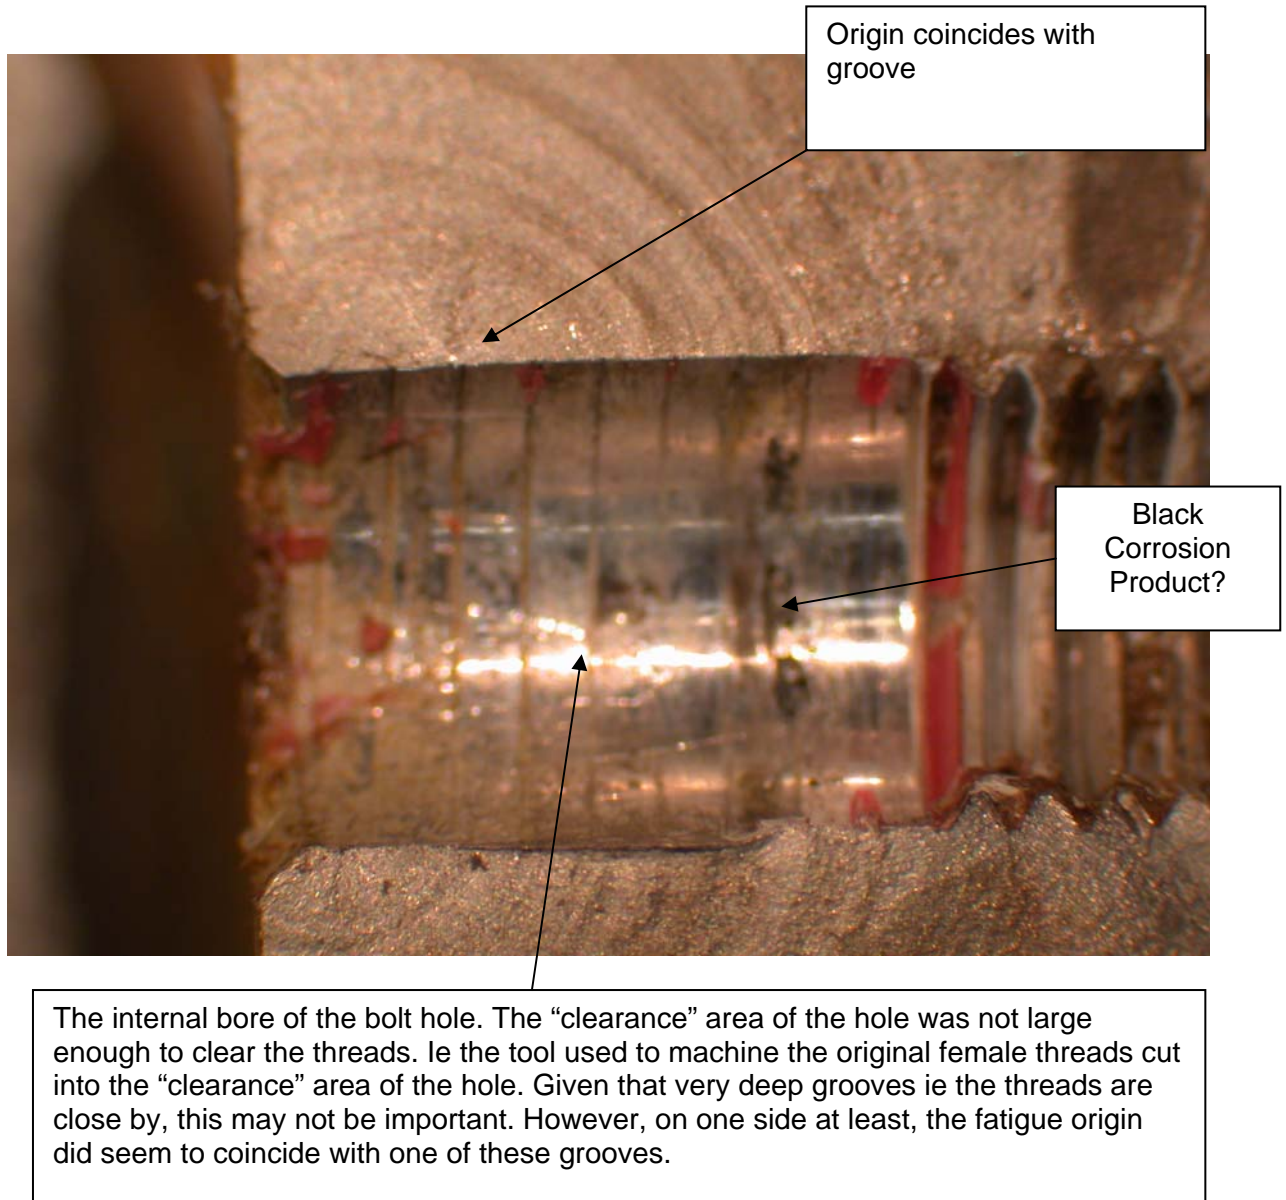
Other than the spiral groove, in the area of the origins, the bolt hole looked clean with no apparent corrosion or other damage (Figure 9). There was one area that was black in colouration and may have been caused by corrosion (Figure 8). However, this small patch was not associated with either fracture origin.

Figure 8. Bolt hole and fracture origins.

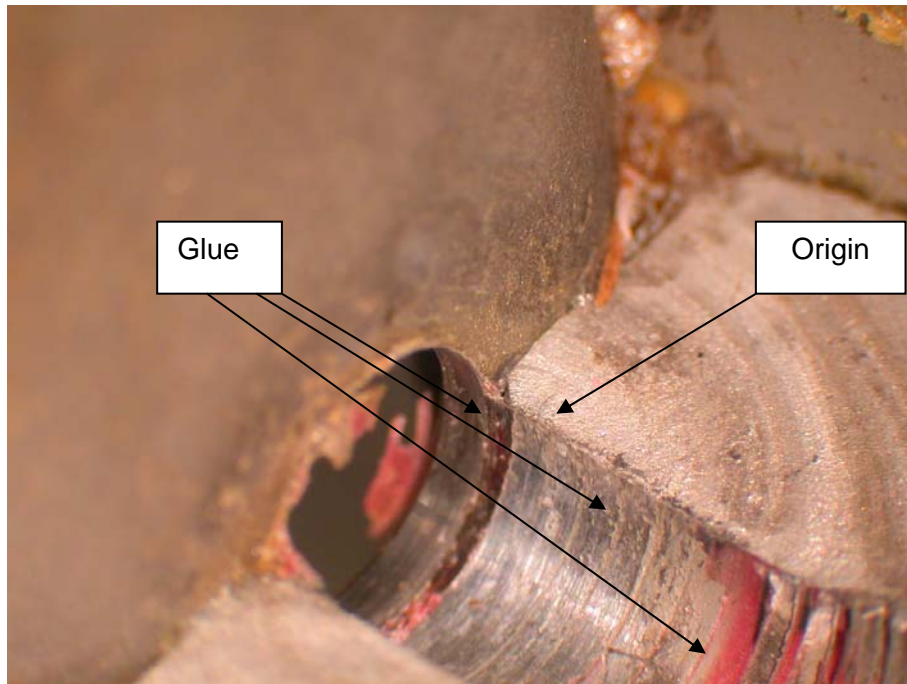
Figure 9. Bolt hole bore at position of fracture origin in root fitting.

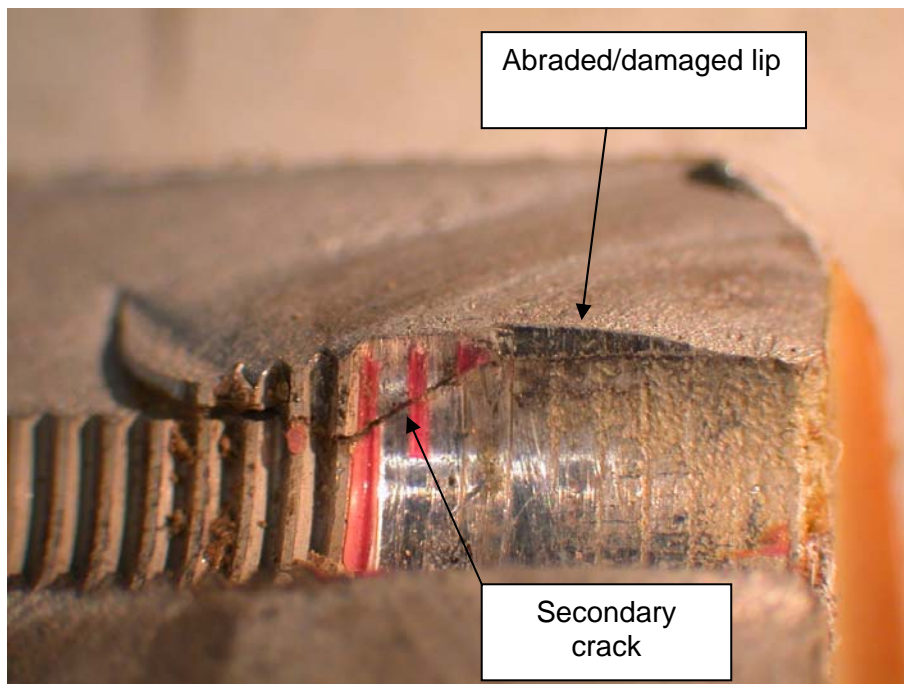
On one side of the fracture, there was a second crack (Figure 10). This was believed to have been caused by a second fatigue crack that originated just below the main crack. The second crack then propagated until it merged with the main crack. Adjacent to this was a damaged/abraded area (Figure 10). This was probably caused by the bolt as it moved past the edge of the hole at the time of the failure.

Figure 10. Second crack at origin.

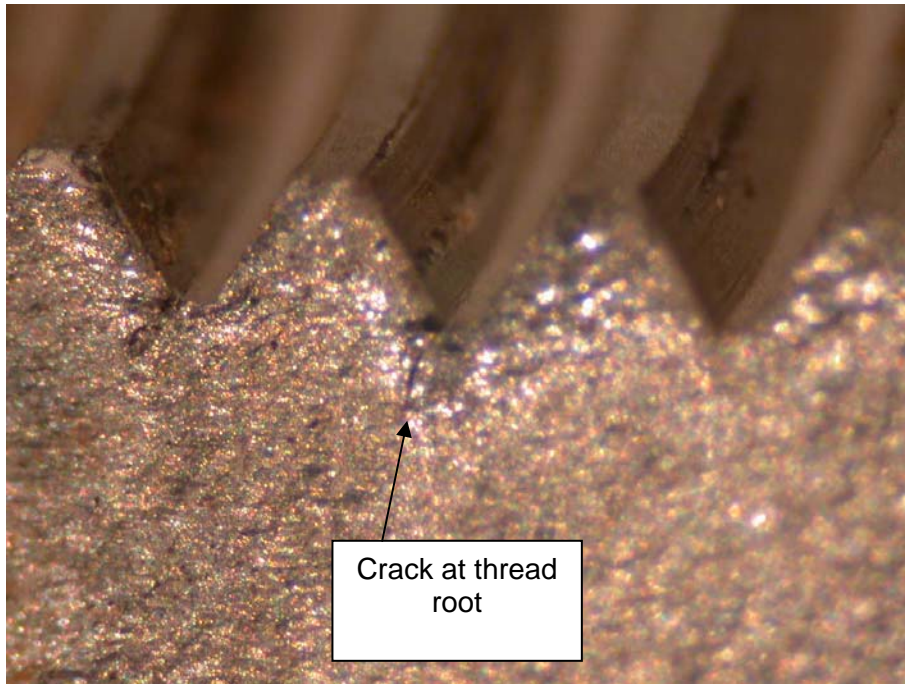
Examination of the threads cut into the root fitting revealed that a number of these had also begun to crack. An example is illustrated in Figure 11. These small cracks were at right angles to the main crack that caused the failure and were caused by loads along the axis of the bolt hole acting to separate the root fitting and the spar. The source of these loads is not known but they may have been caused due to reduction in stiffness of the root fitting as the main fatigue cracks propagated. i.e. the root fitting would have flexed to a greater extent as the main crack propagated. This in turn would have generated higher loads tending to separate the spar and the root fitting.

Figure 11. Cracking at root of thread.

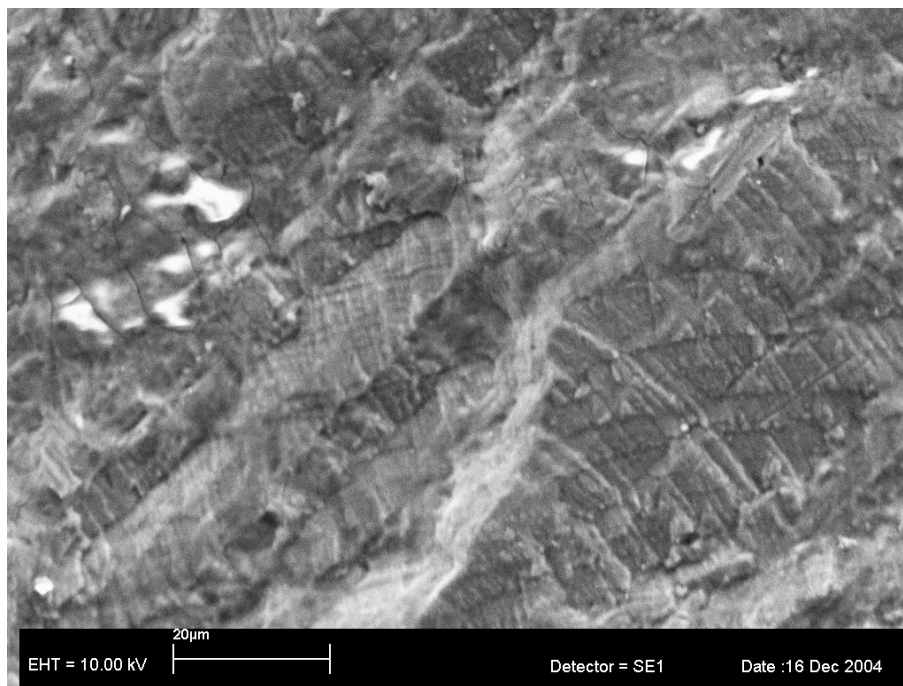
The samples were examined in a scanning electron microscope. In the main root fitting, typical fatigue striations were observed (Figure 12). Attempts were made to identify defects or pits for example that may have encouraged initiation of fatigue. However, no such features were observed (Figure 13).

Figure 12. Fatigue striations on fracture surface of root fitting, Scanning Electron Microscope image.

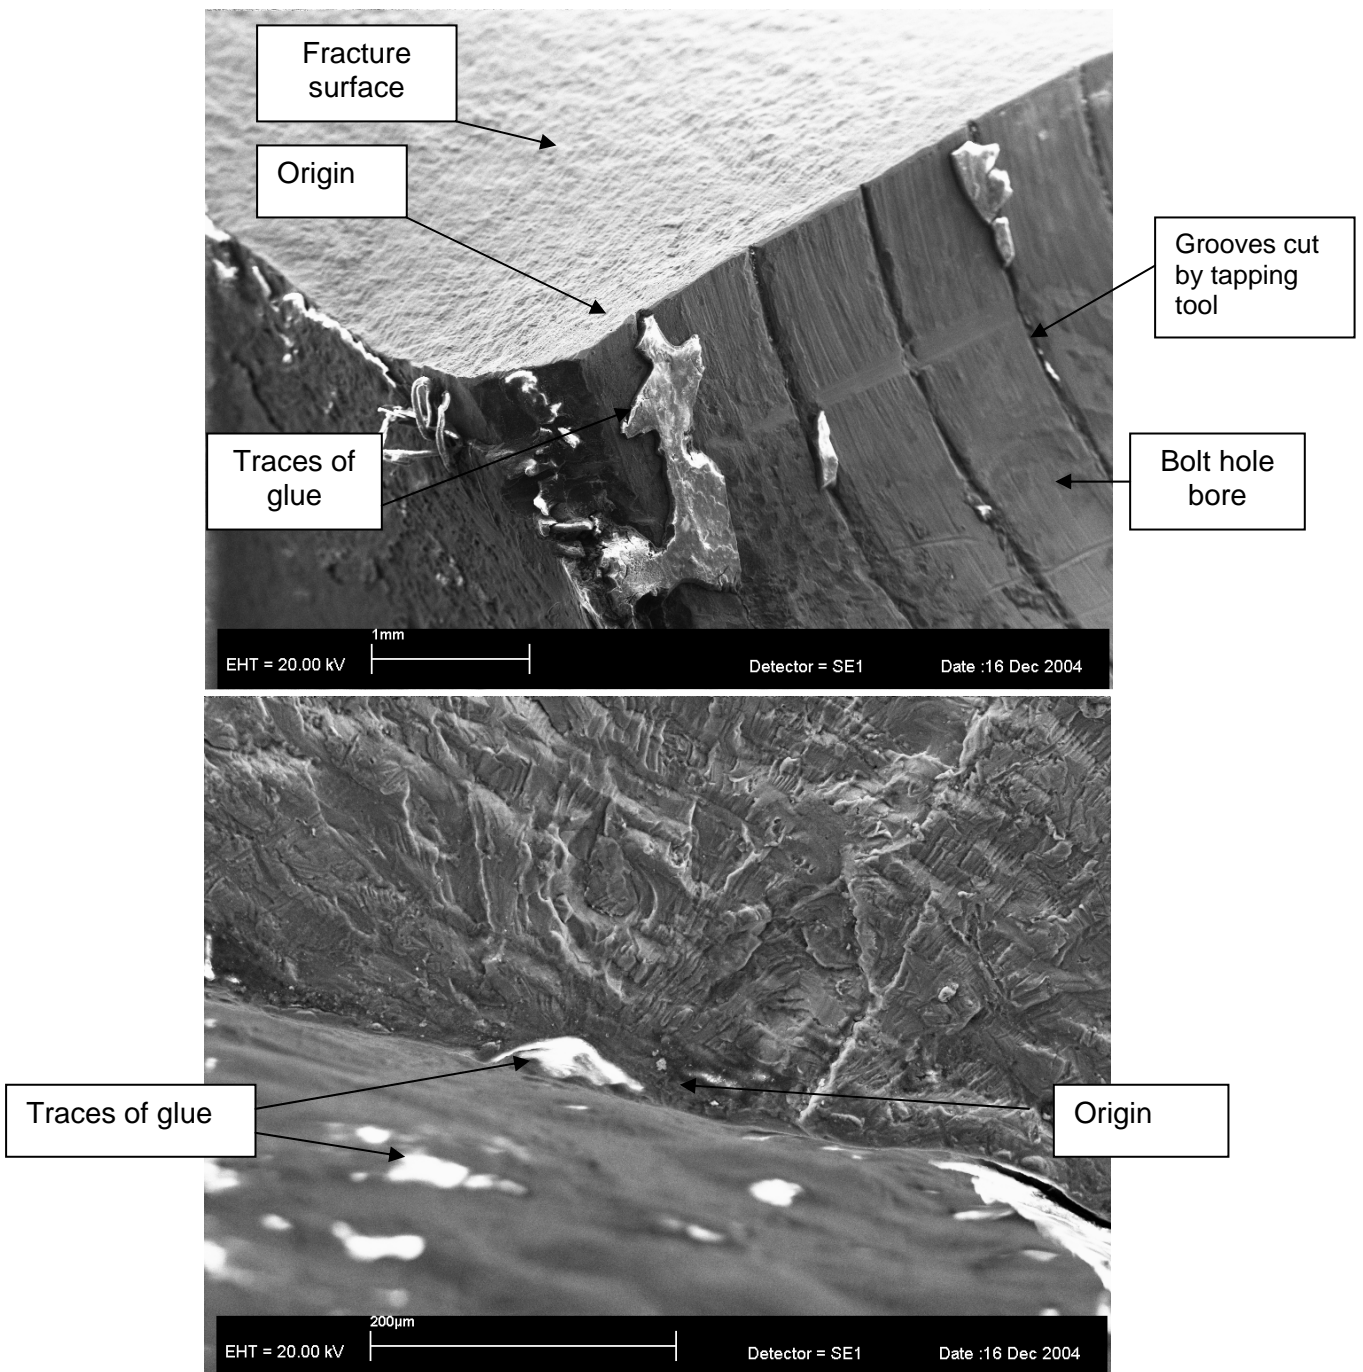
Figure 13. Junction of fracture surface and bolt hole bore at fracture origin.

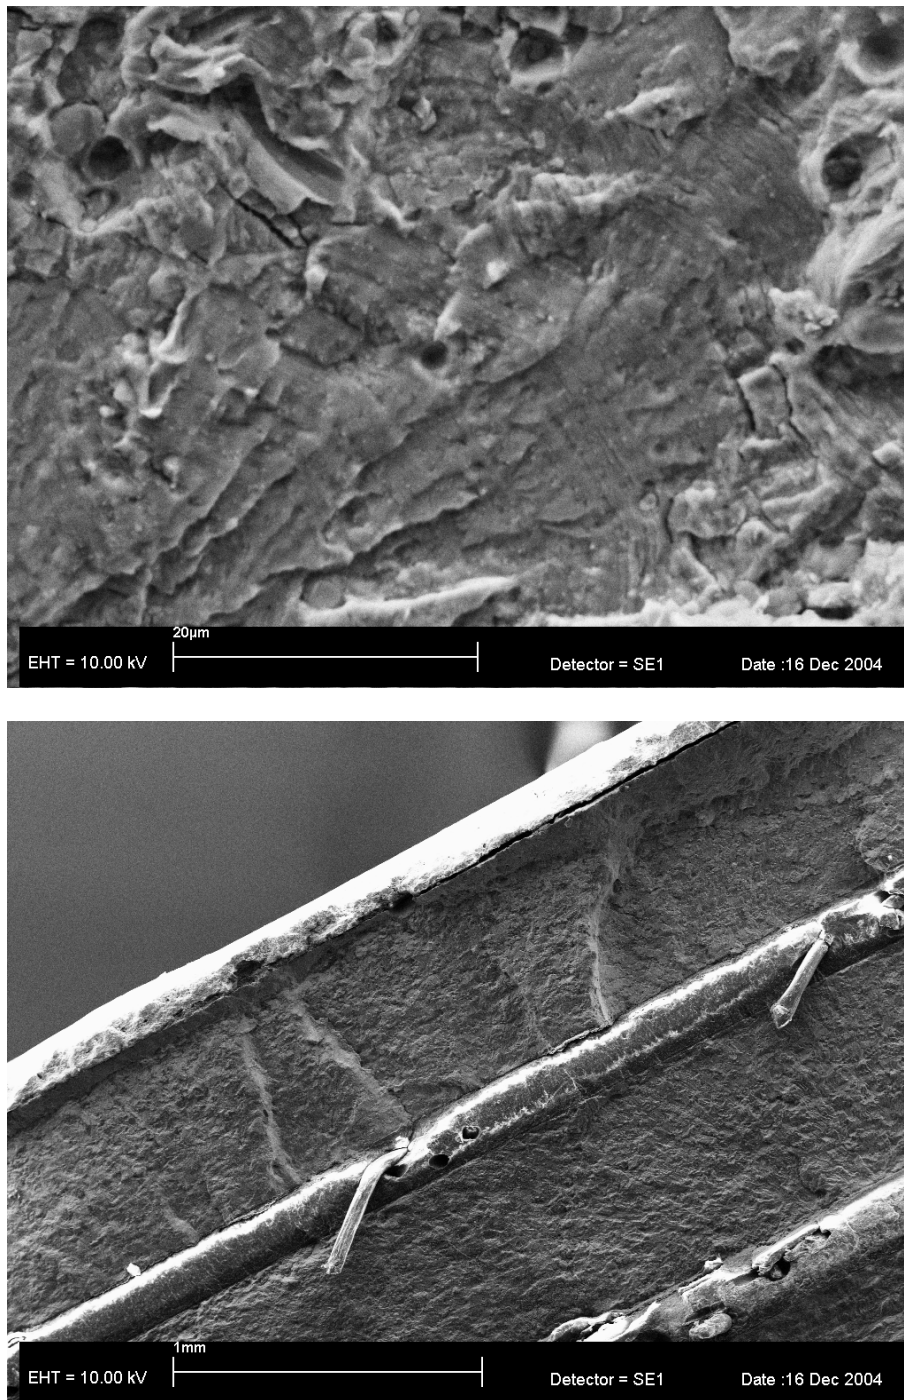
The fracture in the skin was similarly examined. The fracture origin had a number of steps or “castellations” typical of fatigue and fatigue striations were observed (Figure 14). Again, no defects or other features that may have initiated fatigue were noted.

Figure 14. Fatigue striations (top) and castellations (bottom) at the origin indicative of fatigue crack initiation and propagation.

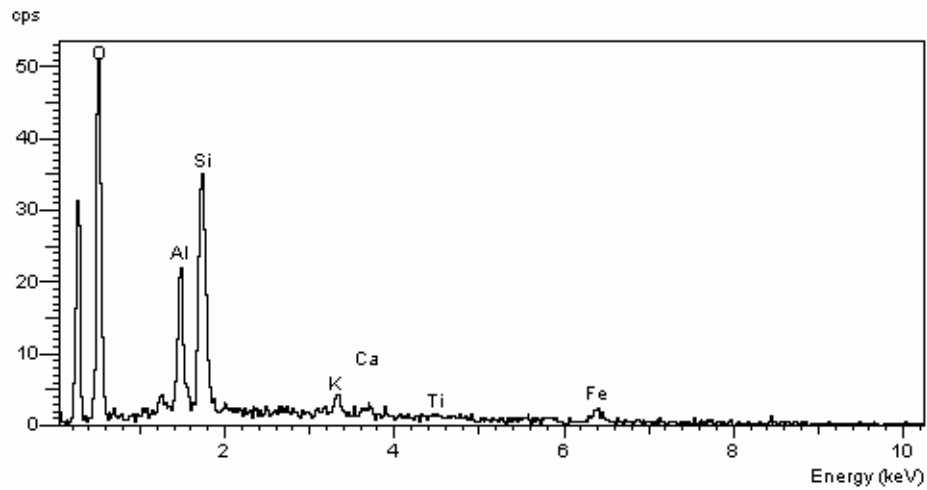
Figure 15. EDA spectrum of small amount of deposit stripped from fracture surface; believed to be indicative of soil contamination picked up at the time of the crash.

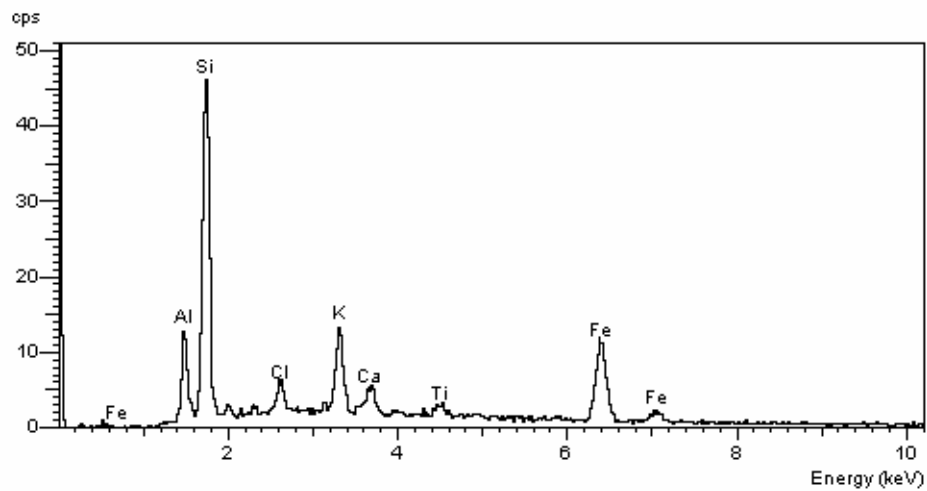
Figure 16. EDA spectrum of small amount of deposit stripped from the bolt hole. Believed to be mainly soil but possible a small amount of chloride.

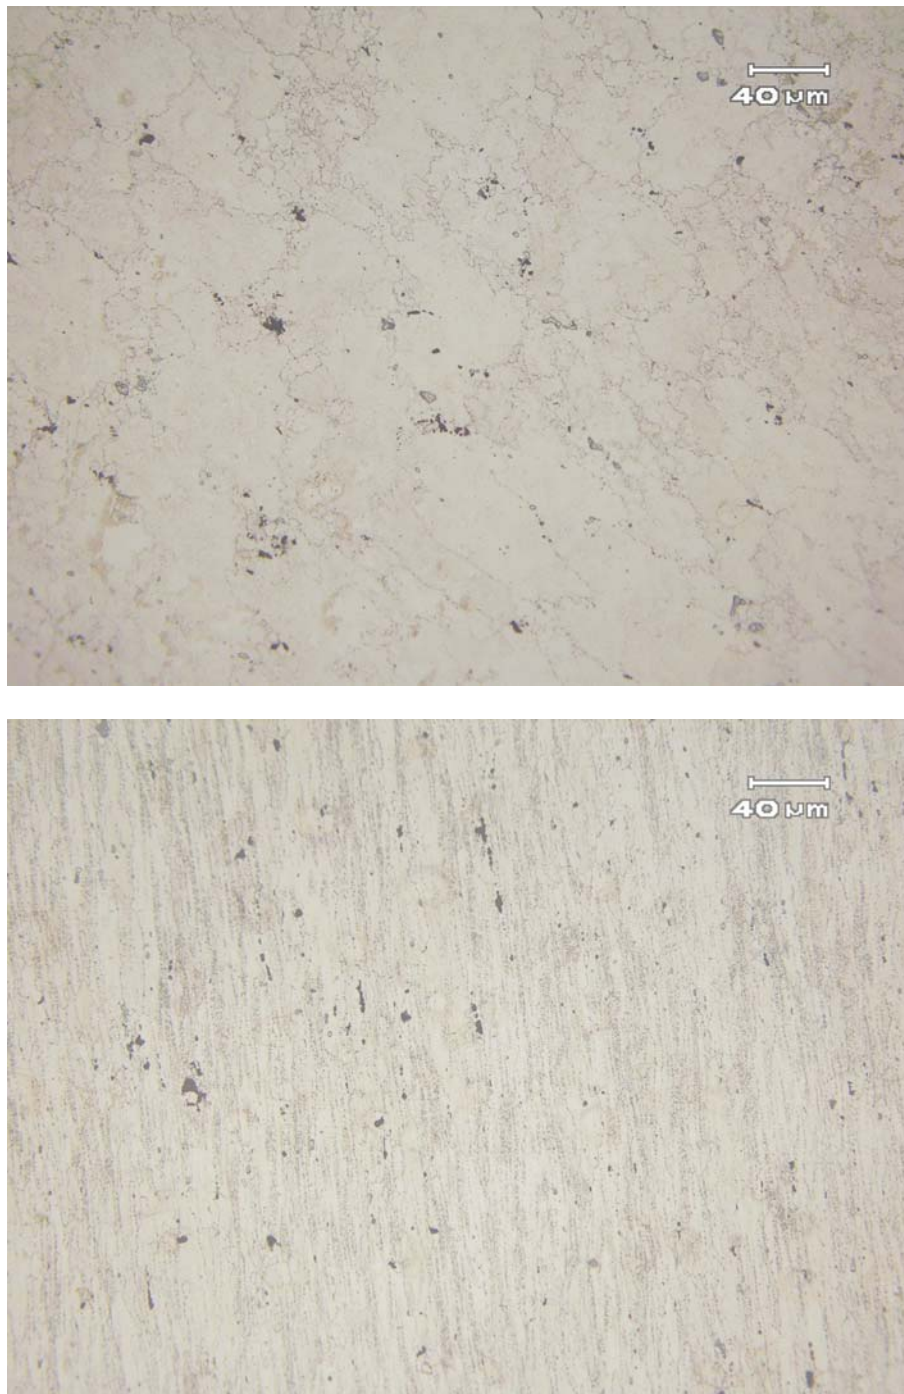
A sample of material from close to the fracture in the root fitting was polished and etched using metallographic techniques suitable for aluminium alloys. The microstructure is shown in Figure 18. The material had a strongly textured structure consistent with the manufacturing process eg extrusion used to manufacture the root fitting ie the grains were heavily elongated parallel to the fitting axis. The various microstructural features have not been positively alloyed but the microstructure was considered to be consistent with grade 7075 series wrought aluminium alloy.

Figure 18. Microstructure of root fitting material; top transverse section; bottom longitudinal section.
