# Airworthiness Directive Schedule

### Piper PA-28 Series (Cherokee, Cruiser, Warrior, Archer, Pathfinder, Dakota, and Arrow)

30 May 2024

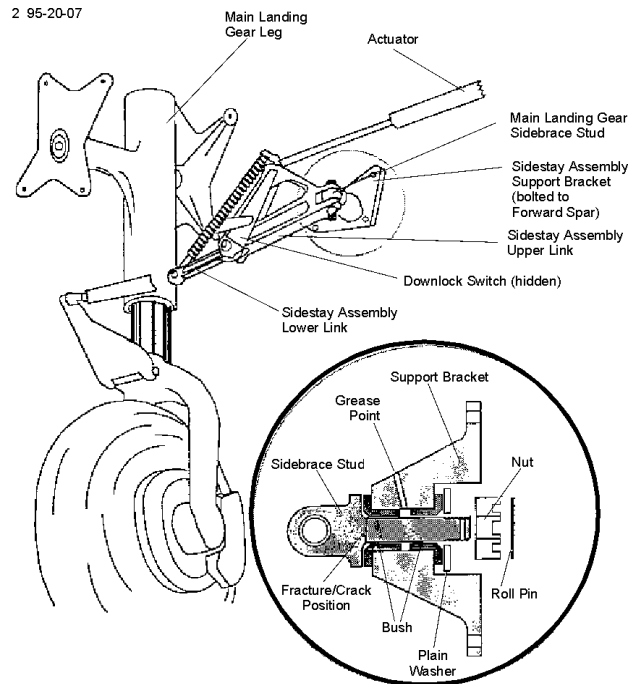
- Requirement:** To prevent main landing gear (MLG) collapse due to possible main gear sidebrace stud cracks which if not detected and corrected could result in loss of aircraft control during landing, accomplish the following:  
Remove both the left and right main gear sidebrace studs from the aircraft per the instructions in the landing gear section of the aircraft MM. Inspect both the main gear sidebrace stud for cracks using Type I (fluorescent) liquid penetrant or magnetic particle inspection methods. Figure 1 of this AD depicts the area where the sidebrace stud is to be inspected.

**Note:** This figure is provided to depict the area of the sidebrace stud to be inspected. This is not intended to represent the configuration of all models affected.

For any main gear sidebrace stud not found cracked, before to further flight reinstall the stud per the instructions in the Landing Gear section of the applicable MM, and reinspect and replace (as necessary) per this AD.

For any main gear sidebrace stud found cracked, before to further flight replace the cracked stud with a serviceable part per the instructions in the Landing Gear section of the applicable MM and accomplish one of the following, as applicable:

- Reinspect and replace (as necessary) per the repetitive requirements in this AD, or
- For affected PA28R-180, PA28R-200, PA28R-201 and PA28R-201T aircraft the 9/16 inch main gear sidebrace studs (P/N 95299-00, 95299-02 or 67543 as applicable) are no longer manufactured: Install a new main gear sidebrace stud bracket assembly P/N 95643-06, 95643-07, 95643-08 or 95643-09 as applicable. No repetitive inspections will be required by this AD for these affected aircraft models when this bracket assembly is installed on both the LH and RH sides, or

- Ream the existing two-piece bushings P/N 67026-6 to an inside diameter of .624 inch to .625 inch, chamfer the head side of the bushing to accommodate the radius in the shank of the main gear sidebrace stud and install the 5/8 inch stud P/N 78717-02. No repetitive inspections will be required by this AD when this action is accomplished on both the LH and RH bracket assemblies. If the bushings cannot be reamed while installed in the bracket (i.e., the bushings are loose), then install a main gear sidebrace bracket assembly P/N 95643-06, 95643-07, 95643-08 or 95643-09, as applicable.
