Continuing Airworthiness Notice – 25-004

Helicopter Lifting Equipment – Load cell failures in service

11 September 2024

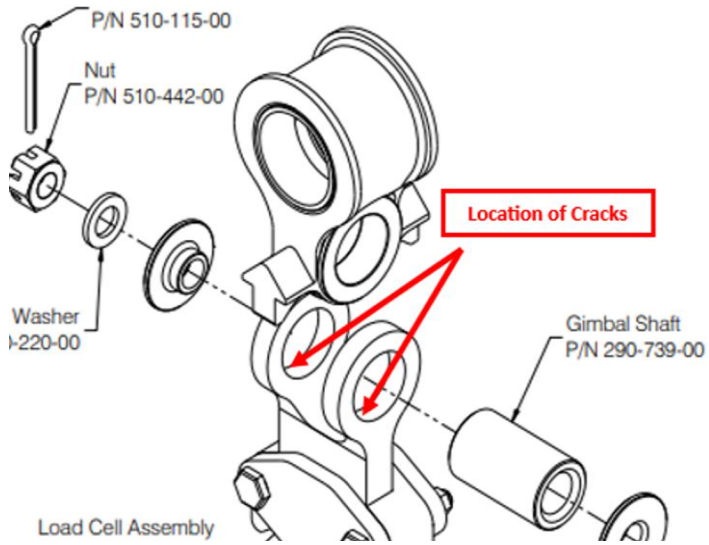
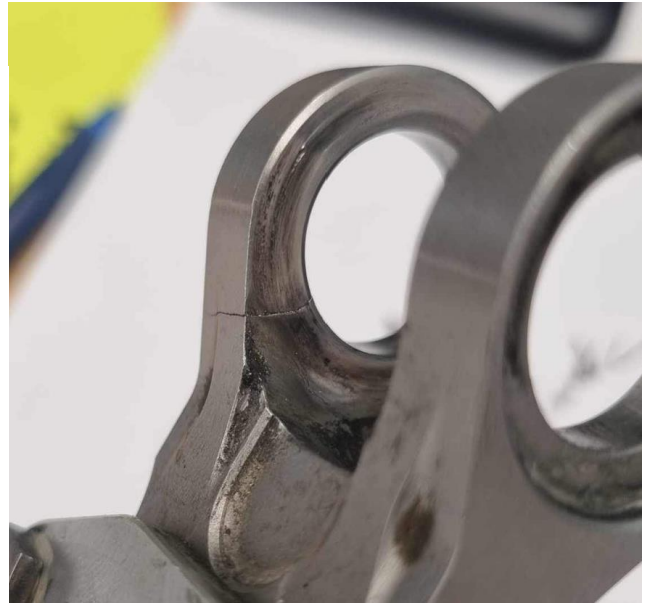
In one reported incident the failure of the load cell was identified during a routine inspection. CAA are advised that the load cell had cracked through the complete thickness of the attachment lug, but the link had not completely failed. Refer Figure 1 below.

Figure 1 – Cracked load cell attachment lugs.

Operators are advised that helicopter external load equipment should be inspected in accordance with CAR 133.307. Equipment which is subject to heavy use over a reduced time period, such as lifting equipment in an ag operation, should also be inspected at the start of each day of operations to ensure it has not suffered damage or deterioration beyond the manufacturer's limits. Operators are advised to pay particular attention to areas of lifting equipment subject to torsional loads, or wear and deformation in service, as these tend to be areas where cracks can initiate.

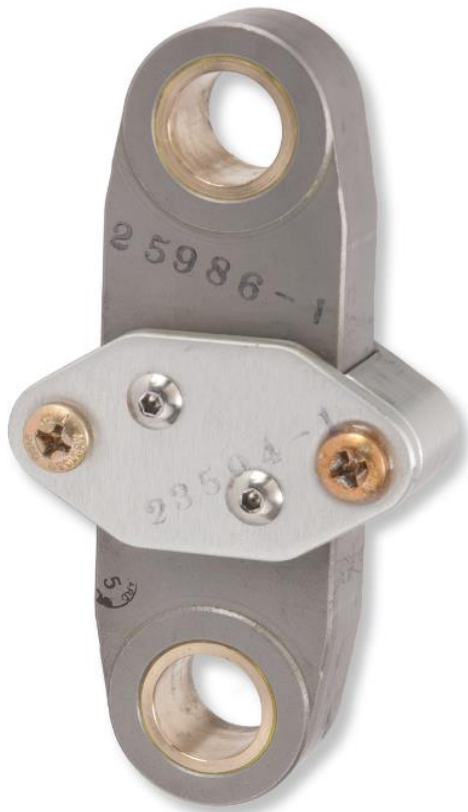
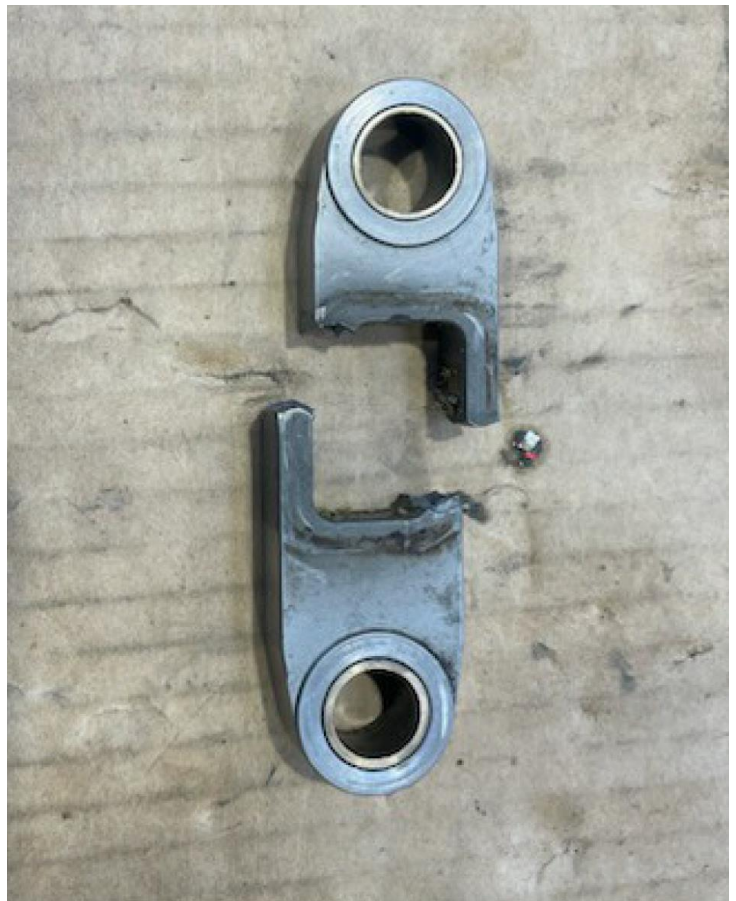
In the other reported incident the load cell link suffered a complete failure resulting in the loss of the underslung load. Refer Figure 2 below.

Figure 2 – Failed load cell link.
