Continuing Airworthiness Notice 27-026

Guimbal Cabri G2 Helicopters – Cracked Pilot Cyclic Base

22 September 2023

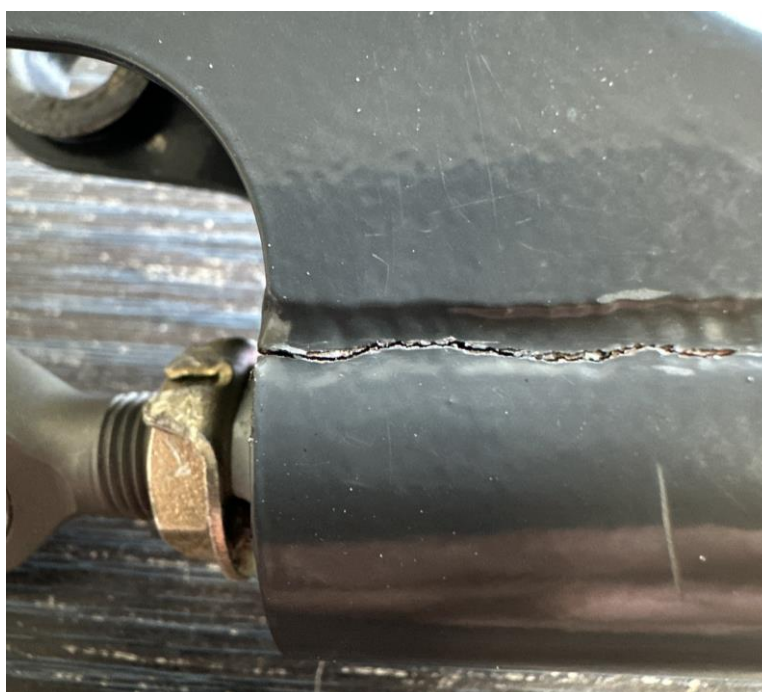
The CAA has received a report from a maintenance provider of finding a significant crack in the cyclic base on the pilot side (RH) of a Cabri G2 helicopter. Refer to Figure 1 below for further details.

While carrying out Guimbal Mandatory Service Bulletin (MSB) 23-006A, engineers found a crack in the pilot cyclic base P/N G41-42-801 (IPC Ref. IPC4.3-00 Rev C Item 18).

It is not clear if a specific event, or the aircraft age are contributing factors to the initiation of the crack.

Figure 1 Cracked Pilot Cyclic Base P/N G41-42-801

The cracked part was removed from service pending installation of a serviceable replacement.

This finding highlights the importance of operators ensuring that they assess and give due consideration to following manufacturer service information.
