AVIATION SAFETY SUMMARY

JANUARY – MARCH 2019

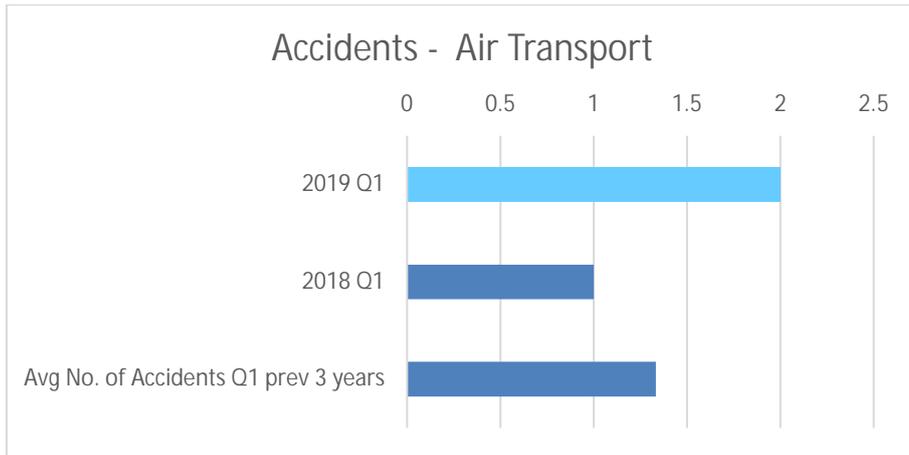
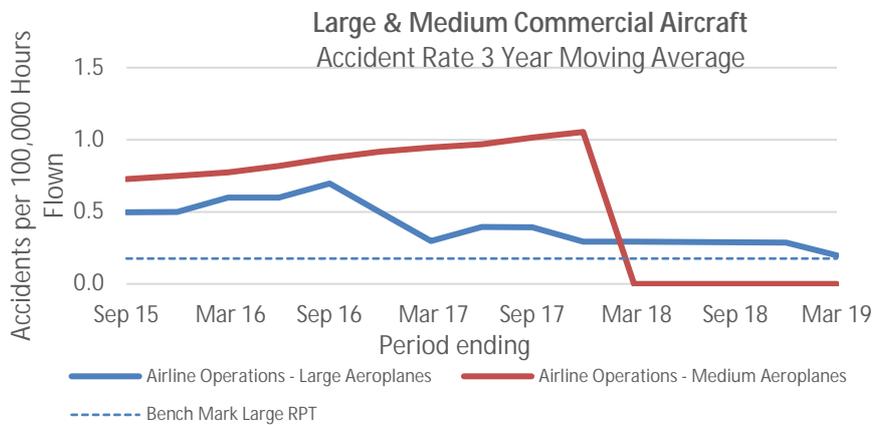
There were two air transport accidents in the first quarter of 2019. This is up on the same period last year, and greater than the average of the previous three years.

The large aeroplane sector had no accidents in this period and the three year average rate has decreased to a level comparable to the benchmark (Australian Regular Passenger transport)

The three year average accident rate for medium aircraft in commercial passenger operations remains at zero as the last accident was more than three years ago.

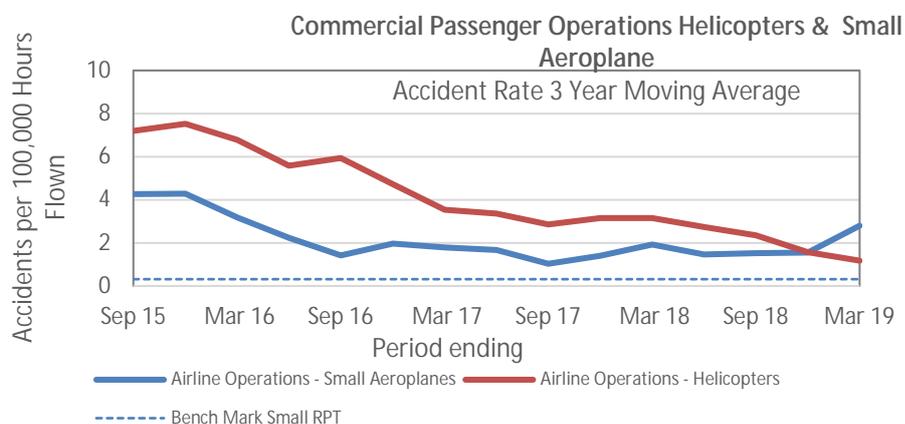
The three year average accident rate for small aeroplane on air transport has increased due to the two accidents this quarter.

The three year average accident rate for helicopters on air transport operations continues to reduce.

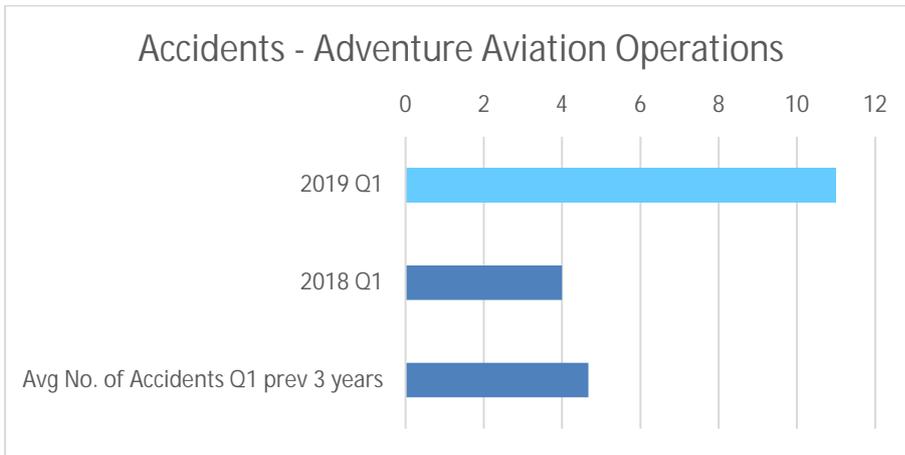
There were eleven accidents in the Adventure Aviation sector in the first quarter of 2019. This is significantly higher than for the same time last year, and also higher than the average number of accidents in the sector for the previous three years.

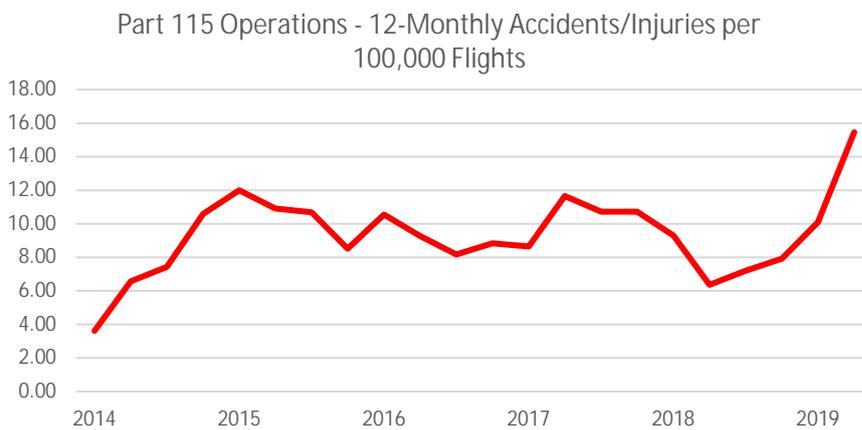
Accident rates

The accident rate for part 115 adventure aviation has increased in late 2018 and early 2019.

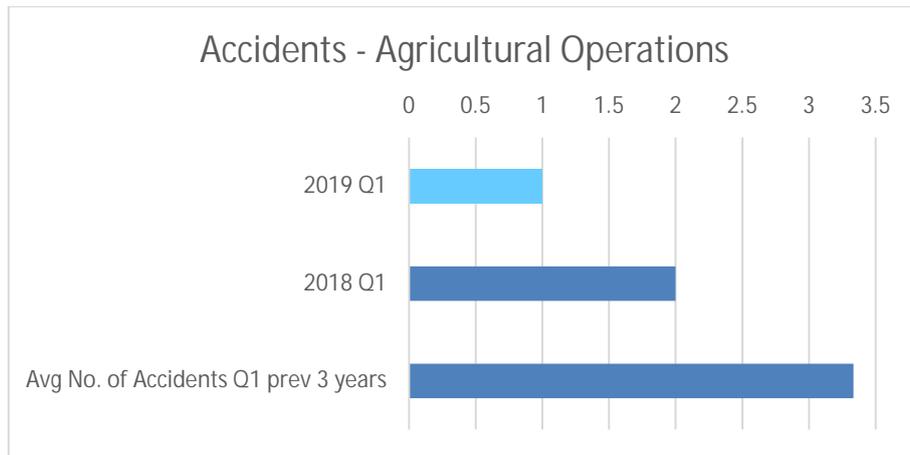
There was one accident in Agricultural Aviation sector in the first quarter of 2019. This is lower than for the same period last year, and also lower than the average of the preceding 3 years. The accident was a wire strike by a helicopter on agricultural operations

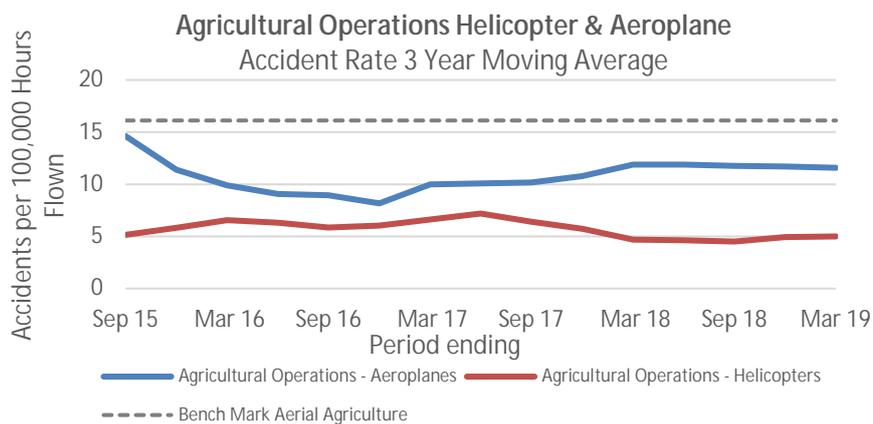
Accident rates

The three year average accident rates for agricultural operations by fixed wing aircraft and helicopters are showing a stable or downwards trend that remains below the benchmark.

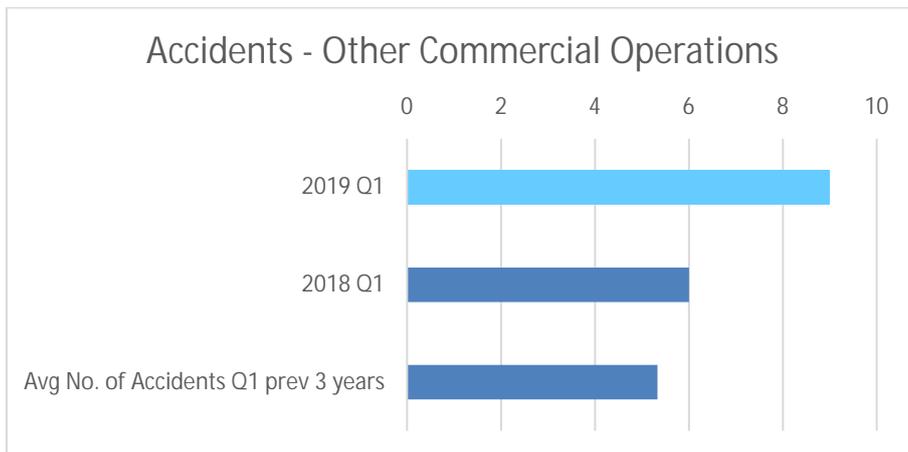
There were nine accidents in Other Commercial operations in the first quarter of 2019. This is three more than in the same period in the previous year, and greater than the average number of accidents in the first quart of the previous three years.

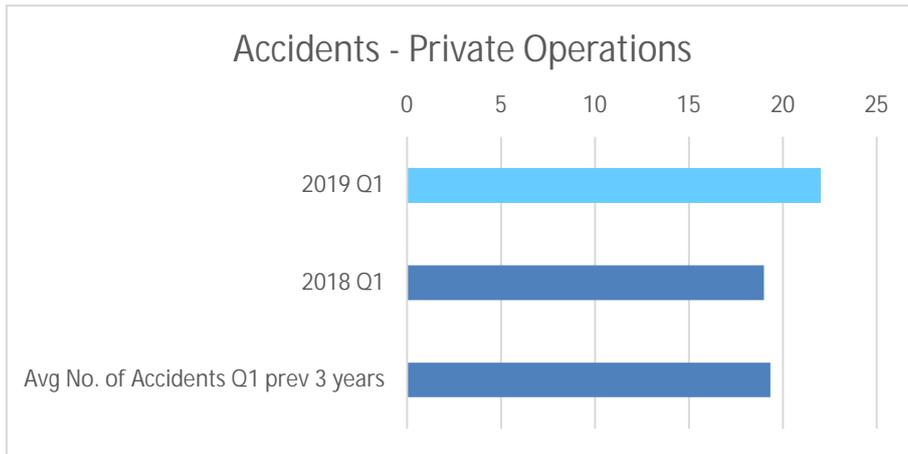
There were 22 accidents in private operations for the first quarter of 2019. This was three more than in the same quarter in the previous year and also more than the average of the preceding 3 years.

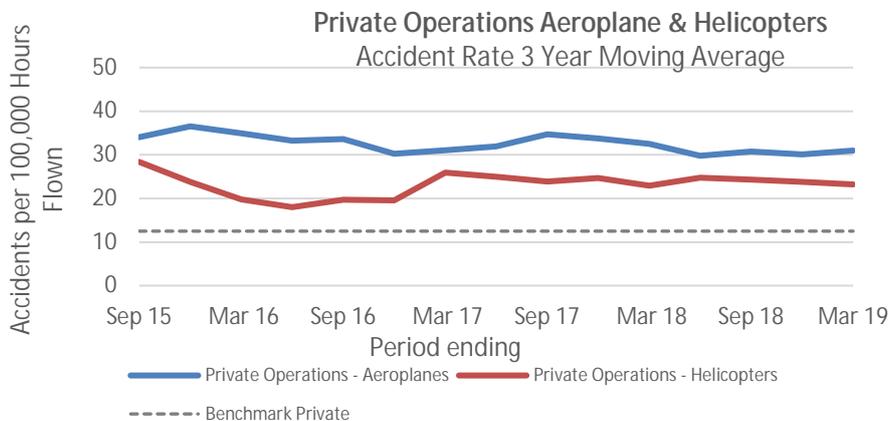
Accident Rates

The number of accidents in private & recreational sector this summer quarter was slightly more than last summer (22 against 19 in 2018). There were no fatalities this summer in the private and recreational sector. This is contributing to the downwards trend in the three year average accident rates displayed below.

The accident rate graph does not include recreational microlight aircraft, parachutes or hang-gliders. No activity data is collected for these aircraft types which precludes the calculation of an accident rate. It should be noted that 18 of the 22 private & recreational accidents this quarter involved non-certified sport aircraft, hang-gliders or parachutes.

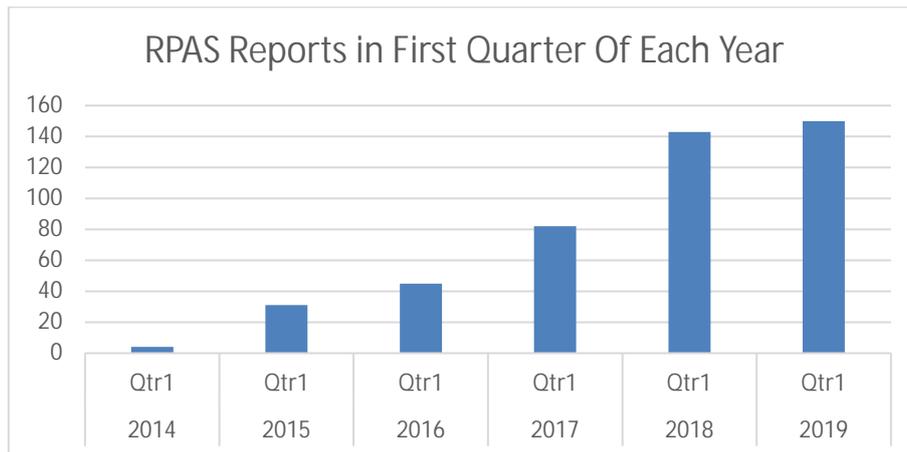
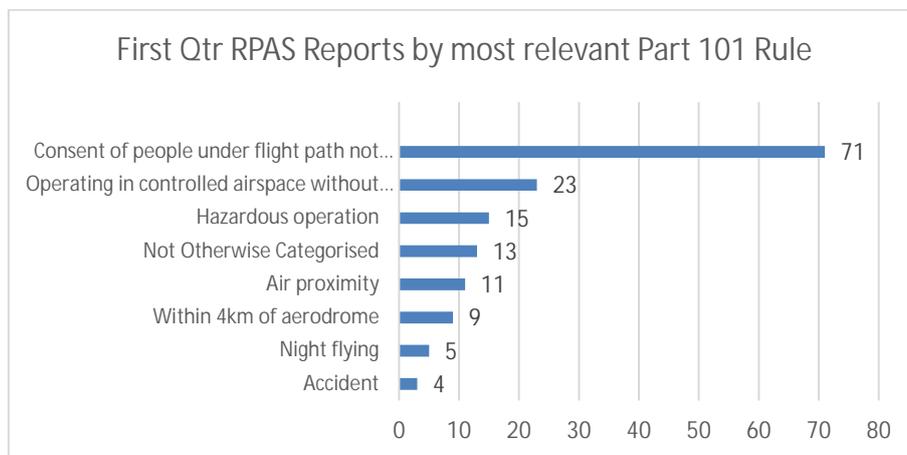
In the quarter ending 31 March 2019 there were 150 reported occurrences involving remotely piloted aerial systems (RPAS). This exceeds the number received in the same quarter in the previous 5 years, although the rate of the increase has slowed.

- The largest share of reports (47%) continues to be complaints from members of the public about drones operating over and around them or their property.
- There were four accidents which resulted in damage or destruction of the RPAS.
- There were 11 reports of RPAS operating in proximity to airborne aircraft. These were provided by Airways NZ or aircraft operators and represent 7% of RPAS reports.
- There have been no injuries or damage to conventional aircraft by RPAS in this quarter or the previous 5 years.
