# AGEING AIRCRAFT WIRING

// By Philip Hutchings, South Pacific Avionics

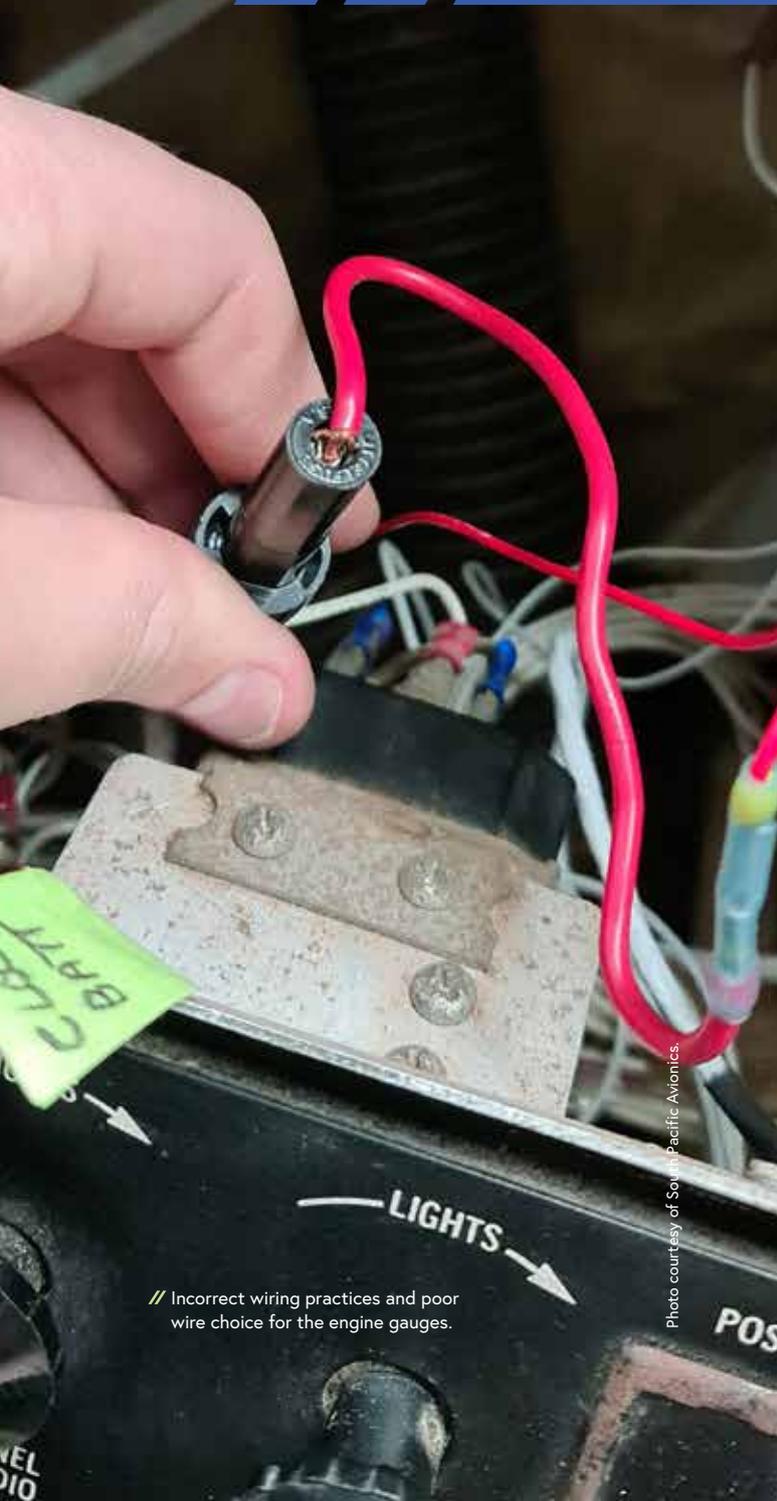
// Incorrect wiring practices and poor wire choice for the engine gauges.

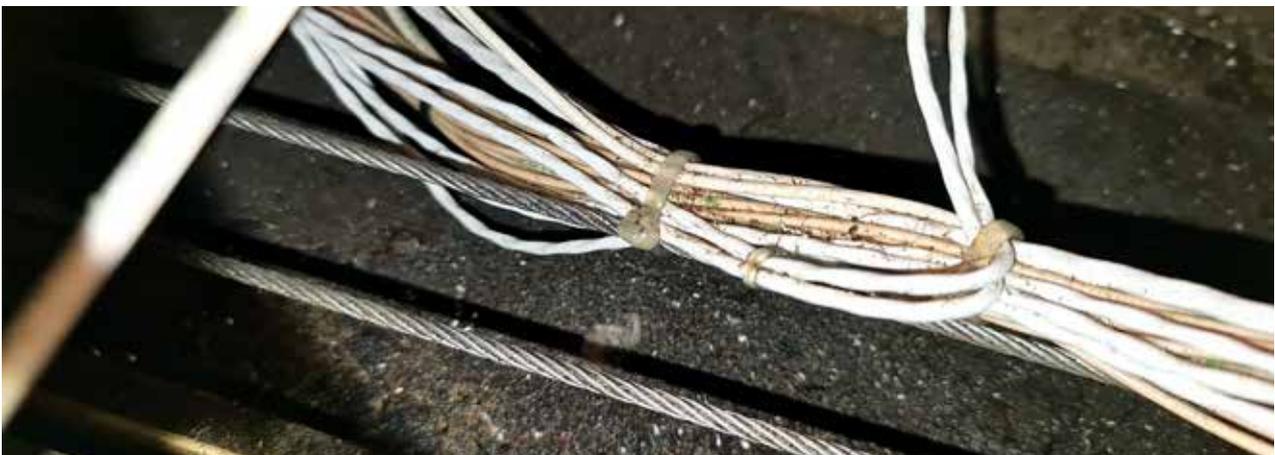
// Wiring bundle attached to a flight control cable – note the metal shavings on the wire.

Many have been the result of poorly secured wiring looms or broken terminations. Others have been due to chafed insulation due to the loom resting on mechanical control cables.
