CAA Safety Investigation Report
Collision with terrain
ZK-HWJ, Robinson R22 Mariner
Benmore Station, Canterbury
11 December 2013

CAA Final Report 13/6223
24 September 2018

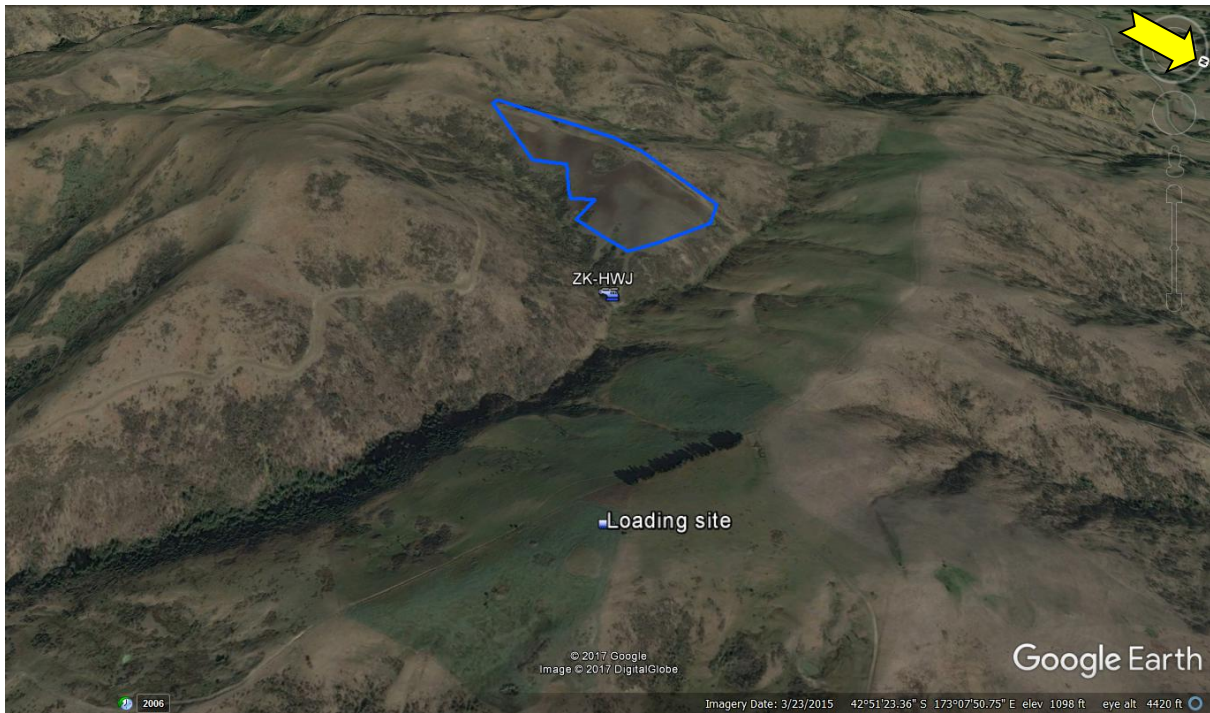
The treatment area to be sprayed comprised approximately seven hectares of sloping land, situated approximately half a mile to the southwest of the loading site (Figure 1 overleaf).

Figure 1. Treatment area depicted in bounds of blue line. (Arrow indicates north) (adapted Google Earth).

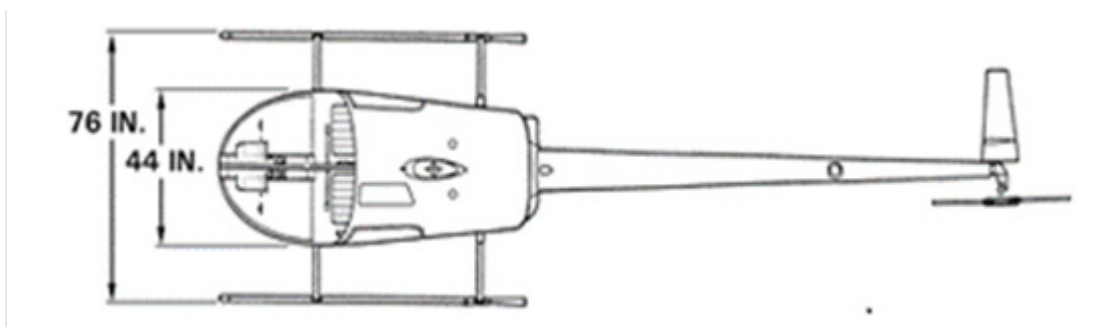
It was apparent from ground marks that the helicopter initially contacted rising terrain, on sloping ground, in a level yawing attitude. Significant depressions made by both the skids in the topsoil, were evident for a distance of 31 ft. It was also apparent that the landing gear skids had splayed from their normal dimension of 76 inches (at MAUW¹⁶) to 91.3 inches at the furthest point of ground contact (refer Figure 2 below and Figure 3 next page).

Figure 2. Plan view of RHC R22 (Source RHC).

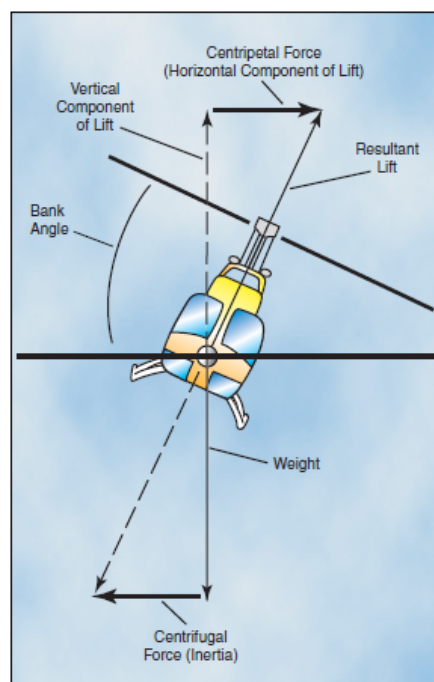
Consider the forces described above on a helicopter conducting agricultural operations close to the ground. The pilot must be ever vigilant to manoeuvring the helicopter in the air relative to the changes in the terrain being overflown. This is a particular consideration when carrying out low level turns over descending and rising ground. When a helicopter is in a turn it is subject to combined forces of lift and weight; centrifugal force acting away from the turn radius and centripetal force acting into the turn radius (Figure 6).

Figure 6. Forces acting on a helicopter in a turning manoeuvre (source FAA).

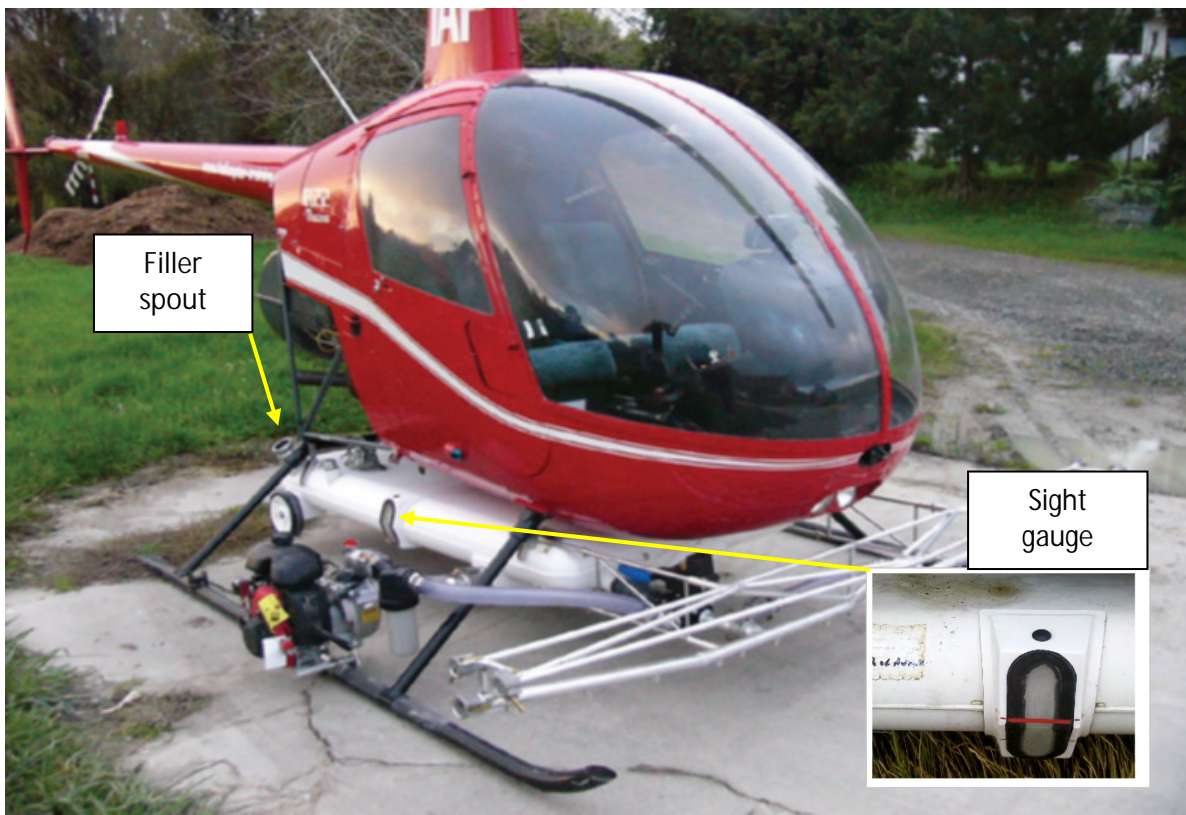
The image below shows the installation of a Helipod III spray system on the test aircraft, ZK-IAF. An open alloy spout aft of the belly tank allows the loading of water and herbicide into the tank. A quantity sight gauge on the same side, halfway along the spray tank, allows the content level to be viewed.

Figure 1. Helipod III spray system installed on a helicopter during testing and certification phase.
