**AIRCRAFT ACCIDENT REPORT
CAA OCCURRENCE NUMBER 13/365
MICRO AVIATION BANTAM B22S
ZK-MLF
Loss of Control,
Due to Spatial Disorientation
CARTERS BEACH, WESTPORT
30 JANUARY 2013**

Aircraft type, serial number and registration:	Micro Aviation (NZ) Ltd Bantam B22s, s/n 97-014, ZK-MLF
Number and type of engines:	1 Bombardier-Rotax GmbH 582 (65 hp)
Year of manufacture:	1997
Date and time:	30 January 2013, approximately 2120 hrs ³
Location:	Carters Beach, Westport Latitude ⁴ : S41° 44' 55.6" Longitude: E171° 30' 47.8"
Type of flight:	Private
Persons on board:	Crew: 1 Passenger: 1
Injuries:	Crew: 1 Fatal Passenger: 1 Fatal
Nature of damage:	Aircraft destroyed
Pilot's licence:	Advanced Local Microlight Pilot Certificate (RAANZ)
Pilot's age:	58 years
Pilot's total flying experience:	Approximately 765 hours total flight time (logged)
Information sources:	Civil Aviation Authority Field Investigation
Investigator in Charge:	Mr M R Harris

Synopsis

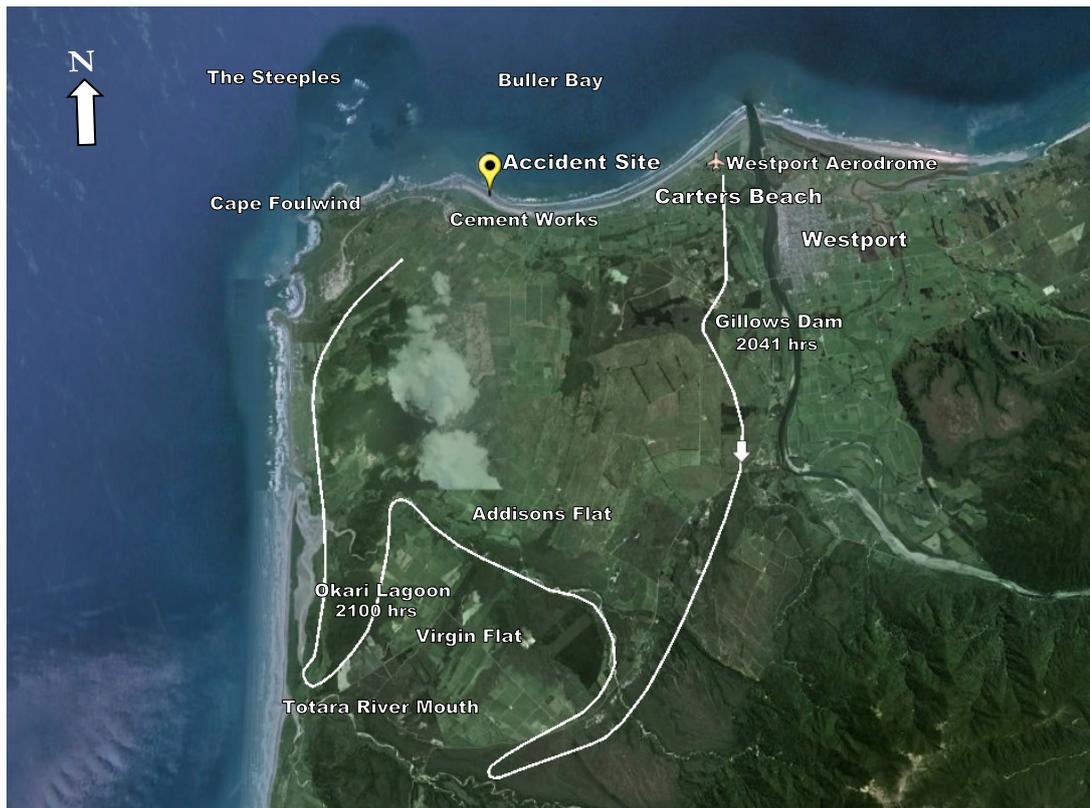
Figure 2:
ZK-MLF's approximate flight path

2.10 Considering the approximate flight track as illustrated in Figure 2, the pilot was well into the return leg of the journey and therefore nearing the maximum chance of a VFR into IMC encounter, as explored by the ATSB.
