# Departure from controlled flight

## Montgomerie Bensen B8MR Gyroplane ZK-00Z

Near Piopio, Waikato

09 April 2017

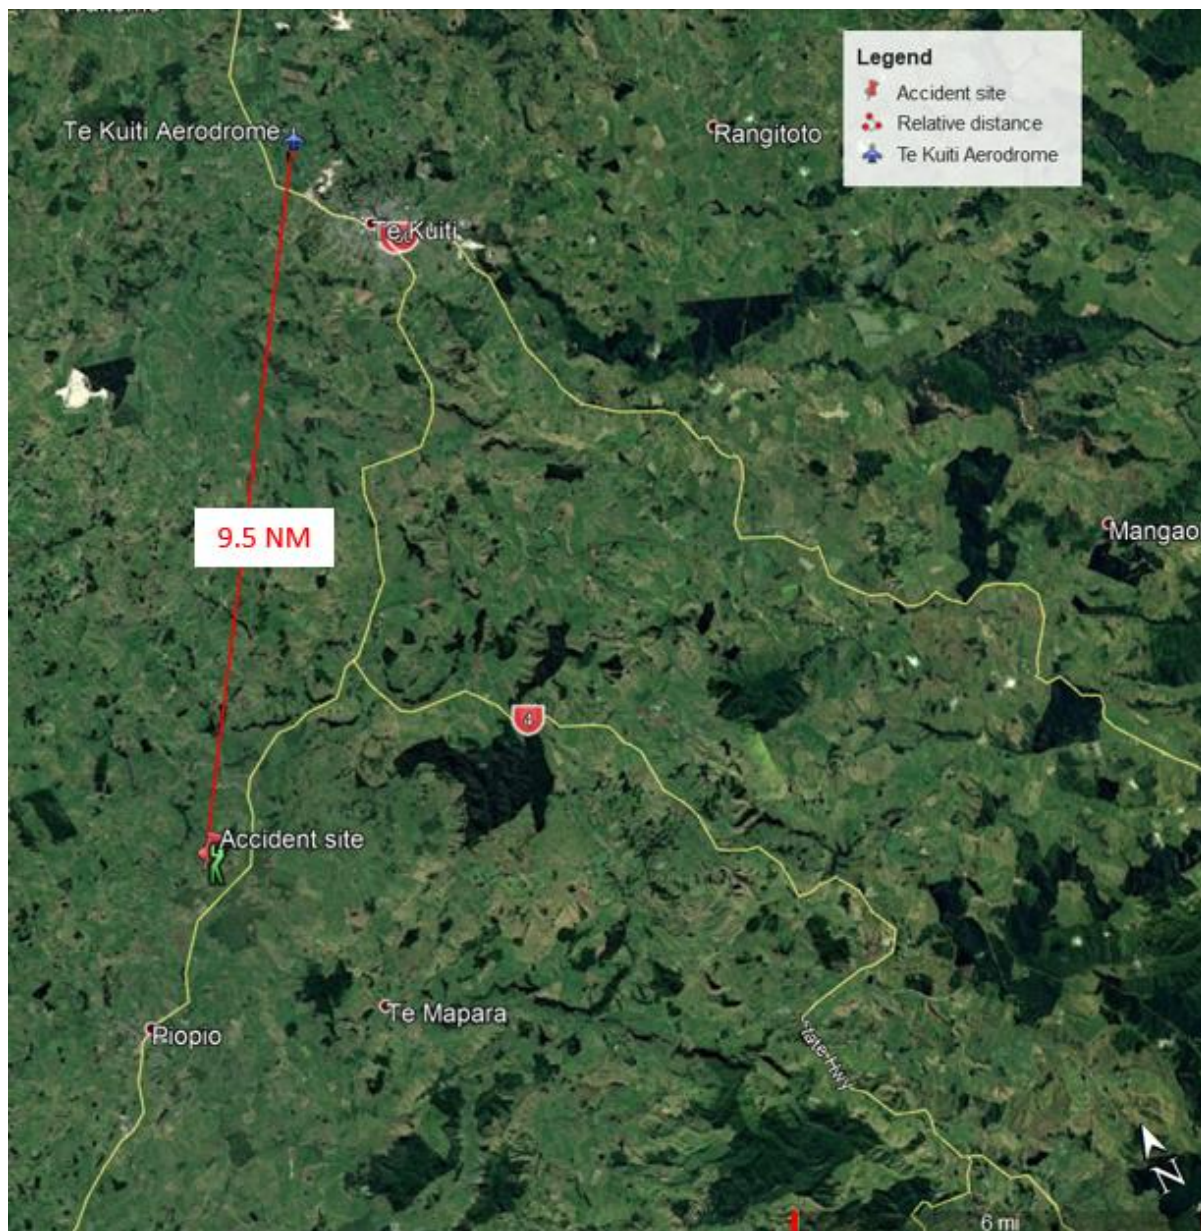
- They observe the gyroplane make a “sharp turn” on departure before flying towards Piopio (where the employer lives), approximately 9.5 NM south (refer to Figure 1).

Figure 1: Map of area. The red line shows relative distance from Te Kuiti Aerodrome to the accident site. The actual flight path of ZK-OOZ is not known. (Source: Google Earth™)

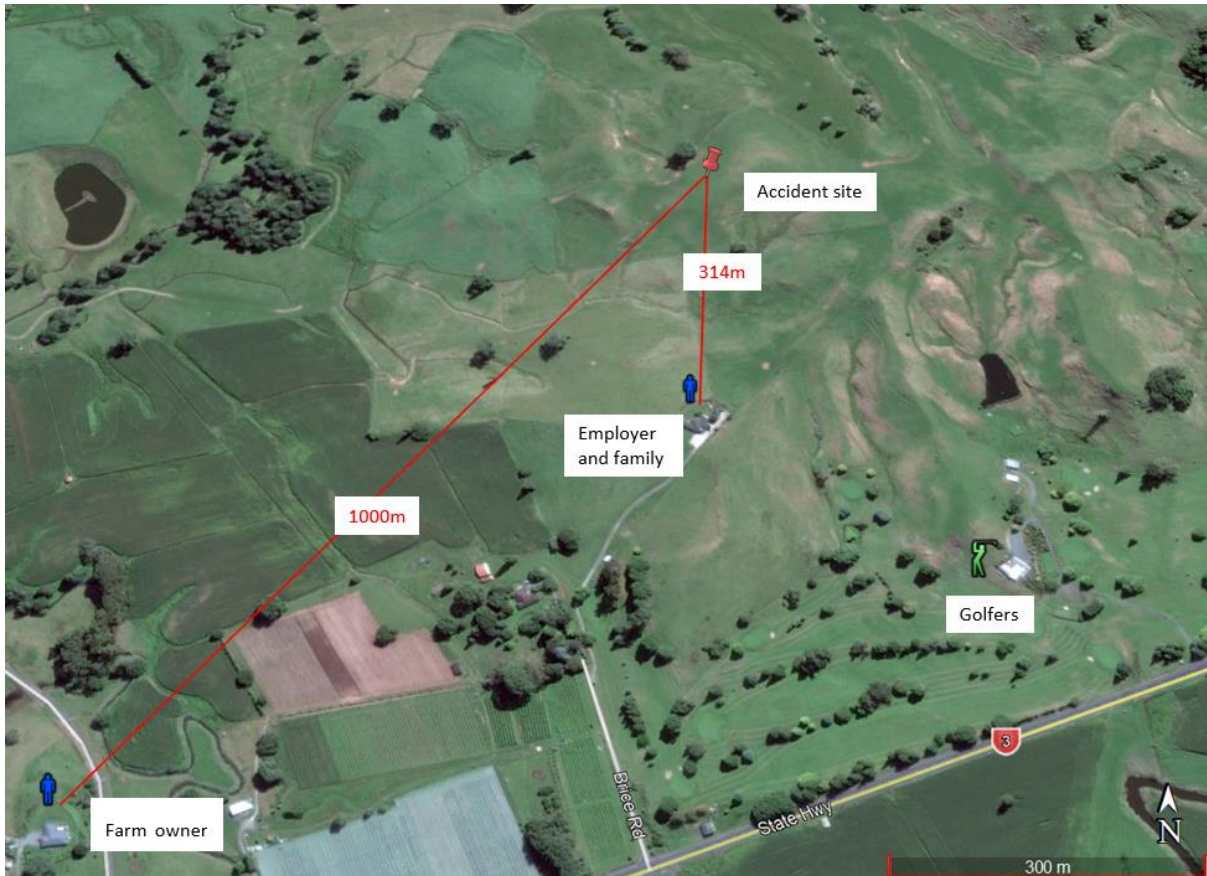
- Refer to Figure 2 for approximate location of witnesses.
- 1441 Emergency services are alerted by several witnesses.
- Approx. 1450 The employer and the golfers run to the site to provide assistance. The gyroplane is found lying on its left side with the pilot motionless inside.

Figure 2: Witness locations relative to the accident site. (Source: Google Earth™)

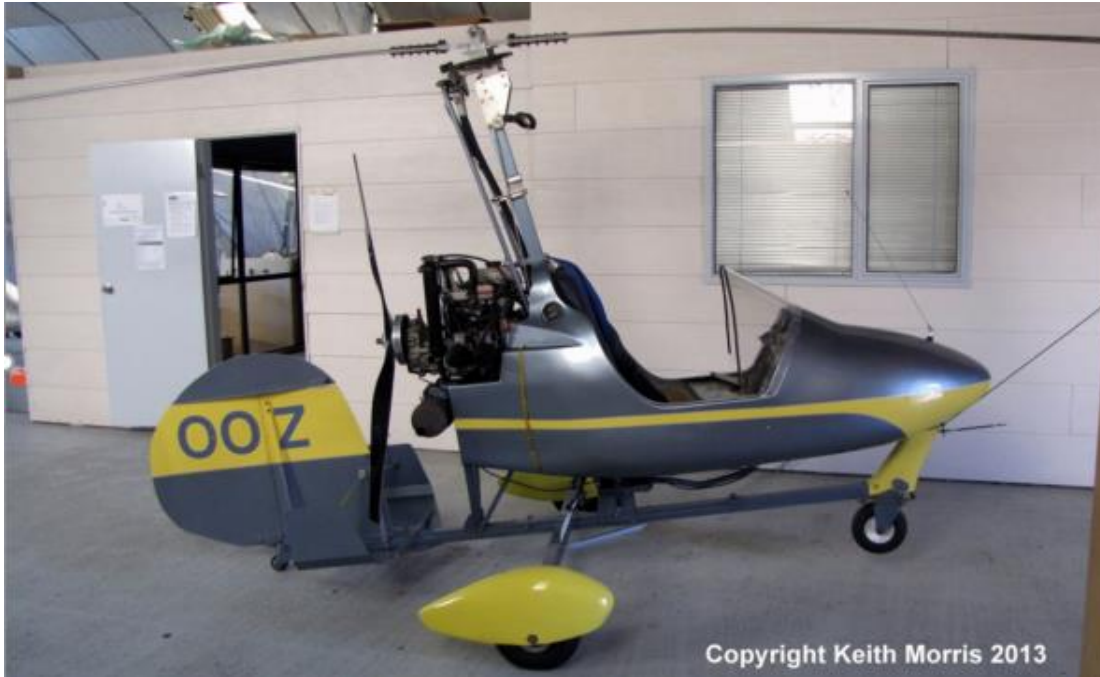
Figure 3: ZK-OOZ-Photo taken shortly after being registration in New Zealand. (Source: Keith Morris 2013)
