Safety Investigation Report

ZK-RGB, serious accident during flight training, Glentui, North Canterbury

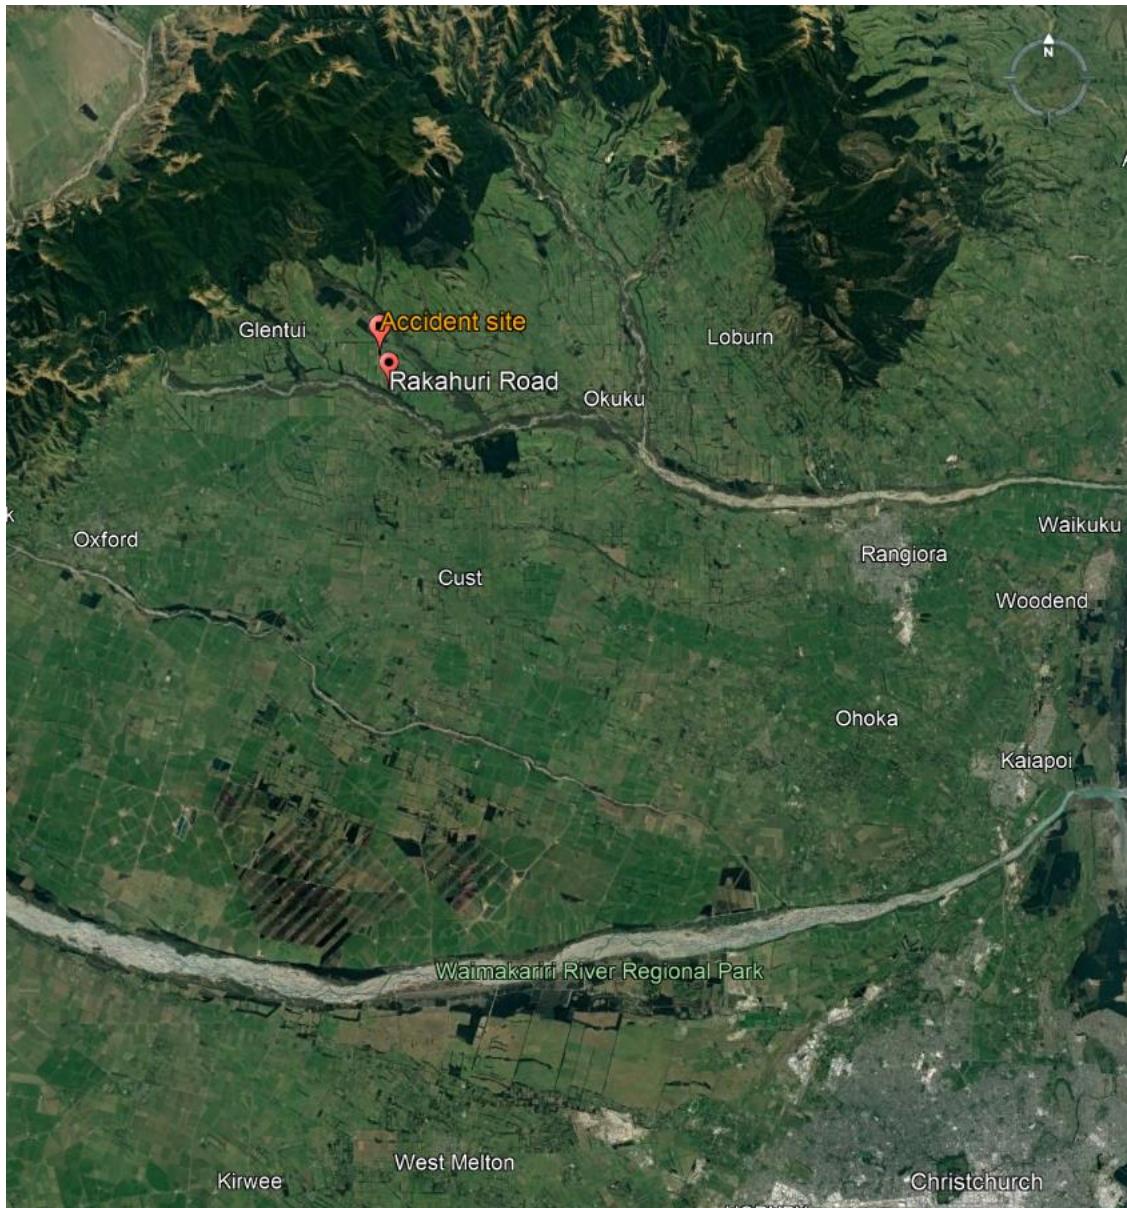
Figure 2. Location of accident. Adapted Google Earth™ image.

At approximately 150 ft the student was instructed to close the throttle again to simulate an engine failure after take-off into Paddock B. During the simulation it was noted the aircraft did not have quite enough altitude to make it over the hedge. There was, however, a sizeable gap in the hedge and the instructor suggested aiming for that. As the aircraft glided towards the paddock over the gap, the instructor explained that landing diagonally across the paddock would increase the potential landing distance, and they initiated a small right turn. It was at this point the right wheel clipped unseen powerlines that were strung across the gap.
