Title: Rotor Blade Failure

Clients Name: Civil Aviation Authority of New Zealand
PO Box 31 441
Lower Hutt

Report Number: 31282.01

Part of a rotor blade from a Robinson R22 helicopter has been examined to determine the reason for failure. The blade failed due to fatigue cracking that initiated at the edge of a bolt hole in the blade root fitting. It was concluded that the primary reason for failure was that the helicopter had been operated in such a way that the loading on the blade was frequently higher than that expected by the manufacturer when the specified retirement life of these components was defined. No evidence that corrosion contributed to the failure was observed.

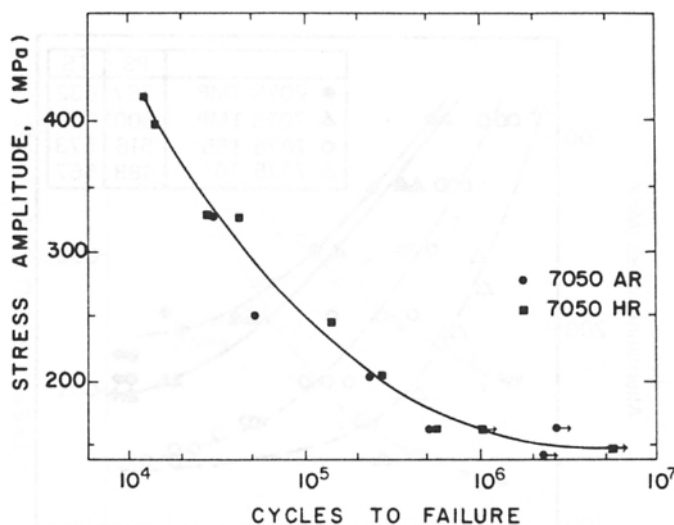
“AR” and “HR”. It does also however, illustrate the way in which fatigue life measured in terms of “Cycles to Failure” varies with load recorded in this case as “Stress Amplitude MPa” for this alloy. The material from which the blade root fitting was manufactured was 7075-T73 rather than alloy 7050 used to generate the data in the diagram.

However, the way in which cycles to failure varies with stress will be very similar for both materials.

Generally, manufacturers will design their components to be as resistant to fatigue as possible. The blades are however, life limited which implies that fatigue may occur. The data in the graph indicates that below approximately 150MPa stress amplitude, long fatigue lives in excess of 10⁷ cycles are obtained. However, a modest increase in cyclic stress amplitude rapidly results in a marked decrease in cycles to failure. For example, a modest increase in stress amplitude from 150 to 160MPa, will reduce the cycles to failure from approximately 10⁷ cycles to 10⁶ cycles ie a factor of 10. (Note, this graph is used to illustrate the
