# Airworthiness Directive Schedule

## Engines

### Continental 520 Series

23 February 2023

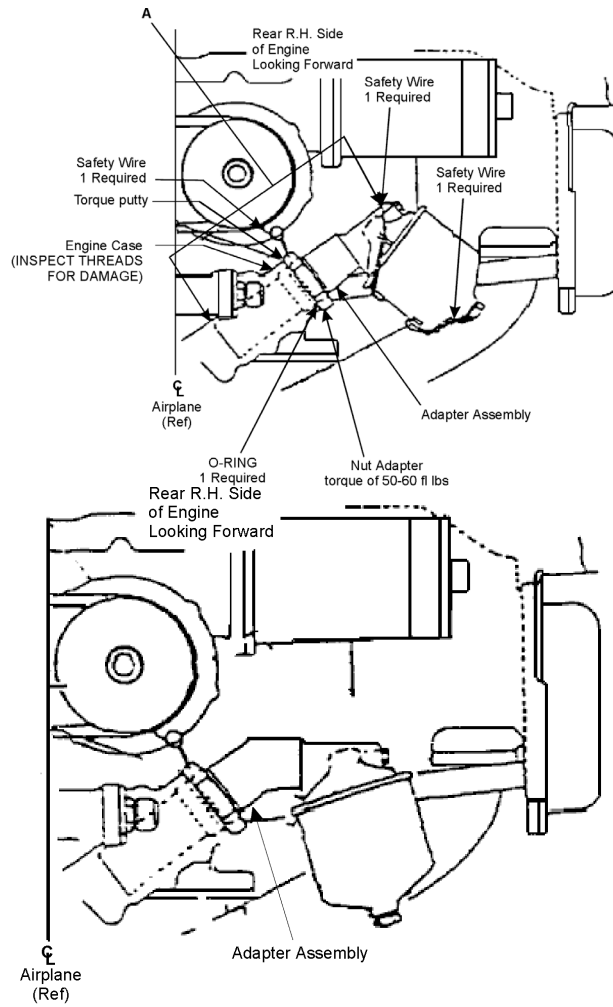
Manufactured by Teledyne  
Continental Motors  
Not Applicable to This AD

2. For oil filter adapter assemblies that do have torque putty between the engine filter adapter assembly, nut, and oil pump housing, inspect the torque putty for misalignment, evidence of oil leakage, or cracks.
