CAA Safety Investigation Report
Loss of control in-flight
U-Turn GMBH 'Black Out' paraglider
Queenstown 22 April 2017

CAA Final Report 17/2075

31 May 2018

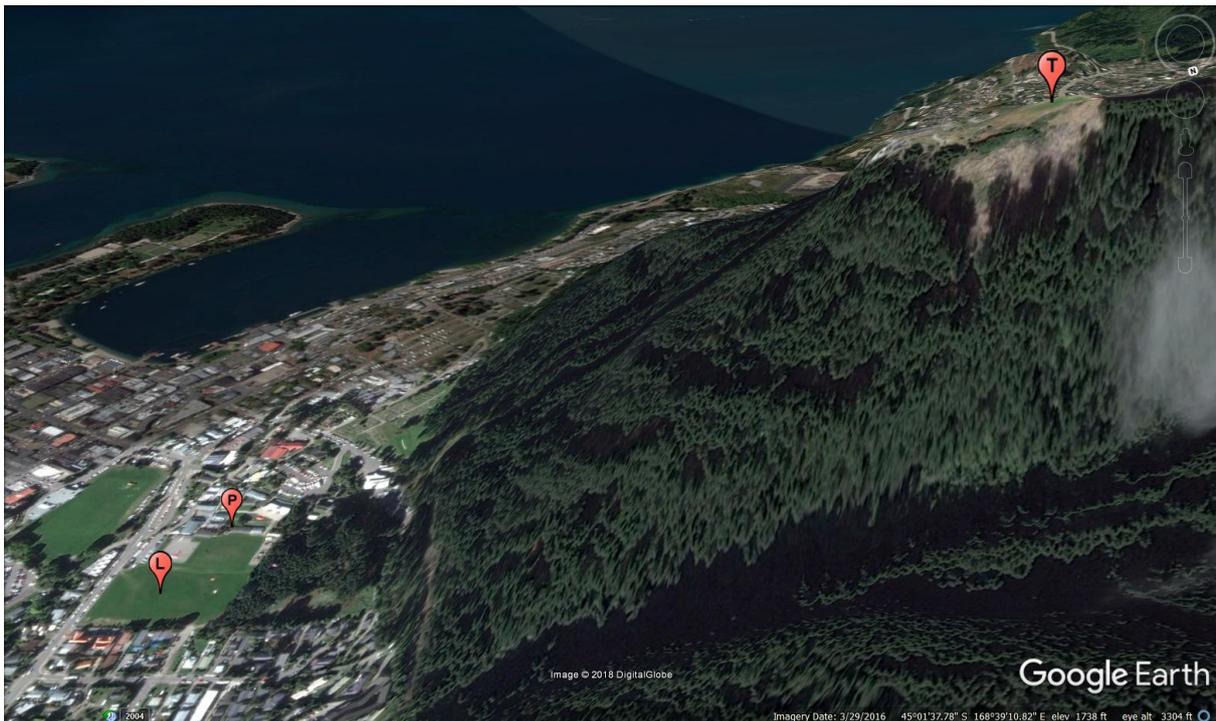
Figure 1. Launch site (T), Landing site (L) and Accident site (P) (adapted Google Earth image)
