vector

**THE LIFE-SAVING
IMPORTANCE OF
THE DUPLICATE
INSPECTION**

Cover: Don't allow a once-over-lightly duplicate inspection in your workshop endanger your aircraft and pilots – and their passengers. Read "The life-saving importance of the duplicate inspection" on page 14.

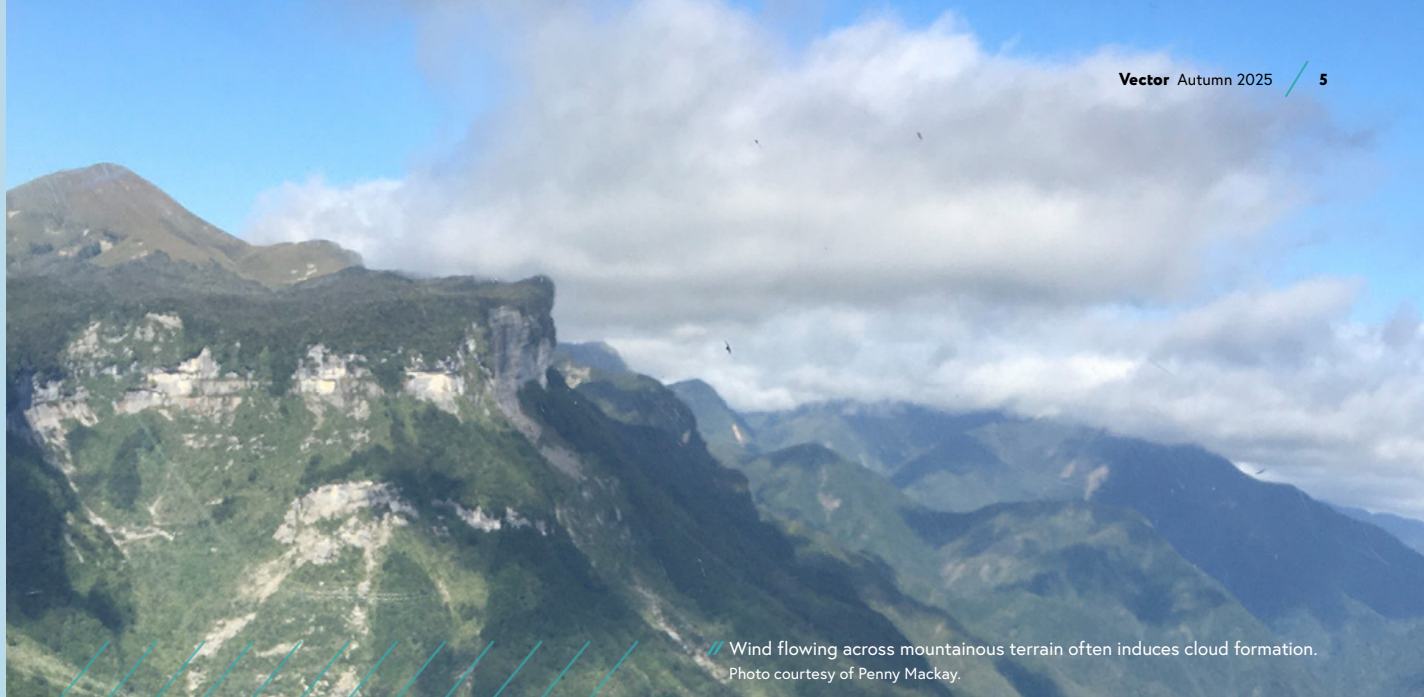
Wind flowing across mountainous terrain often induces cloud formation.
Photo courtesy of Penny Mackay.

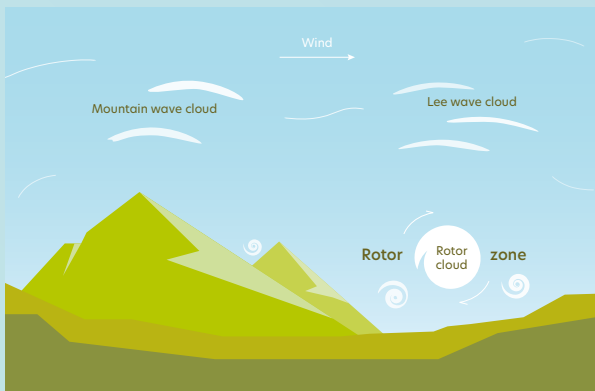
// Typical mountain wave and associated turbulence. Source: CAA

The orographic effect can lead to strong, localised turbulence. The leeside can experience turbulent eddies and wind shear, which can be hazardous for pilots. These effects, Rochelle says, can be unpredictable and greater than you would normally expect in the lee of a mountain. The effects can continue for some distance downwind.
