VECTOR

Pointing to Safer Aviation

CNS/ATM – THE FUTURE IS HERE

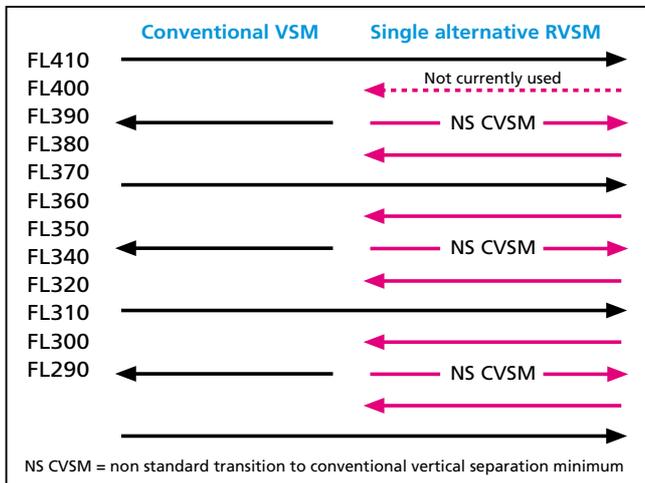
Modern altimetry systems, and the monitoring of aircraft altimetry accuracy within a Reduced Vertical Separation Minimum (RVSM) environment, has allowed the traditional 2000-foot separation required above FL290 to be reduced to 1000 feet. RVSM offers aircraft operators, and air traffic control providers, a major advance in airspace efficiency. North Atlantic trials have demonstrated that jet aircraft save approximately one percent in fuel for every 1000 feet closer they can get to their optimum cruising level. As a result of RVSM, ATC now have several additional flight levels available, which enable greater air traffic management efficiency (see table below).

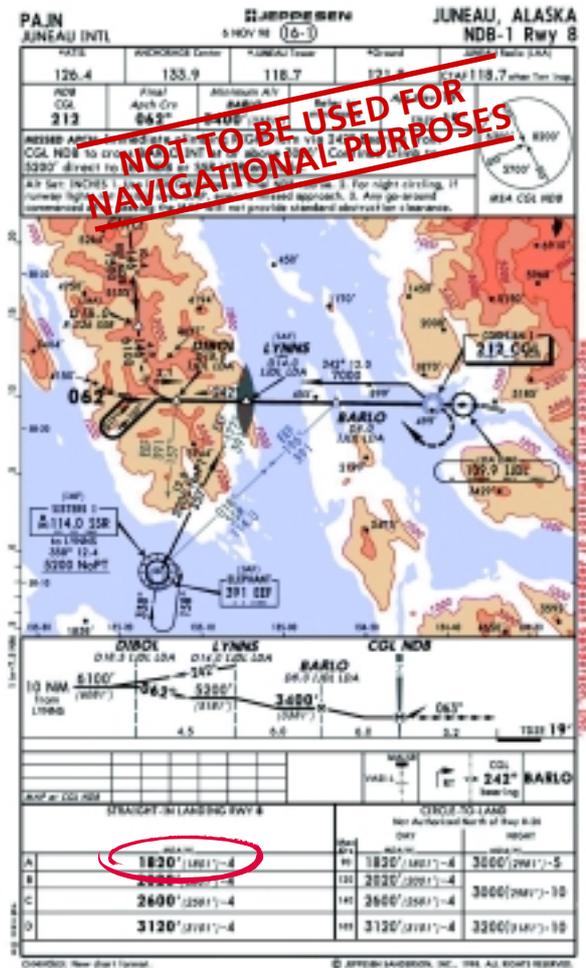
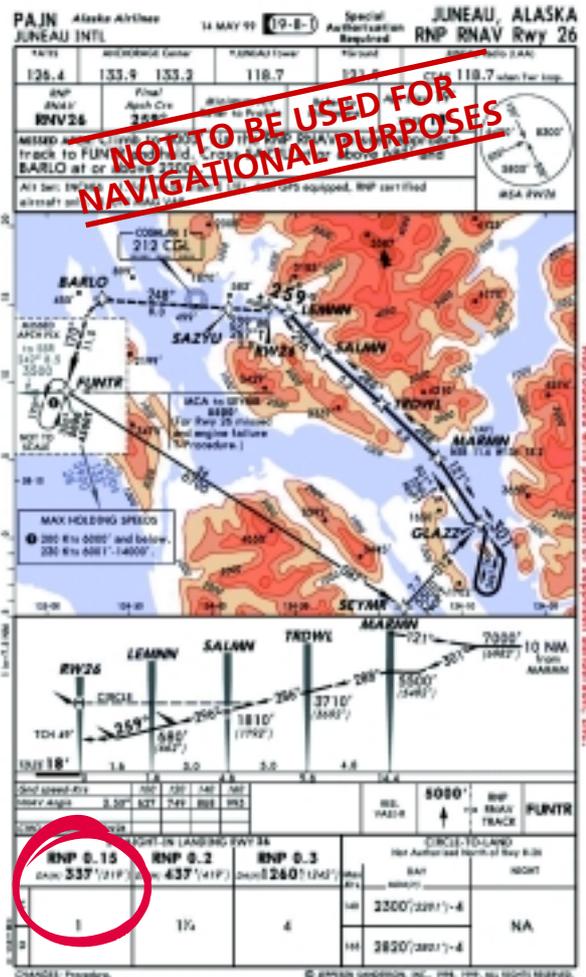
VECTOR would like to acknowledge Jeppesen Sanderson, Inc. for allowing us to reproduce the above Instrument Approach Plates.

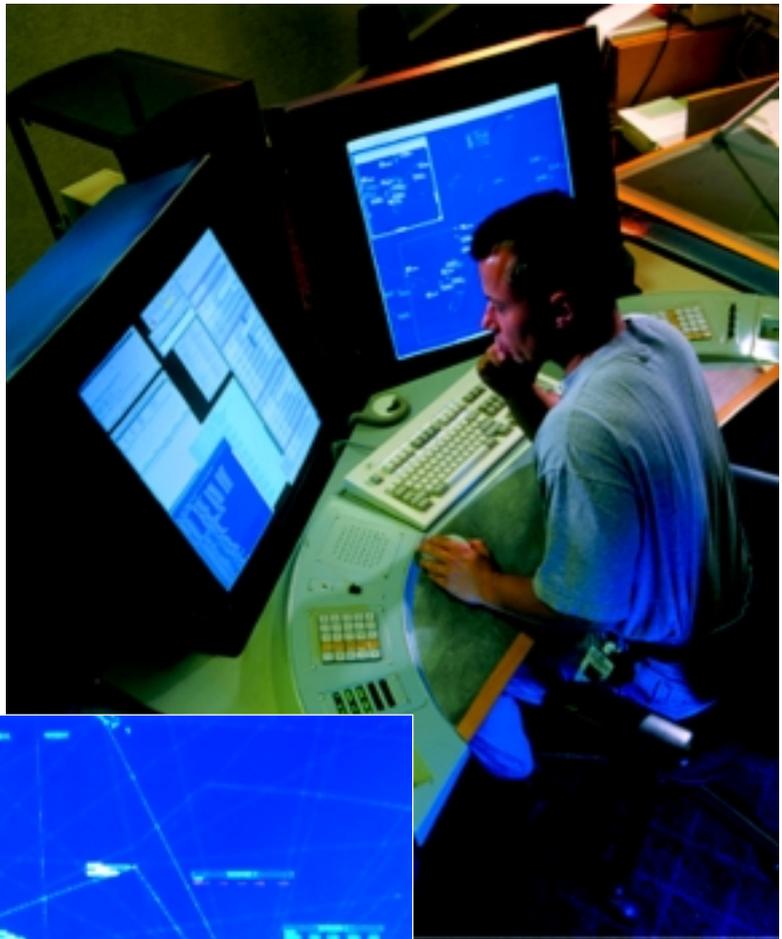
The Oceanic Control System (OCS) facility at Auckland is the world's first operational fifth-generation ATC system. The OCS is revolutionary in its concept. Modern ATC systems have evolved from early facilities that had no radio, to facilities using radio and radio-navigation aids, then to radar, and finally to the datalink environment. The OCS has advanced beyond these by providing a platform where machine automation, rather

Photo courtesy of Airways Corporation of New Zealand.

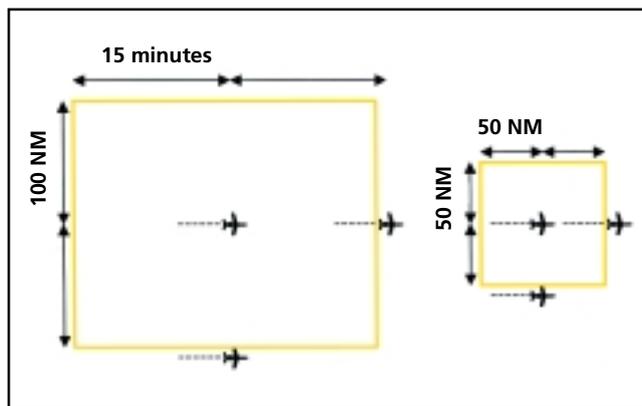
Comparative volumes of airspace using standard and RNP10 separations

The Auckland Oceanic FIR was, in December 1998, the first in the world to be fully designated as RNP10 airspace above FL245 (excluding the Antarctica McMurdo Sector). It allows 50 nautical mile longitudinal and lateral separation to be applied between RNP-approved aircraft (see accompanying diagram). Eventually, as new route structures are implemented and the navigational performance of aircraft improve, lesser separations (such as 30 nautical mile RNP4) will safely allow higher traffic densities. This has particular significance for domestic airspace, where traffic density is steadily increasing.
