VECTOR

Pointing to Safer Aviation

Ways To Hurt Your Aircraft – The Vn Diagram

Ways to Hurt Your Aircraft – The V_N Diagram

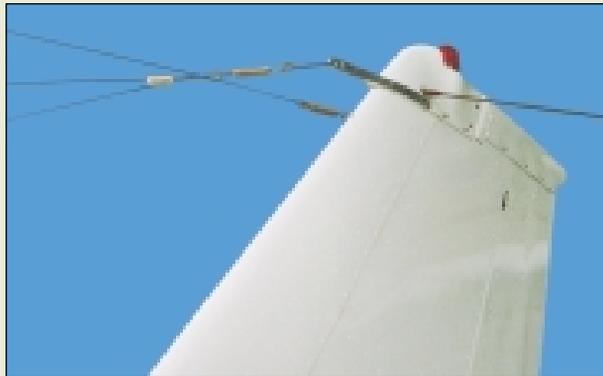
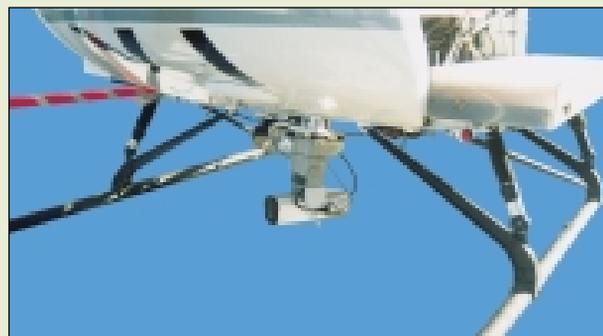
Two examples of modifications that require CAA approval are pictured above.

The CAA is becoming increasingly concerned about the number of unapproved modifications being made to general aviation aircraft. Problems typically relate to the fitting of aircraft role equipment such as spray and spreader gear, camera mounts and hatches, parachute doors and fixtures, air ambulance equipment, and aircraft abrasion strips.

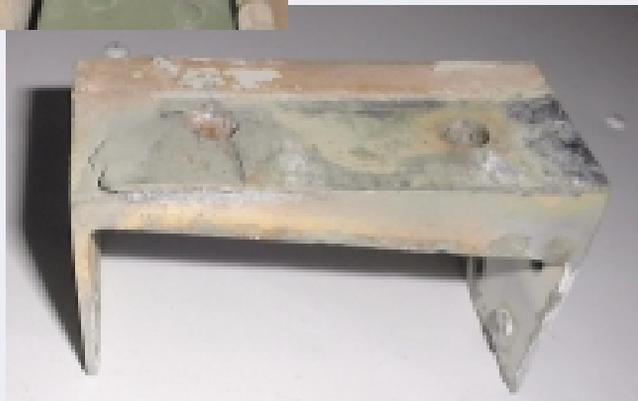
The offending wing/fuselage attachment prior to its replacement.

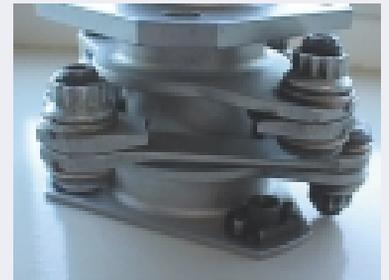
Some of the damage to the failed 369HS tail rotor driveshaft is pictured above.

out in accordance with the MD Helicopters' HMI (helicopter maintenance inspection). The drive shaft couplings are of the Kamatics type, and they were inspected as per the HMI, which does not indicate that they have to be removed. In this case, the rear drive shaft coupling was removed and inspected, but the forward one was not. It was the forward coupling that failed.

The helicopter was recently imported from Japan. It had suffered a tail rotor strike prior to importation and was consequently received minus its tail rotor gearbox assembly and tail rotor blades. An after-tail-rotor-strike inspection was carried
