VECTOR

Pointing to Safer Aviation

So, You Want to Be a Glider Tow Pilot?

Crossing Cook Strait

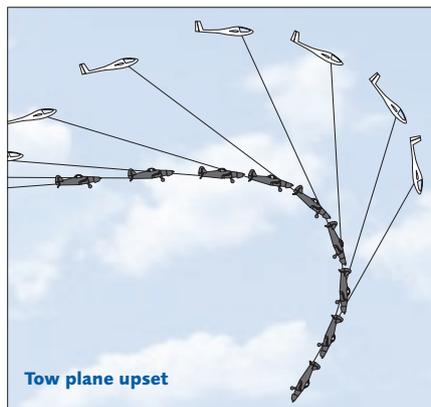
The glider kites rapidly after a pitch-up displacement as it runs out of elevator authority.

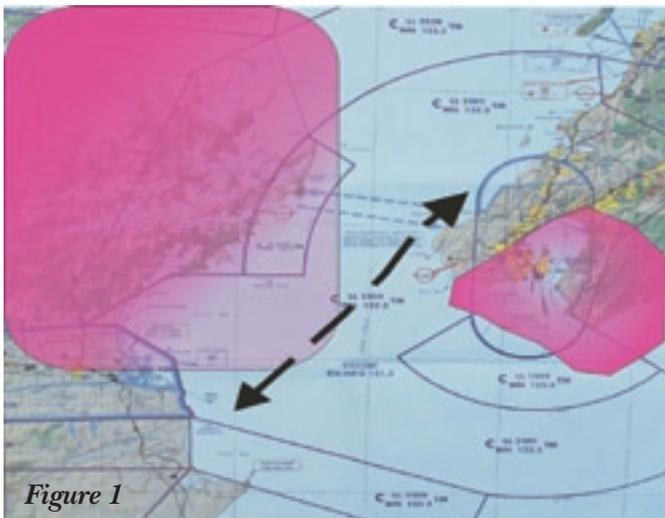
Figure 1

■ Area of turbulence, if the aircraft is flown below the ridge heights. Shading indicates severity of turbulence, from severe (dark shade) to light (light shade)

← - - - → Recommended route to travel across Cook Strait

Pre-frontal weather conditions in strengthening northwesterly and westerly winds over 25 knots can provide very turbulent conditions over the area identified in red in Figure 1. It is recommended that pilots avoid low-level flight in the lee sections of this area and fly above ridge height to avoid turbulence. Generally, this means that the flight across the Strait should be above 3500 feet. Pilots crossing the Strait (north or southbound) should fly as high as possible (request a clearance above 2500 feet from Wellington Control on 122.3 MHz) and track on a course between Ohau Point and White Bluffs.

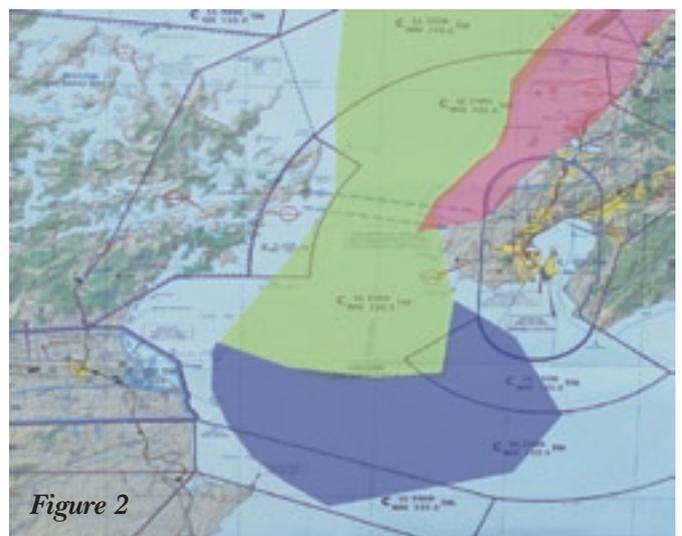
Figure 2

Cloud Base height

Pilots attempting to cross the Strait from south to north should be aware that they would likely encounter lowering cloud bases and reducing visibility. (Refer to Figure 2). There is a high risk of being caught mid-strait with neither island in sight, which makes navigating extremely precarious. Always maintain a visual reference with at least one island. It is dangerous to proceed in the 'hope' of seeing the other side of the Strait if you cannot see the island you have just come from.

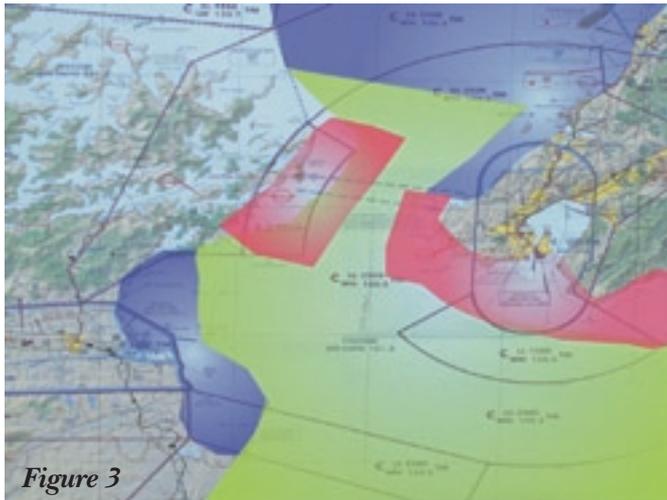
Cloud Base height

In conditions of strong easterly flow the Cloudy Bay section can have cloud bases below 500 feet

Moist easterly, southeasterly and southerly airflows (except for abating southerlies behind a cold front) provide the worst weather conditions in the Cook Strait area. Figure 3 shows the cloud base heights to be expected in southeasterly wind conditions. In conditions of easterly wind, the cloud base will be below 500 feet throughout many areas of the Strait, possibly with sea-fog in very moist flows and visibility less than five km. Consequently, VFR flight in these conditions is usually not possible. Pilots caught in such conditions should request assistance from Wellington Control. When these conditions are forecast, pilots intending to transit north should divert to Omaka, and those intending to transit south should divert to Paraparaumu.

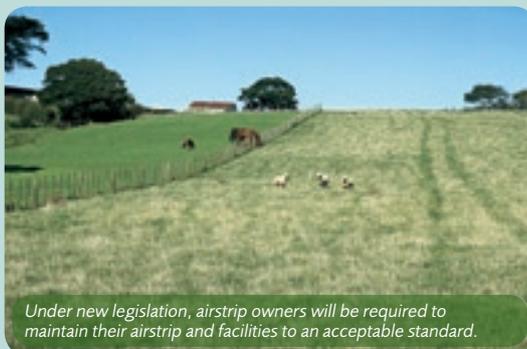
Under new legislation, airstrip owners will be required to maintain their airstrip and facilities to an acceptable standard.

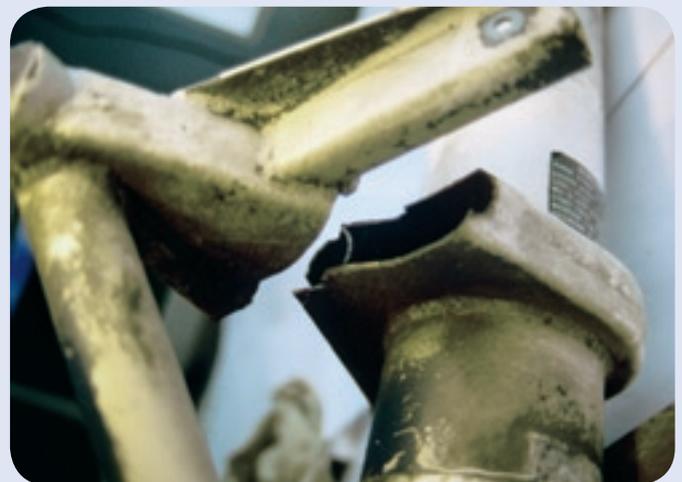
Robin R2160

Stabilator bearings crack
