VECTOR

Pointing to Safer Aviation

Carbon Monoxide

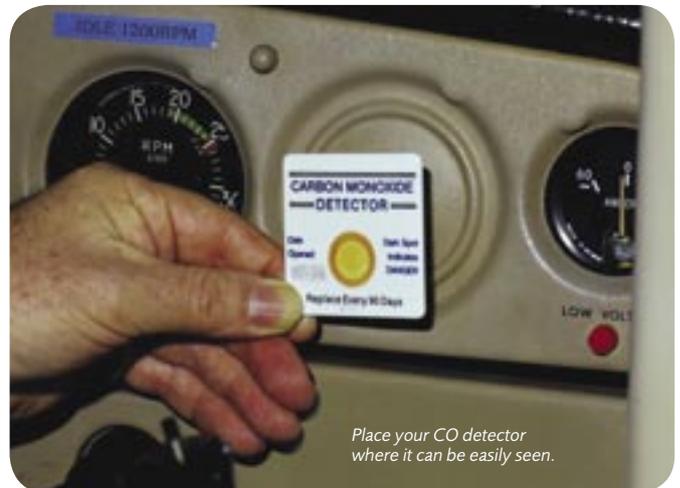
Place your CO detector where it can be easily seen.

The simplest, and initially the cheapest, are panel mounted 'spot' detectors. About the size of a credit card, these units have an exposed spot of a chemical that changes colour in the presence of CO.

These cards do have a downside, in that all of the currently available products have a limited life in service. While the chemical reaction that causes the spot to darken is nominally reversible, in practice most units discolour over time. The instructions that come with the unit will state the in-service life of the particular product. They typically range from one to 18 months, depending on the cost of the unit. Costs are generally in the order of \$10 to \$20.

The *Vector* observation is that, towards the end of the stated in-service life, most of these detectors start to show significant darkening or discoloration. This could pose a dilemma to the pilot who isn't sure whether the colour observed is due to the age of the detector, or is a result of the presence of CO. It therefore pays to replace the units whenever discoloration is apparent, or the stated life, whichever comes first.

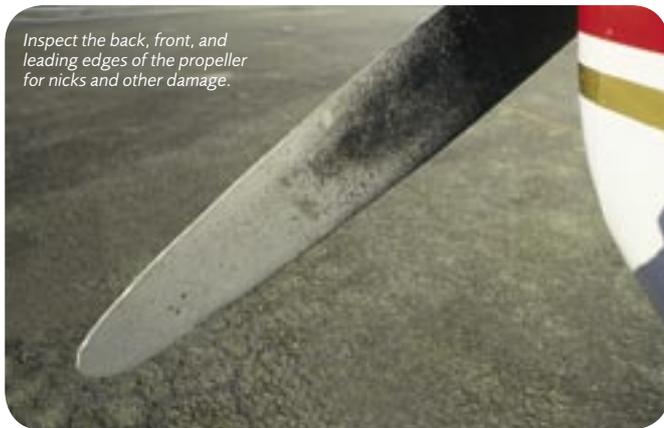
Inspect the back, front, and leading edges of the propeller for nicks and other damage.

Inspect the back, front, and leading edges of the propeller for nicks and other damage. Nicks can cause stress points, which could develop into cracks and result in propeller failure. Even if a small piece of the propeller is lost, the propeller will become severely imbalanced. This will cause vibrations that can become so severe that the engine may depart the airframe.

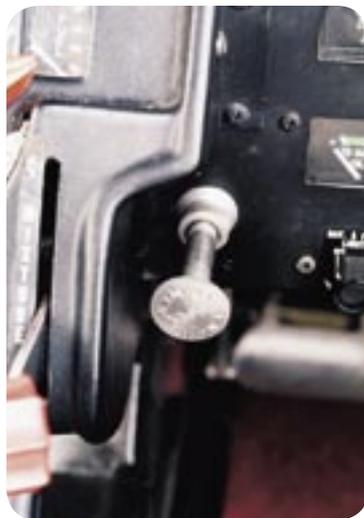
Manual primer system, on a Piper Tomahawk.

The discharge nozzles of the priming system have a small discharge orifice, which causes the fuel to atomise much like the nozzle on a spray bottle of window cleaner. The nozzles are usually located in the cylinder head in front of the intake valve.

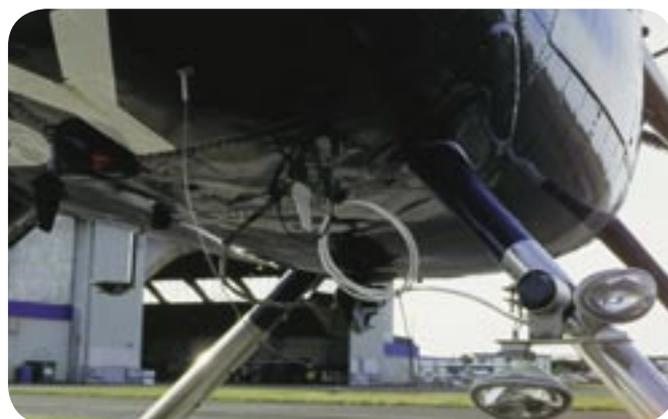
Additional lighting on a Hughes 369.

It is advisable to remove the hook mirror to reduce the possibility of reflection from the landing light, as this will degrade night vision. Installation of additional lighting, as a back-up, must be

an approved modification in accordance with acceptable technical data (CAR Part 21 *Certification of Products and Parts*). For more information, contact the Aircraft Certification Unit at the CAA.

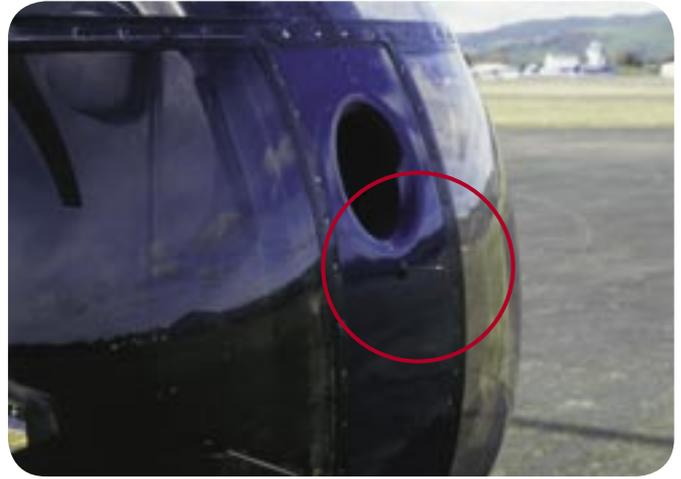
A temperature probe (circled), linked to a digital temperature display inside the cockpit.

The nature of the frost protection operation will depend on the height of the inversion layer. The inversion layer is distinguished by a ‘warmer layer of air’ above which the temperature increases with height. Typically it is between 50 and 150 feet agl. Flying below the inversion layer is not efficient, because the helicopter will not be down-washing the warmer air onto the crop. To identify the height of the inversion layer, the helicopter needs to be fitted with an outside air temperature probe, linked to a digital back-lit display. The pilot can then vary the altitude of the helicopter accordingly.
