# VECTOR

*Pointing to Safer Aviation*

## Fog

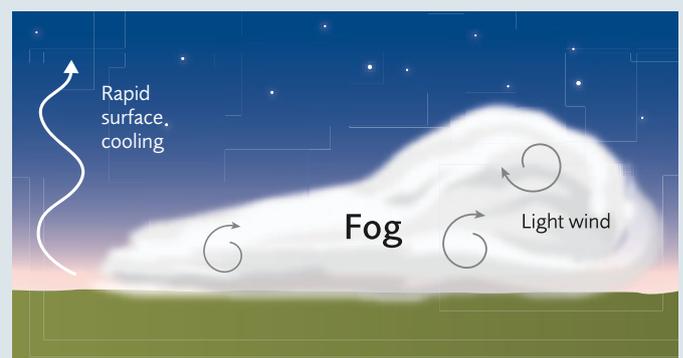
Radiation fog can occur on a clear night with a light wind, if humid air is cooled enough to reach its saturation point.

Radiation fog forms when humid air next to the ground is cooled enough to reach its saturation point, and water vapour starts to condense into liquid droplets. This generally occurs on a clear night with light winds, usually under an anticyclone, but is highly dependent on the wind speed.

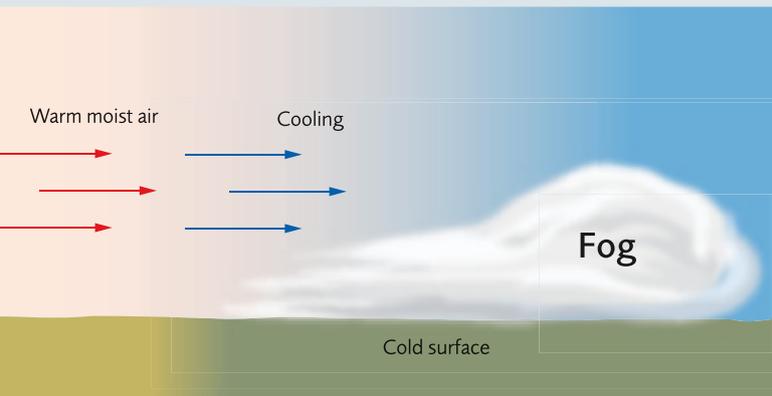
Advection fog can occur when warm moist air is blown across a sufficiently cold surface to lower the air temperature to its saturation point.

Advection fog forms when moist air is transported (advected) over a surface that is sufficiently cold to lower the air temperature to its saturation point. It can form over water as well as land and is more persistent than radiation fog. It is not uncommon for advection fog to linger for an entire day.

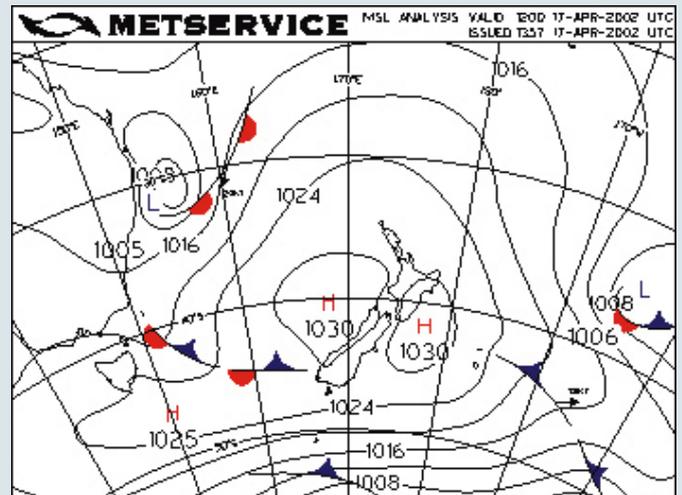
Weather chart with fog occurring at Auckland. Note the very high pressure and the light winds ideal for the development of radiation fog during the early hours of the morning.

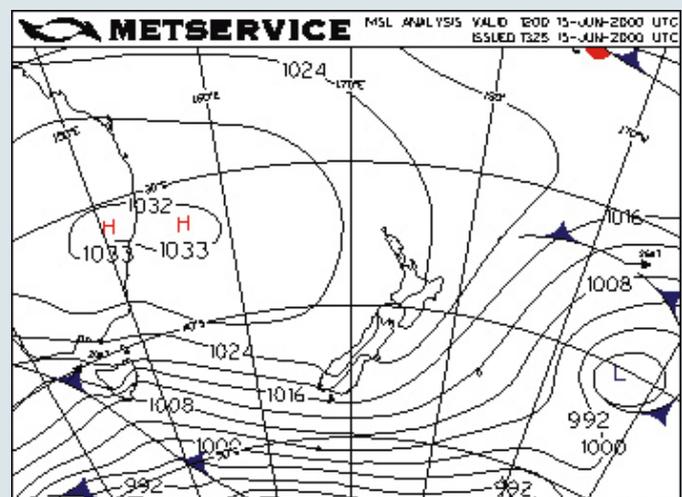
Radiation fog at Hamilton is more persistent during the early stages of anticyclone development over New Zealand.

Radiation fog forming in situ over the airfield is the most common. It is more persistent during the early stages of anticyclonic conditions when light westerly winds during the day have brought moist air from the sea to the Waikato area. In winter, fog can form as early as 2000 hours. During the night, the fog may be quite thin if there is little wind. In the morning, fog tends to thin temporarily shortly before sunrise but thickens again at sunrise, before clearing between 0900 and 1200 hours. This will vary depending on the time of year, and wind strength. This type of fog can cause frequent disruption to morning flying.

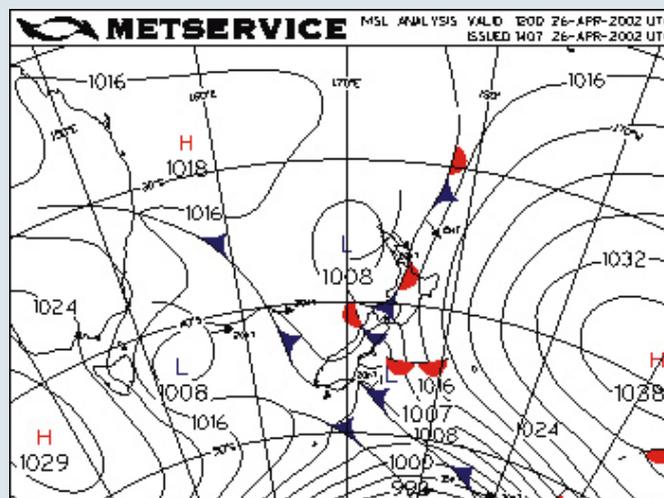
An occluded or warm front from the Tasman Sea can bring advection fog to New Plymouth. Note that anticyclonic conditions are not required for this fog to form.

Advection fog is more common than radiation fog, especially during spring. This fog is advected from the North Taranaki Bight and occasionally is advected over the airfield. When it does so, this type of fog can persist for a few days.

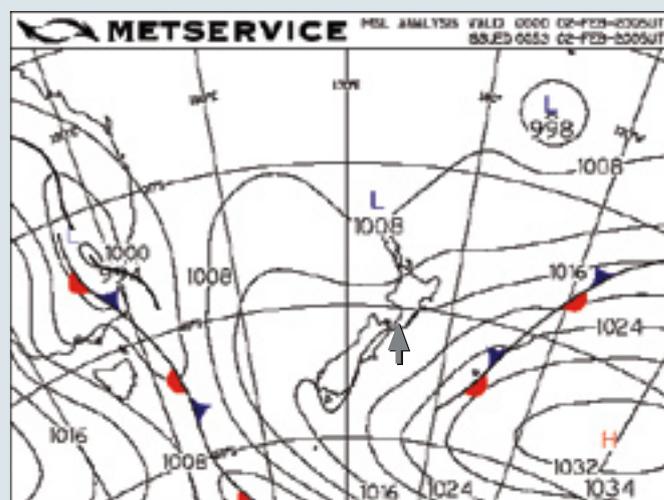
Advection fog forms at Wellington when an intense and slow-moving anticyclone is situated over, or to the east of, the Chatham Islands. If the easterly wind turns to a southerly both at Mount Kaukau and Wellington airport, fog and low stratus is advected over Wellington.

Generally, if the wind on Mount Kaukau and at the airport changes from the southeast to the south the fog bank, which typically sits in Cook Strait during easterly conditions, will be advected over the airport. This fog can be very persistent, and may remain over Wellington airport for several days.

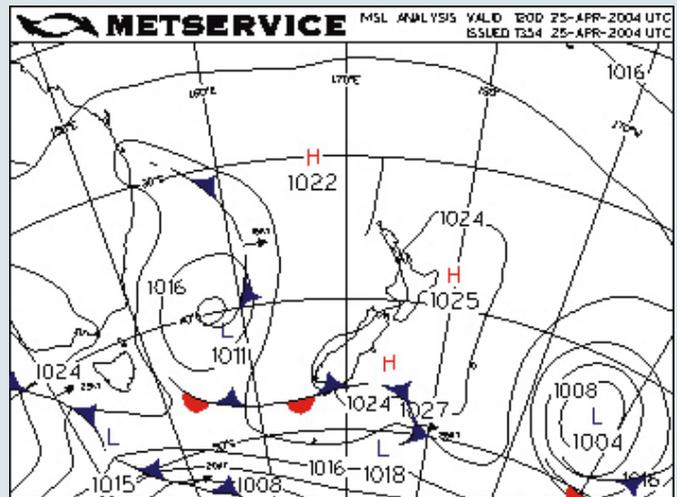
If an anticyclone is positioned to allow a light northeast flow over Christchurch, advection fog that has formed over Pegasus Bay may be advected over the airport.

Christchurch also experiences advection fog. For example, when sea fog has formed over Pegasus Bay to the northeast of the airport, or over the Waimakariri River, it may be advected over the field. This fog usually lifts clear of the ground as it does so.

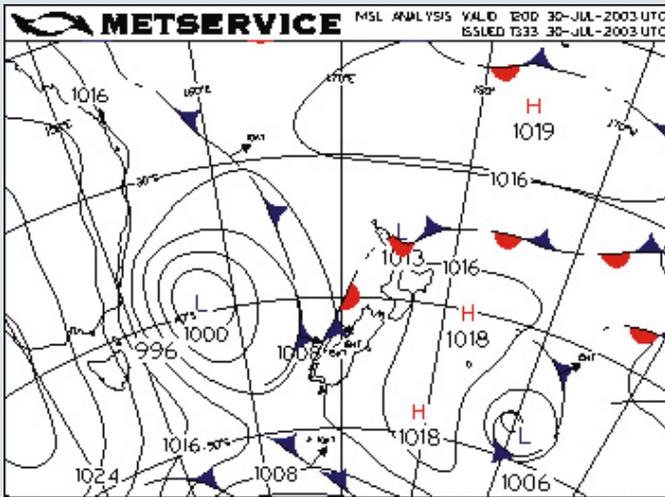
Radiation fog at Dunedin is most likely to form during autumn and winter.

Fog forms mainly between 0300 and 0600 hours, but on occasions as early as 2000 hours in the evening during autumn and winter. Fog usually persists until at least 0900 hours, and occasionally until late morning. When radiation fog affects the airfield, it is normally widespread over the Taieri Plain. The swampy areas and the lake areas to the south tend to have more persistent and thicker fog than elsewhere. On some occasions, if there has been no wind during the night, fog may form after sunrise when mixing occurs after the development of a light wind.

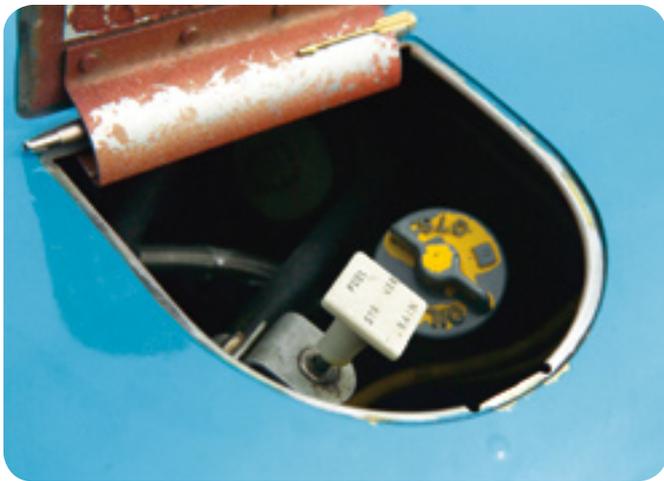
Fuel strainer drain on a C152.

When the student returned from his cross-country flight, he told us as an aside, that the fuel strainer drain in the nose of the aircraft had needed to be pushed down (when he had checked it earlier), rather than returning by itself to the seated position.

It was subsequently noted in the incident report, that the likely reason for the fuel loss was the strainer drain had not seated properly after being checked – resulting in the subsequent loss of fuel – and may have re-seated in the turbulence that the pilot encountered.
