VECTOR

Pointing to Safer Aviation

Strike One – You're Out!

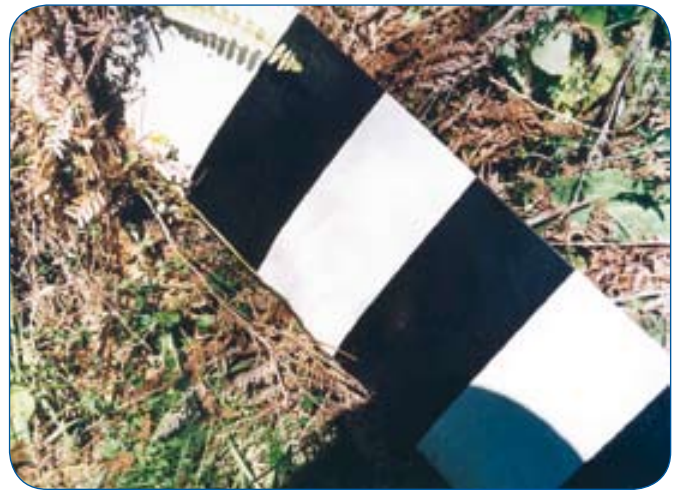
The seemingly minor dent on this Iroquois tail rotor blade was caused by a flailing longline that had been picked up by the main rotor.

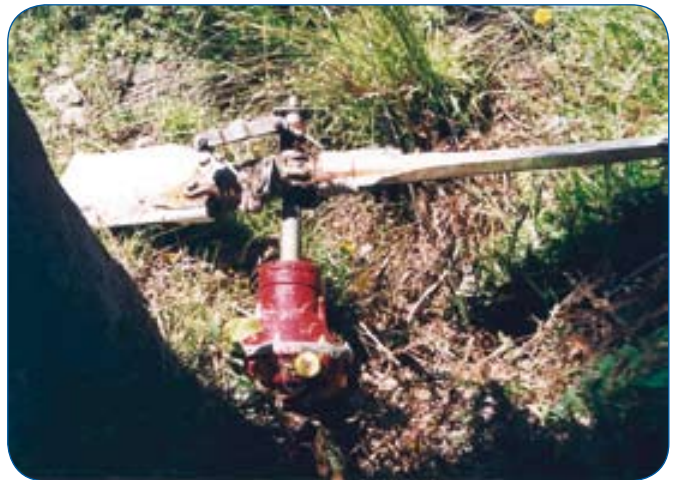
The result of the strike was the departure of the tail rotor and 90-degree gearbox from the airframe.

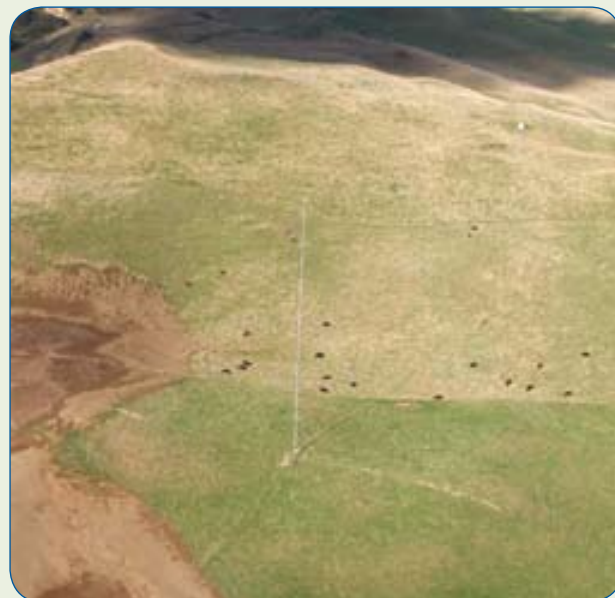
From the photograph, it can be seen that this mast is very hard to see even in good weather. The ground at the site is approximately 300 feet **amsl** (100 metres), and the mast height is just under 200 feet **agl** (60 metres). If the pilot had been at 500 feet **amsl** over the sea, then the turn inland would indeed have been a hazardous manoeuvre. Now there's a lesson.

On a recent occasion in the vicinity of this mast, because of deteriorating weather, a pilot turned inland in order to preserve his horizon. Because the mast was on top of a hill right on the coast, and reportedly reaching about 600 feet above sea level, he nearly collided with it. The pilot acknowledged that he probably infringed the 500-foot-agl rule.

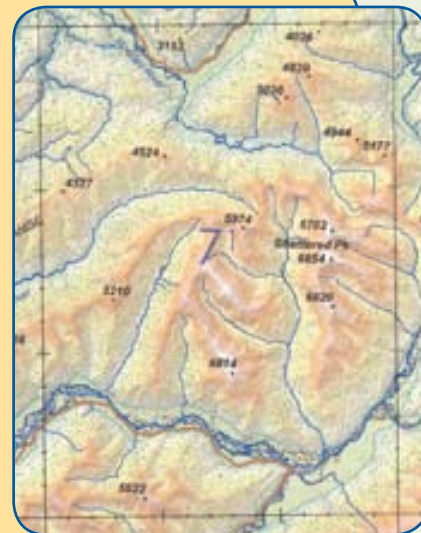
Have you ever wondered what are those 2-figure (sometimes 3) numbers that appear in each grid rectangle on Visual Navigation Charts? They are called Maximum Elevation Figures, MEFs. The large figure(s) are thousands of feet of altitude, the smaller figure hundreds. For example, **12⁵** means 12,500 feet amsl, and **9⁴** means 9400 and **0⁹** means 900.

Have you ever wondered how are they arrived at? For each rectangle, the altitude of the highest contour and the highest spot height are determined. To each of these is added 50 metres (164 feet) of allowances for mapping inaccuracies. The altitude of the top of the highest mast-like obstacle is also determined, but no allowances are added to this. The highest of these three altitudes is taken as the ruling altitude. This is converted from metres to feet, then rounded up to the nearest 100 feet to arrive at the MEF.

Have you ever wondered how to use them? Simple! If you flew at the MEF your clearance from the highest obstacle in the rectangle would be anything between 1 foot and 264 feet – not good. **Treat MEFs as representing solid obstacles. Add your 500-foot (or 1000) safety margin to the MEF to determine a minimum safe altitude in the rectangle.**
