VECTOR

POINTING TO SAFER AVIATION

Flying IFR in Uncontrolled Airspace

CIVIL AVIATION AUTHORITY
OF NEW ZEALAND

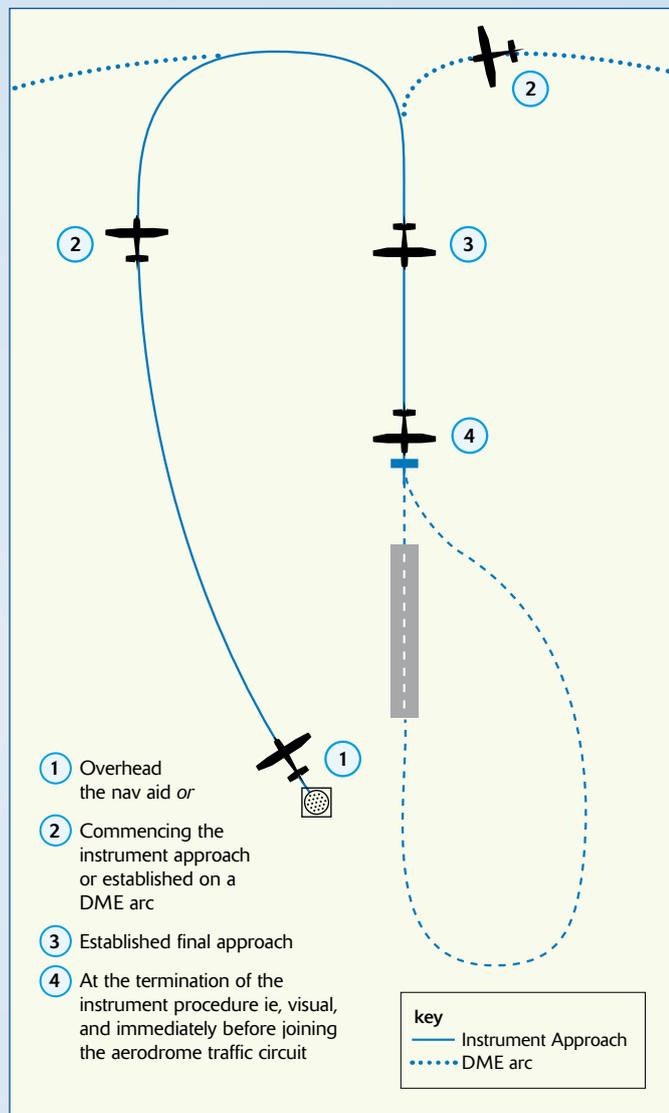
FIGURE 1: For the benefit of other traffic, IFR pilots should broadcast their position, altitude and intentions as shown. Reference AIP New Zealand ENR 1.1–11.

IFR pilots should broadcast their intentions as shown in Figure 1. IFR pilots should, in addition to the required

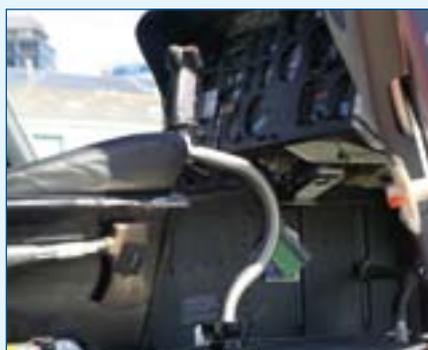
An AS355 cyclic – despite the distinctive curvature, pilots have been known to install the dual cyclic the wrong way round.

Control travel is limited if the stick is installed the wrong way round, and can (did) lead to an irretrievable loss of control once the machine is airborne.

Generally, a quick visual comparison with the other stick will establish whether it is the right way round – the offset of the hand grip is a prime clue here. If the systems permit a 'full-and-free' check while the machine is shut down, you should do one after installation. A modification for the Squirrel cyclic has been available since 1985 (Aerospatiale Service Letter 726-67-85 refers), and once embodied, permits installation the correct way only.

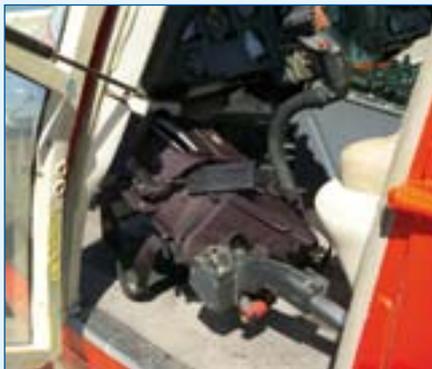
A photographer's bag placed here in flight could cause major control difficulties.

loop his camera strap around the rotor brake lever and pull it out of its detent. Detected in time, it didn't cause a problem. On another photo flight, a Jet Ranger pilot noticed a sudden restriction in rearward cyclic movement, and found that a camera had wedged under the dual cyclic 'stub'. Normally hidden by a soft leather sleeve, the stub was not readily apparent to the photographer. Not long after this event, the operator fitted a rigid cover to prevent future similar occurrences.
