# VECTOR

POINTING TO SAFER AVIATION

## Low Visibility Operations at Auckland Airport

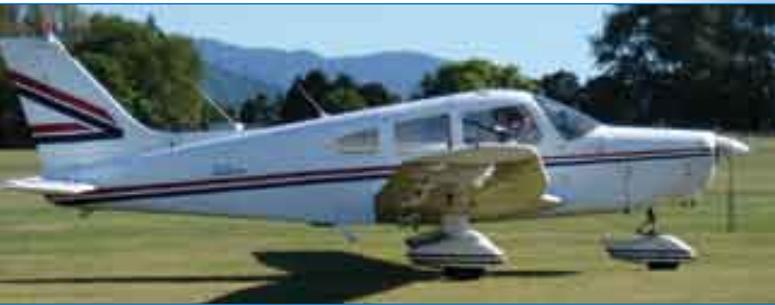
G-LOC can occur in GA aircraft such as the Piper Warrior II

Recently, a 19-year old pilot with a CPL, an Instrument Rating, and an Aerobatic Rating, suffered G-LOC during a max rate turn in a Piper Warrior II. This pilot and a colleague were preparing for their C-Cat Instructor Rating flight tests. They went out on a flight to practise stalling, steep turns, and max rate turns. While the pilot's colleague was conducting a max rate turn, he noticed some resistance to rudder inputs. He looked across to the other pilot, saw that he was convulsing, and immediately rolled out of the turn. The convulsions lasted seven seconds; the pilot regained consciousness after a further five seconds, and returned to normal function after approximately five minutes. Afterwards, the pilot was confused and asked what had happened.

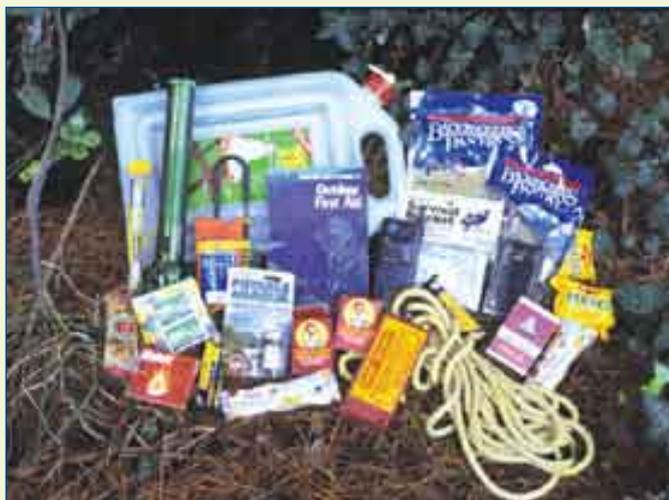
A typical survival kit.

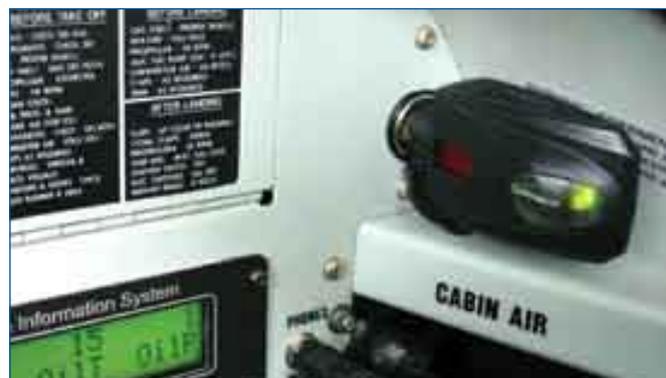
An example of a portable electronic CO detector fitted to an amateur-built aeroplane. Photo courtesy of Bob Jelley.

CO detectors come in 'card' or electronic types. The card types usually have a central 'dot' that changes colour in the presence of CO – usually, the greater the colour change, the greater the concentration. Electronic types can either be permanently mounted on the panel, or portable – the latter typically plug into the cigarette lighter socket. The card types have a finite life (as little as 30 days, depending on make) once removed from their sealed packaging, and now that they are a mandatory item, their expiry date must be entered in the aircraft logbook. The expiry date should also be written in permanent marker on the actual detector. If the detector has expired, a new one must be fitted before the aircraft is next flown.

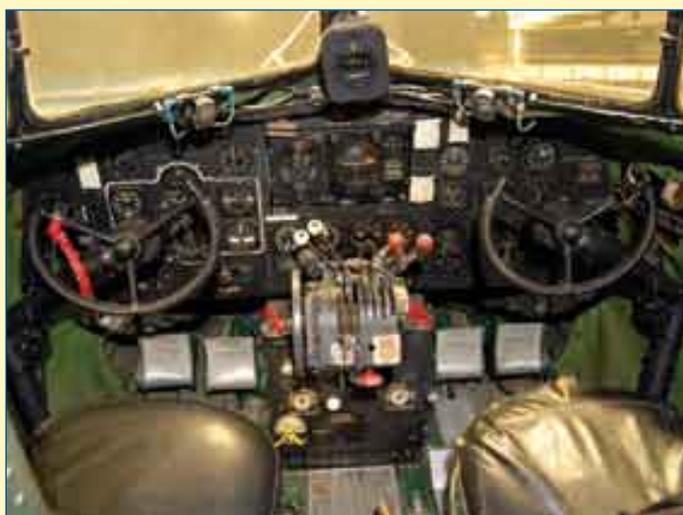
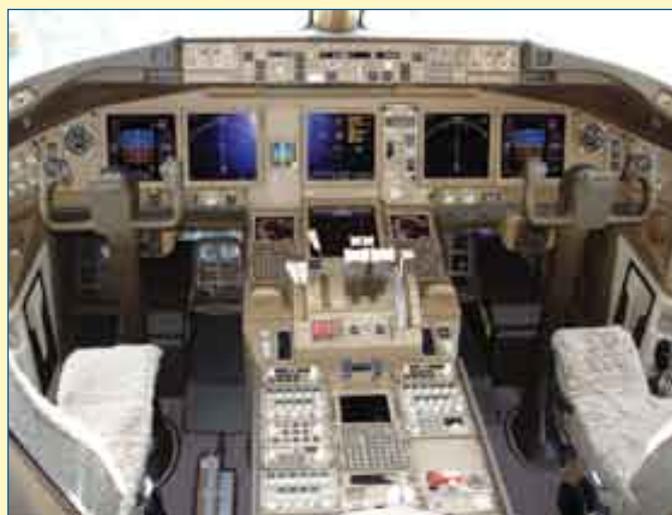
The old and the new – a contrast between 1940s (DC-3) and current (Boeing 777) technology. DC-3 photo courtesy of the Air Force Museum, Christchurch.
