VECTOR

POINTING TO SAFER AVIATION

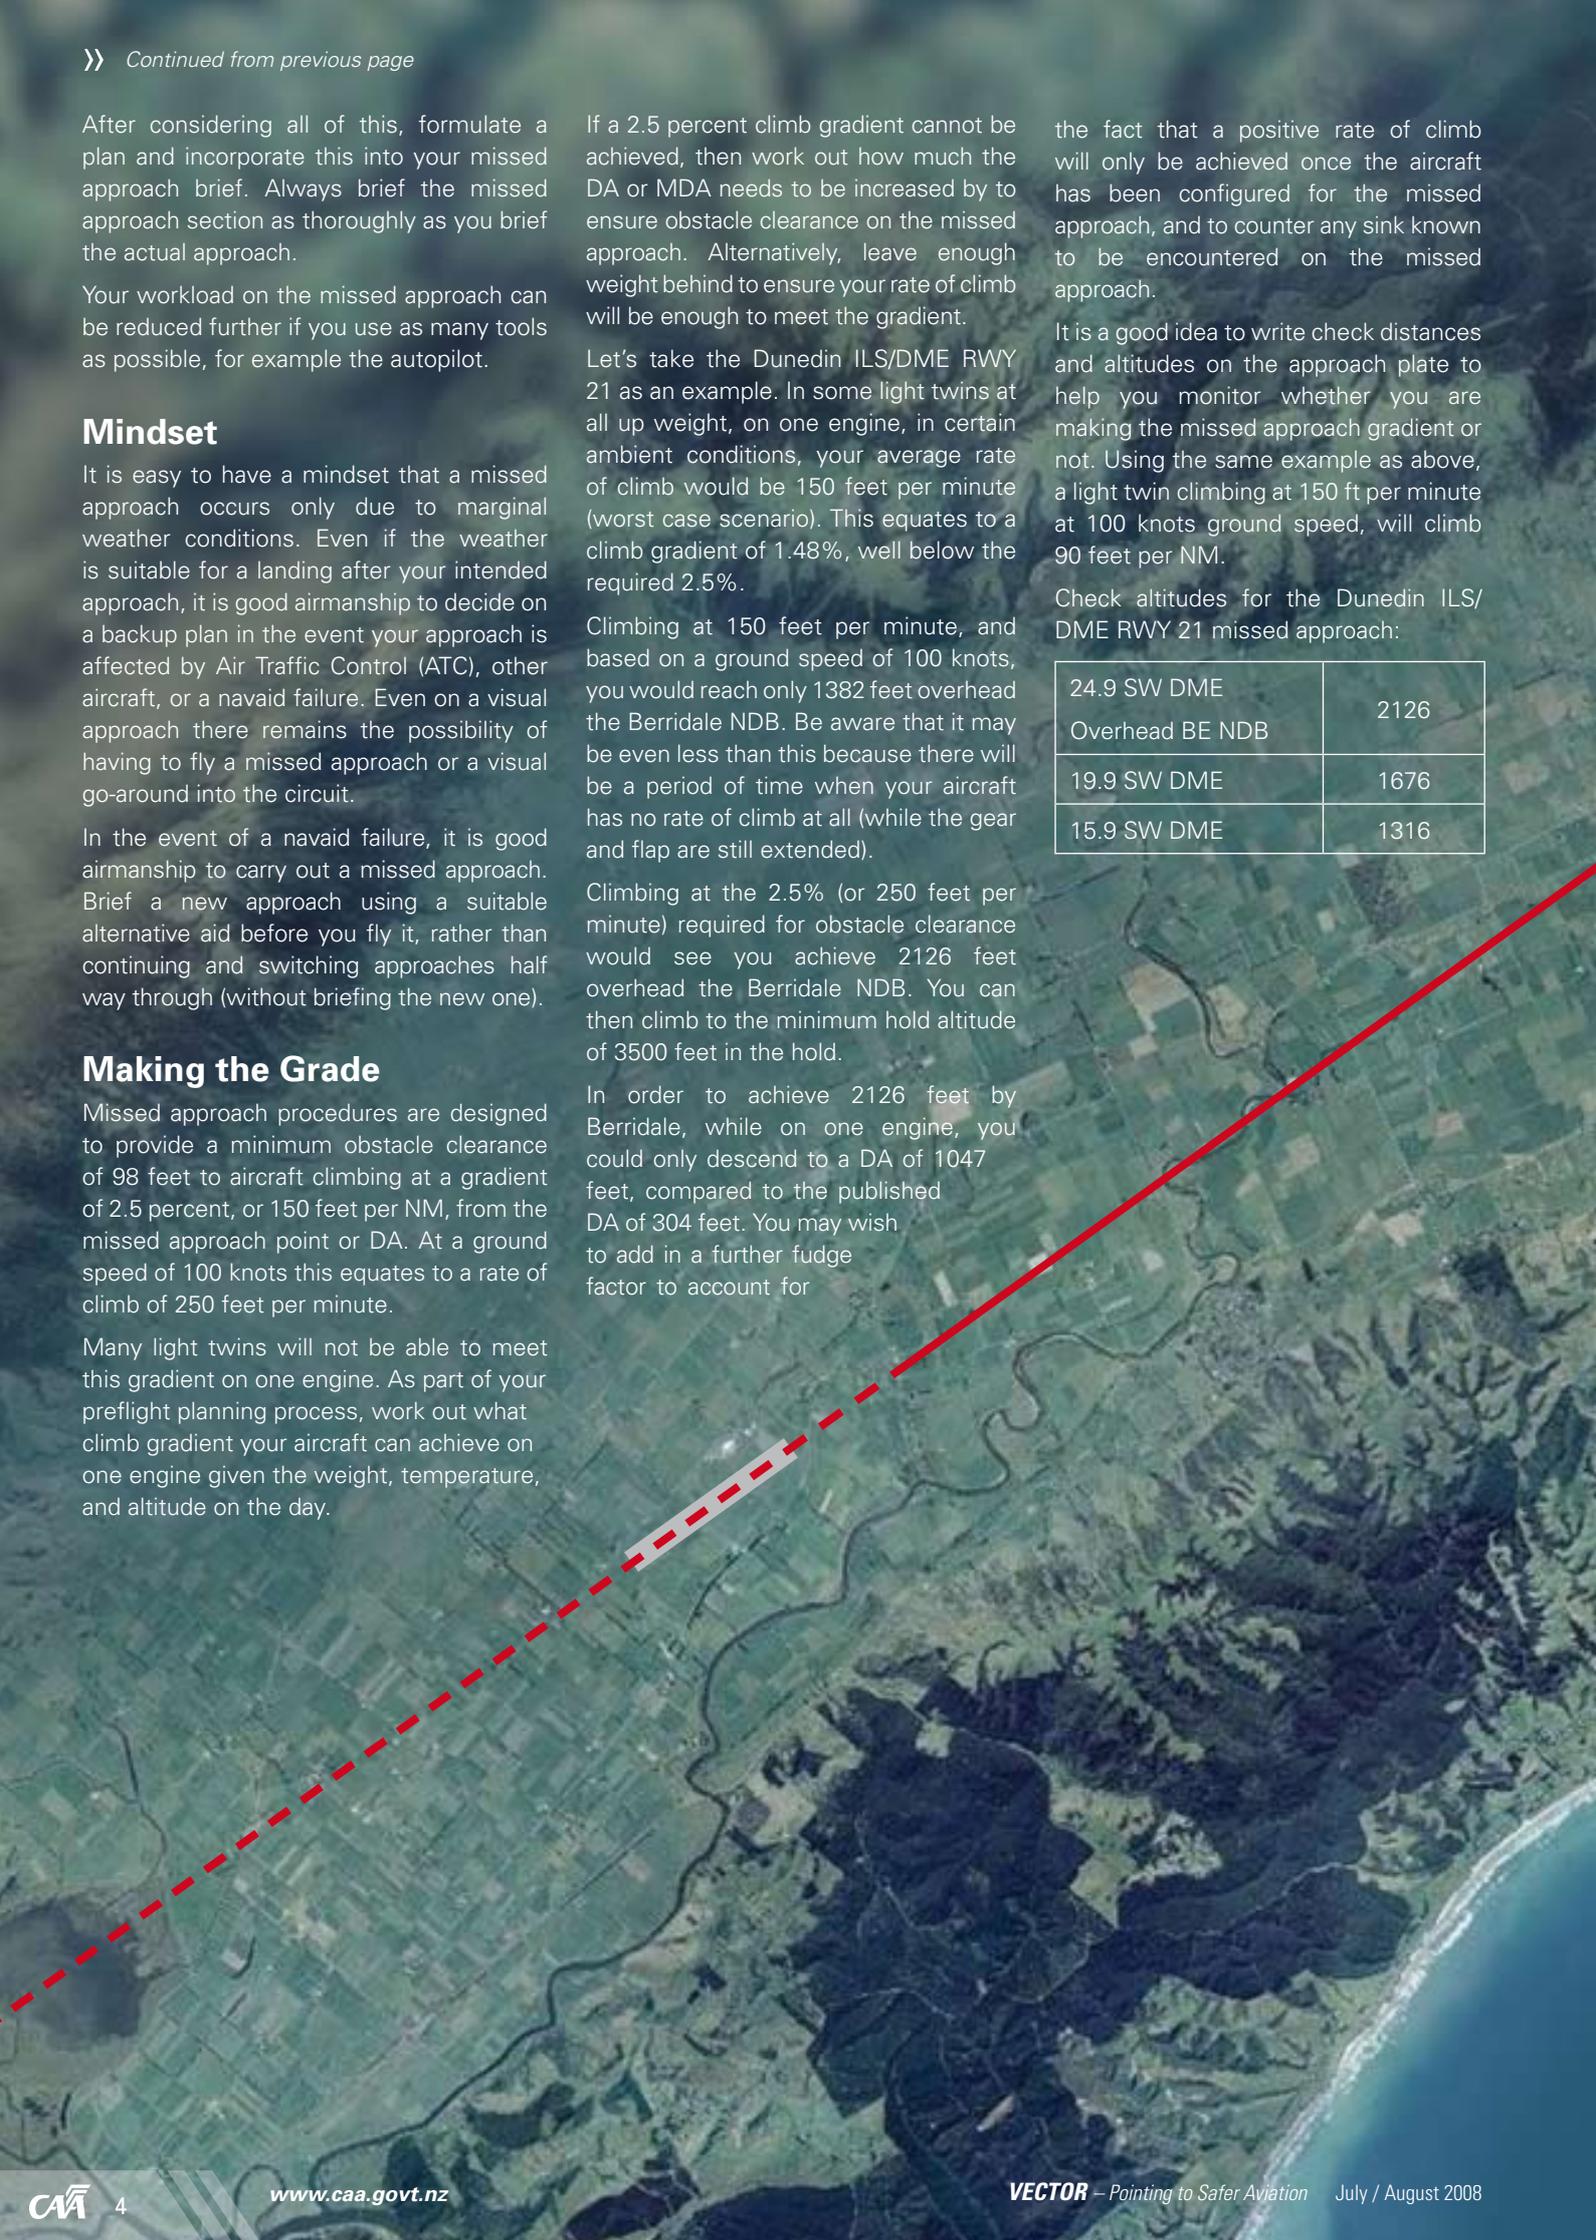
Check altitudes for the Dunedin ILS/DME RWY 21 missed approach:

24.9 SW DME	2126
Overhead BE NDB	
19.9 SW DME	1676
15.9 SW DME	1316

Let's take the Dunedin ILS/DME RWY 21 as an example. In some light twins at all up weight, on one engine, in certain ambient conditions, your average rate of climb would be 150 feet per minute (worst case scenario). This equates to a climb gradient of 1.48%, well below the required 2.5%.

Think about a back up plan you can implement if you are not making the gradient. In the case of the Dunedin ILS/DME RWY 21, at a safe altitude for turning you could carry out a left procedure turn, taking you to the east of the missed approach track and away from high terrain. You could then carry out the ILS/DME RWY 03 approach to land or continue climbing on the missed approach to land or continue climbing on the missed approach for the ILS/DME RWY 03.

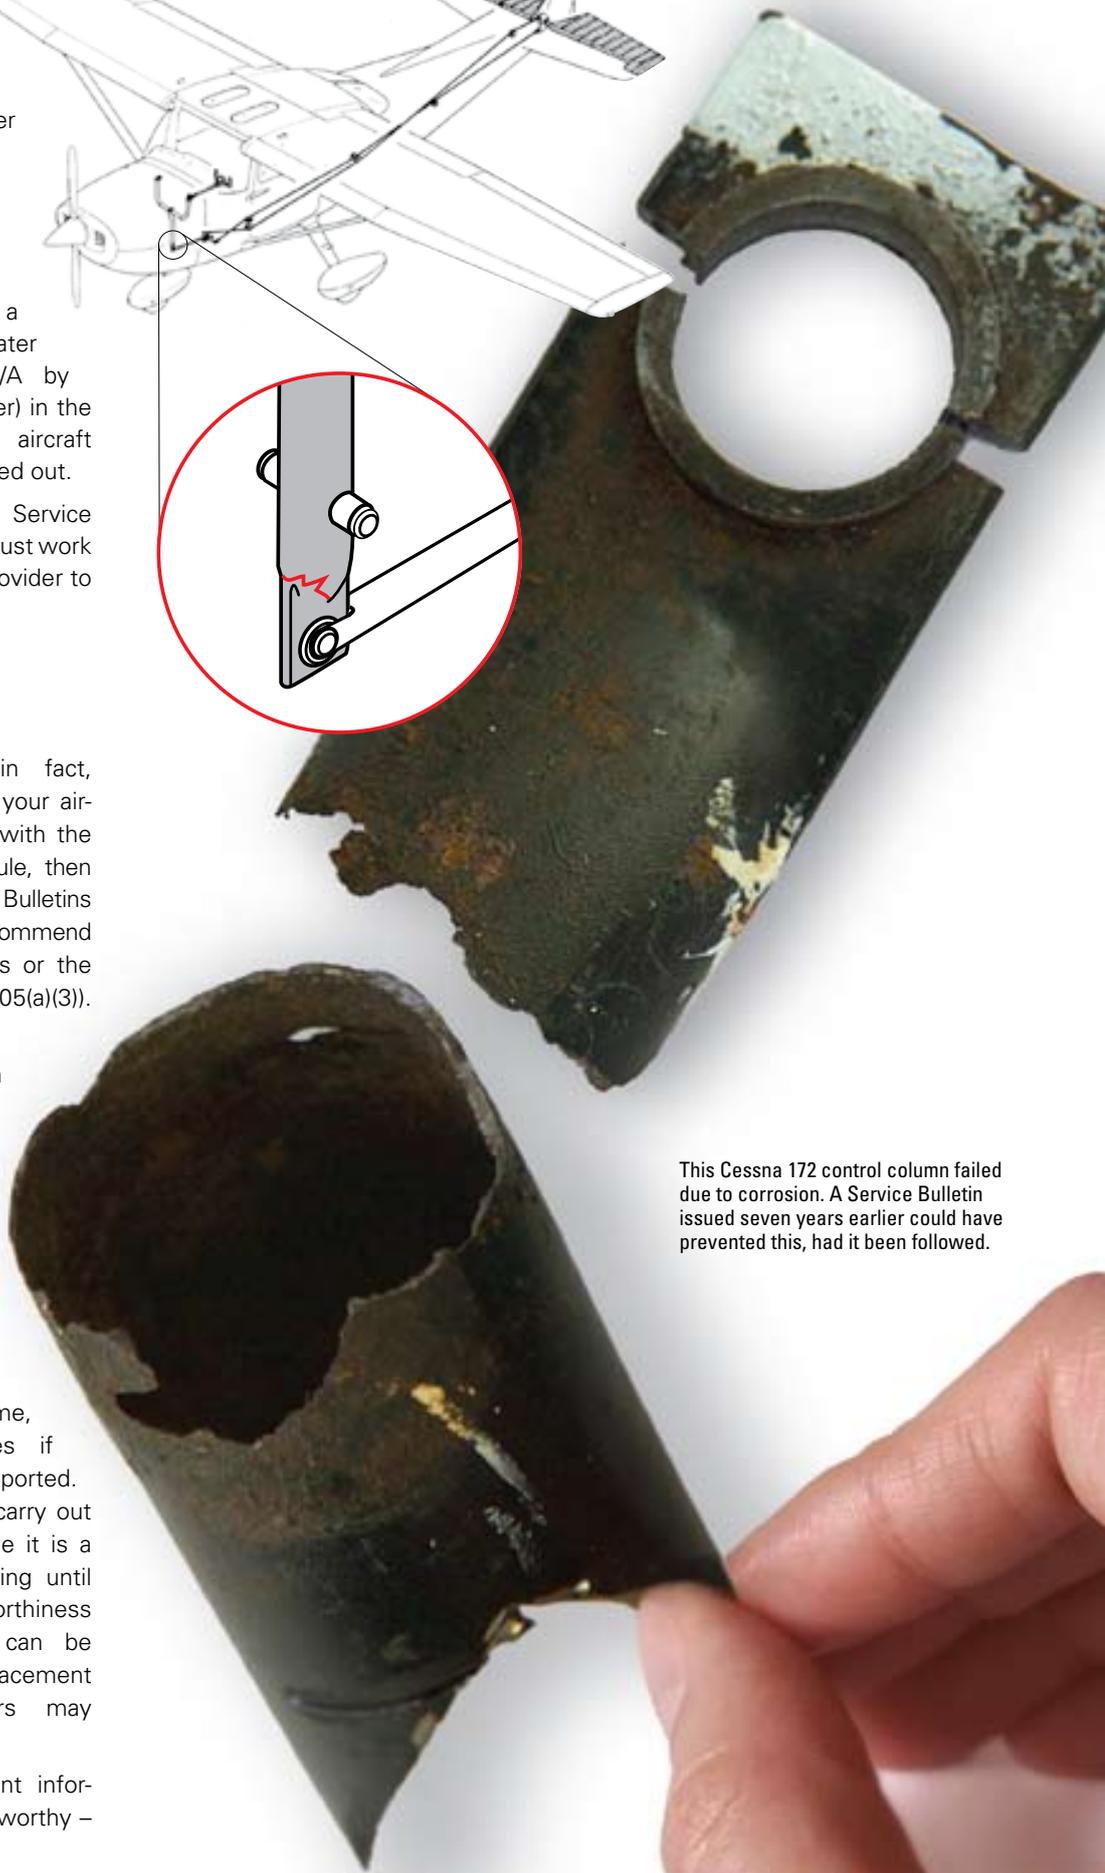
C172 Elevator Control System

This Cessna 172 control column failed due to corrosion. A Service Bulletin issued seven years earlier could have prevented this, had it been followed.

This control column failure while taxiing happened in March 2008 at Awaroa airstrip. It failed below the pivot point at the lower elevator control lug, resulting in a loss of elevator control. The C172's design has a closed tube section below the pivot point where moisture can collect. This led to corrosion and failure of the control column assembly. Failure above the pivot point would have resulted in loss of aileron *and* elevator control.

Defect reports of control column failures received by Cessna and the FAA, led Cessna to issue Service Bulletin No. SEB01-3, in 2001. This applies to Cessna and Reims Aviation 172, 180, and 185 series aircraft with serial numbers listed in the Service Bulletin. The C172 whose control column failed at Awaroa is one of those affected. The Service Bulletin recommends an in situ ultrasonic inspection of the lower section of the control column assembly. The assembly should be replaced if the tube wall thickness is less than 0.037 inches. The Service Bulletin contains a detailed list of affected aircraft, instructions for performing corrosion treatment and recommends an annual external visual inspection of the control column assembly.

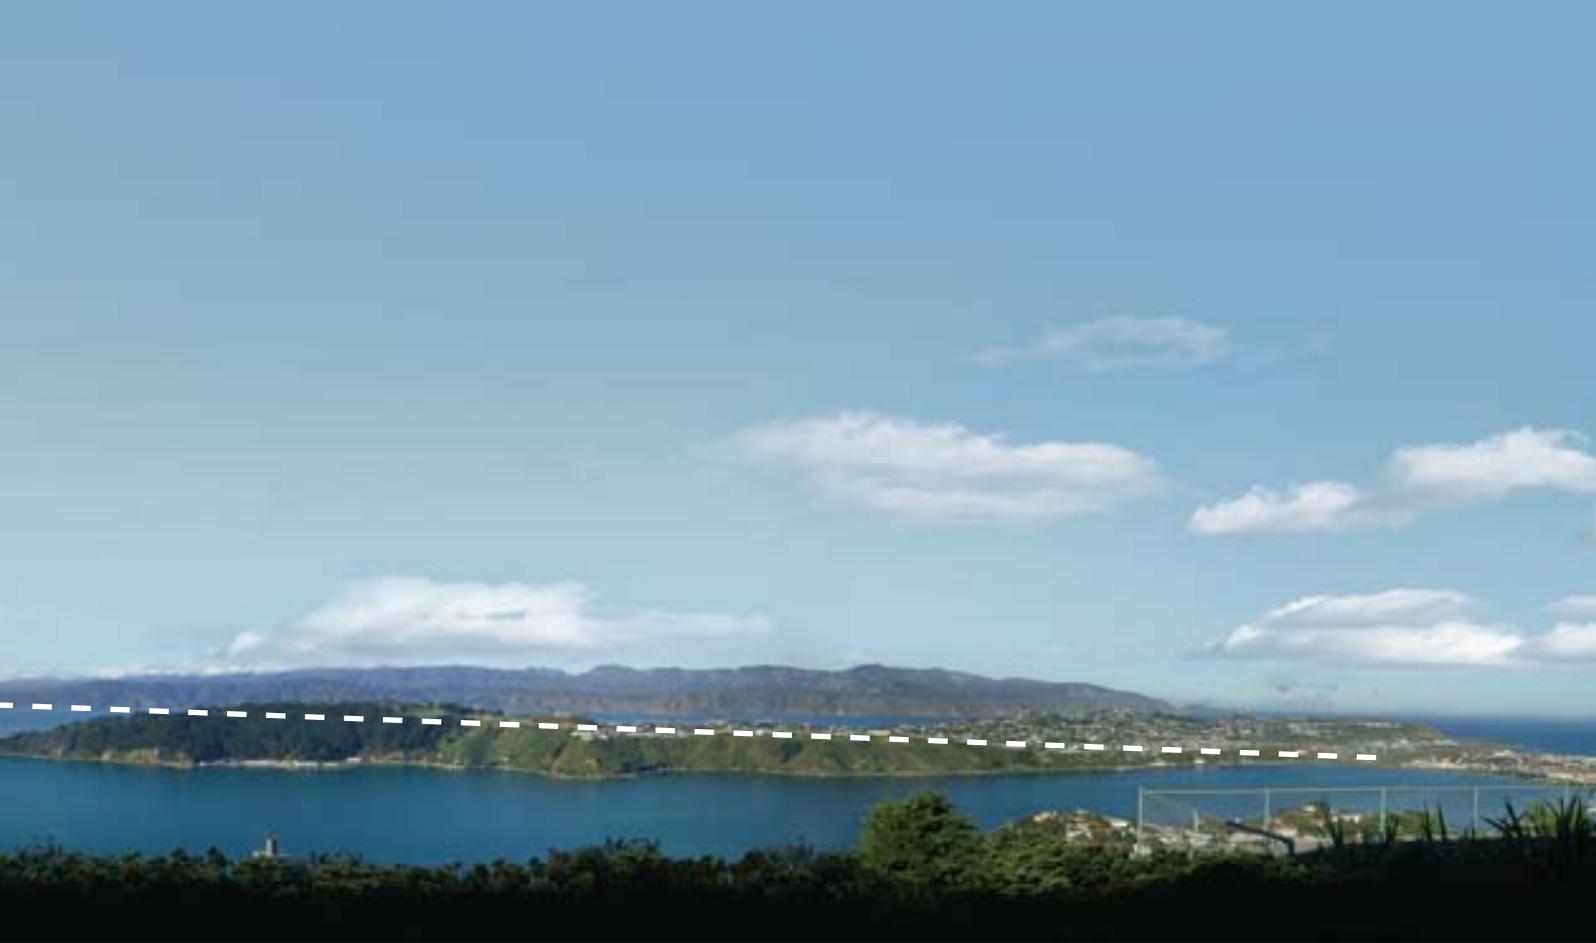
Wellington Runway 16 approach from Mt Victoria.

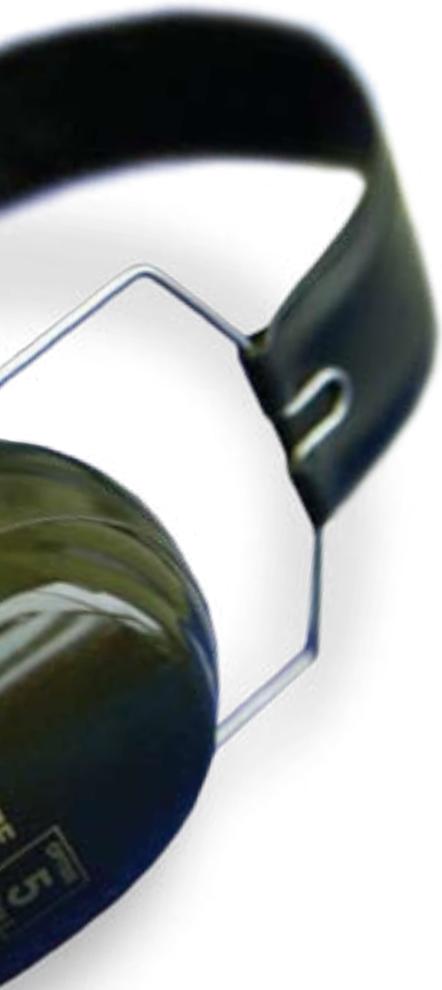
- CLASS 5
- CLASS 4
- CLASS 3
- CLASS 2
- CLASS 1

All hearing protection in New Zealand should meet the joint Australian/New Zealand Standard AS/NZS1270, 2002: *Acoustics – Hearing Protectors*. This standard uses a class system, which provides a simple way of selecting hearing protection appropriate for the level of noise exposure.

To see what class of hearing protection you require, match your exposure level to the appropriate class level on the graph right. For more information on hearing protection standards, see the Department of Labour web site www.dol.govt.nz.
