# vector

March / April 2009

# Agricultural Aircraft Safety Review

A CAA study confirms long-held concerns about the safety of fixed-wing agricultural aircraft.

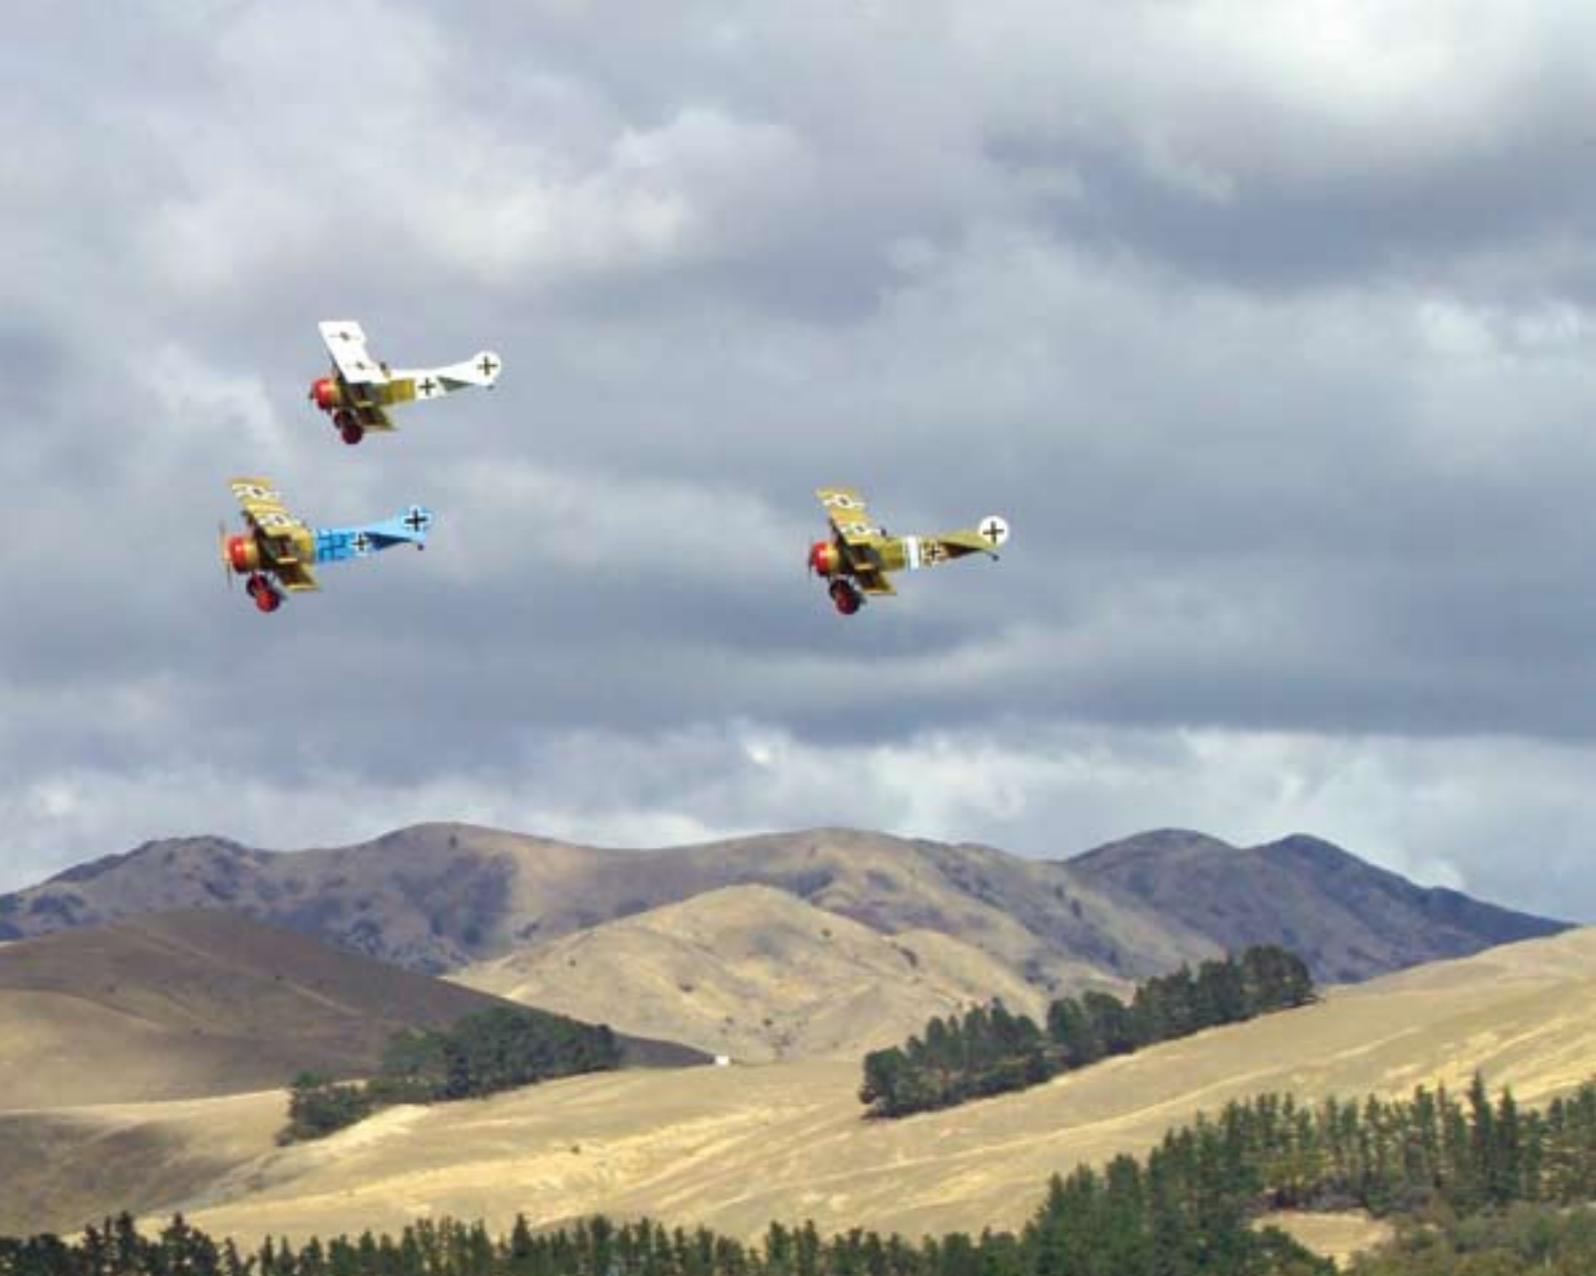
### Temporary Restricted Area

NZR694 will cover the Maxwell Sector and the Fairhall Sector within the Woodbourne CTR/D, from the surface to 4500 feet amsl.

It will be active daily from 0630 to 1830, 9 to 12 April 2009 and 0630 to 1200, Monday 13 April 2009 NZST. When active, the airspace within NZR694 becomes Class G (uncontrolled).

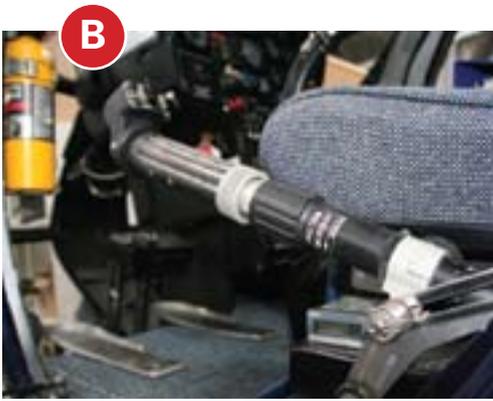
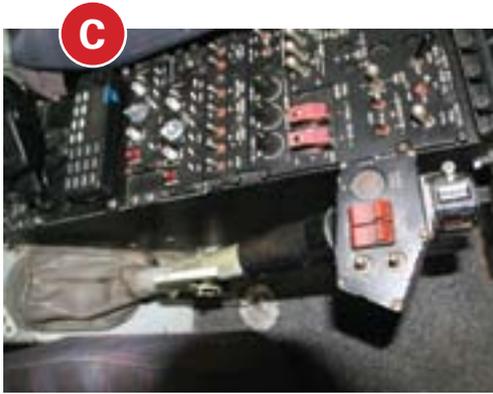
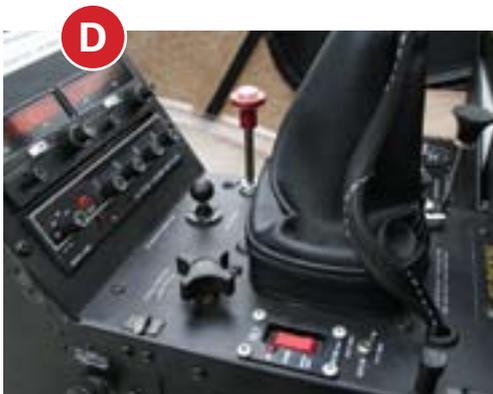
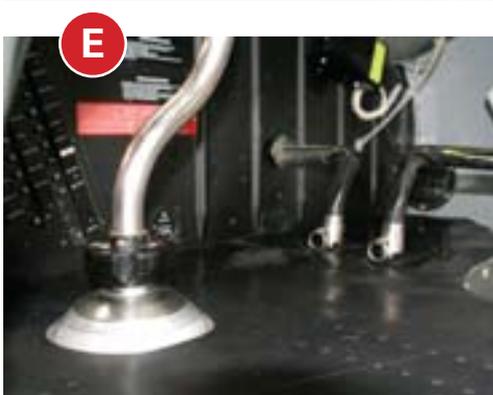
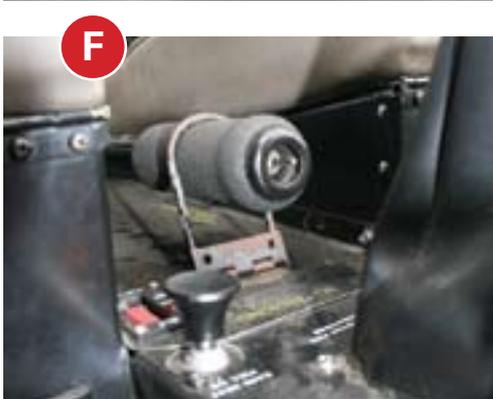
When a helicopter is on the ground a friction lock, and/or similar device, is applied to the collective to stop it being raised. If the friction lock is faulty, and the collective vibrates up, it will increase the pitch on the blades. The governor will then increase the power by a corresponding amount. If there is enough weight in the helicopter, this in itself would not be enough for it to become airborne, but sometimes the reduction in weight from the pilot getting out can mean there is just enough power applied to get the helicopter airborne.

A friction lock is also applied to the cyclic. If this fails the rotor disk will flop around. The yaw pedals also have the potential to creep or be bumped by a passenger. This can lead to the helicopter rotating on the ground and more than likely rolling over as a result. ■

Collective lock not applied, and failure of factory friction nut, allowed collective lever to rise, and the machine flew unattended before crashing.

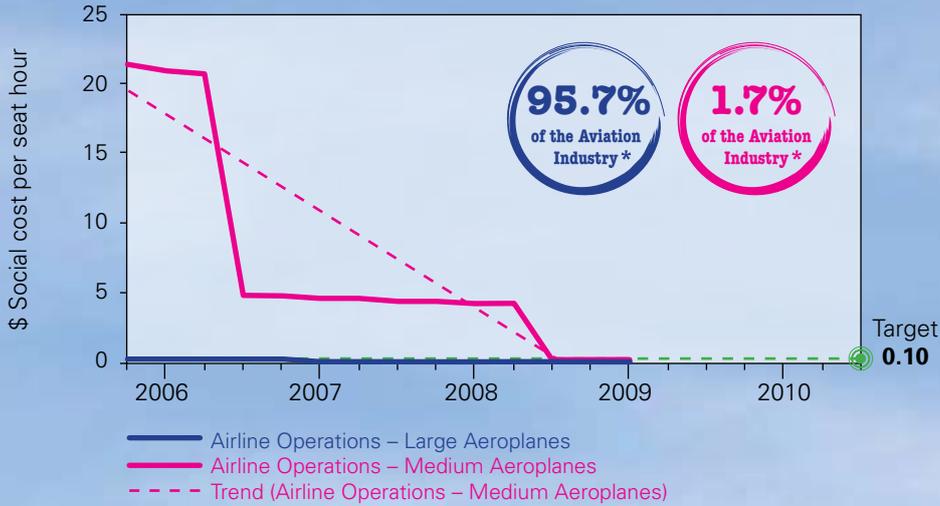
### Social Cost Airline Operations – Large and Medium Aeroplanes

Large aeroplanes have remained at or below the required target since 2005.

The medium aeroplane sector currently exceeds its target, but is trending down. It is possible for the target to be achieved in 2010. There were no injuries in this sector over the two and a half years to December 2008.

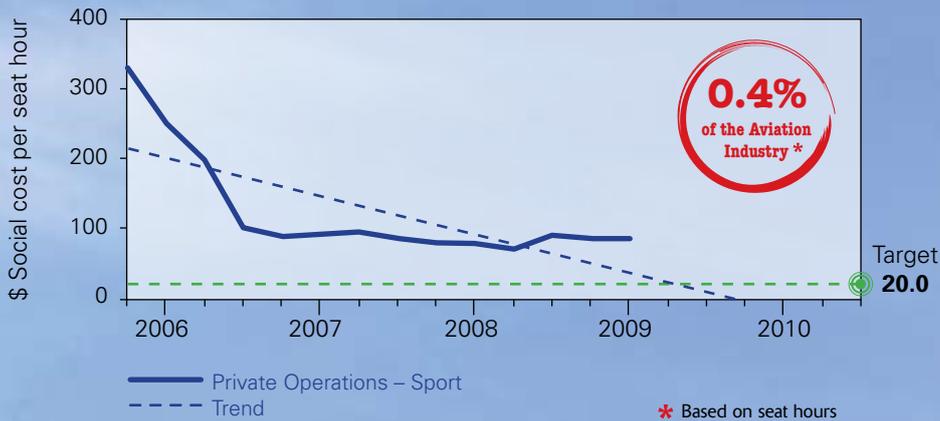
**Social Cost  
Private Operations – Sport**

Sport aircraft used in private operations have been trending down since late 2005. There were 13 fatal, 25 serious and 24 minor injuries in the three years to December 2008. ■
