POINTING TO SAFER AVIATION

vector

July / August 2010

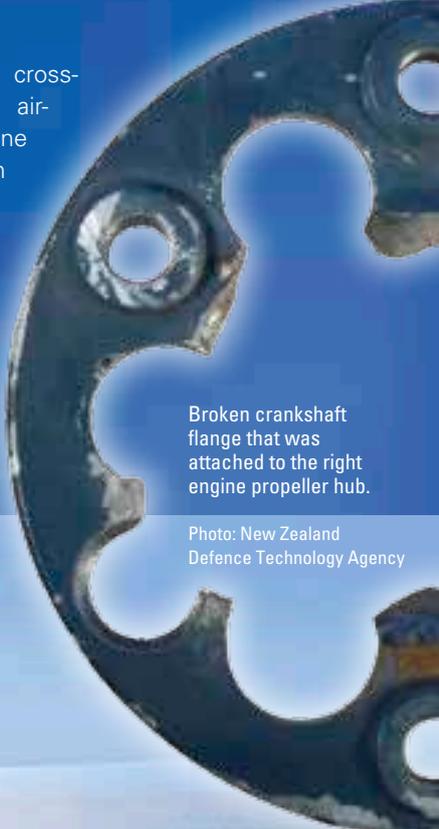
Broken crankshaft flange that was attached to the right engine propeller hub.

Photo: New Zealand Defence Technology Agency

About 500 feet after takeoff the pilot of a Trislander with 10 passengers on board heard a “pattering” sound. Seconds later the right-hand propeller assembly detached from the crankshaft flange and sliced into the side of the aircraft.

The Britten Norman Trislander landed safely after the accident in July 2009, with minor injuries to three of the 10 passengers. The Transport Accident Investigation Commission (TAIC) investigation found that the right-hand engine had been imported from Indonesia with records that understated its time in service. In all, the part was found to have been in service 392.4 hours longer than the records stated, which meant it was 230.2 hours overdue for overhaul.

Had the company known the real operating hours, the engine would have been overhauled well before the crankshaft failure, and this accident would not have occurred.

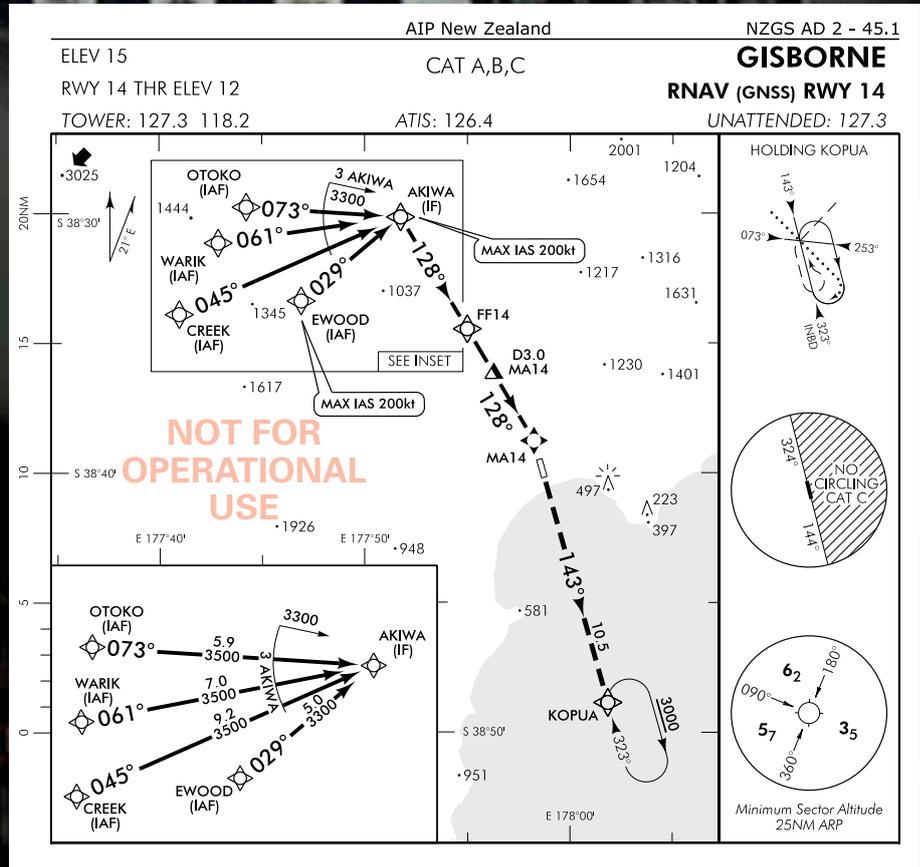
MISSED APPROACH: Track 143° to KOPUA 3000

Instead of taking you back to the IF, this type of missed approach takes you to a Missed Approach Holding Waypoint (MAHWP) with a hold at the end.

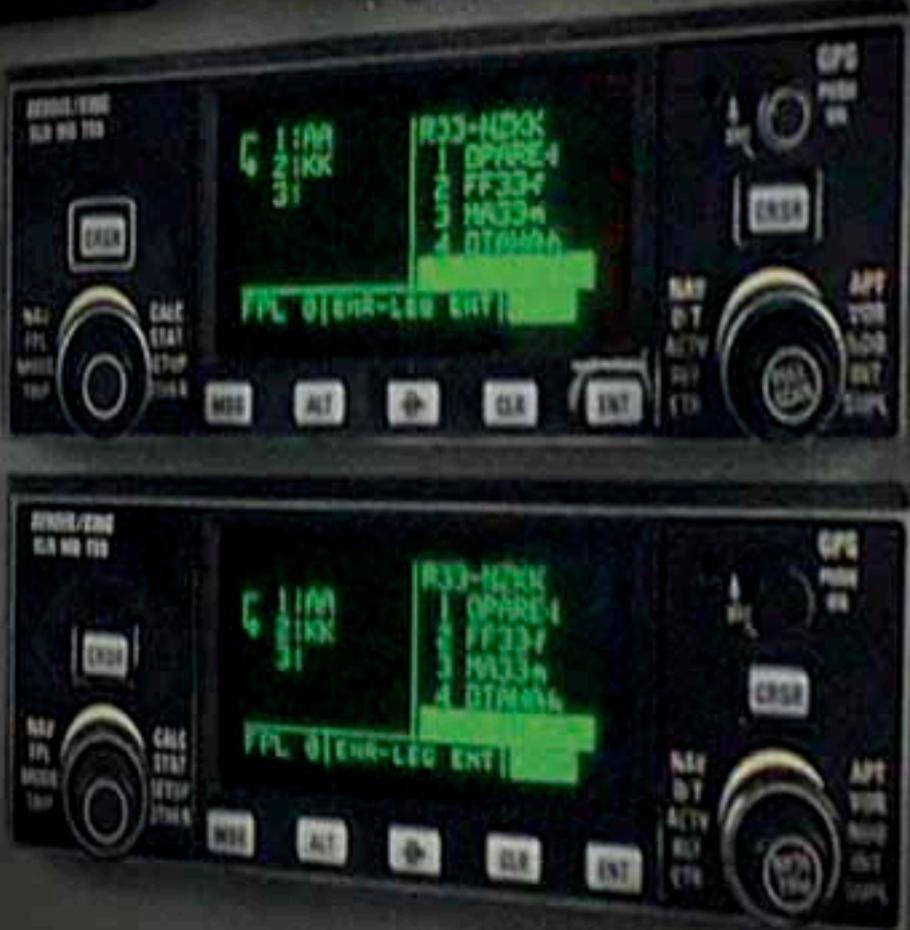
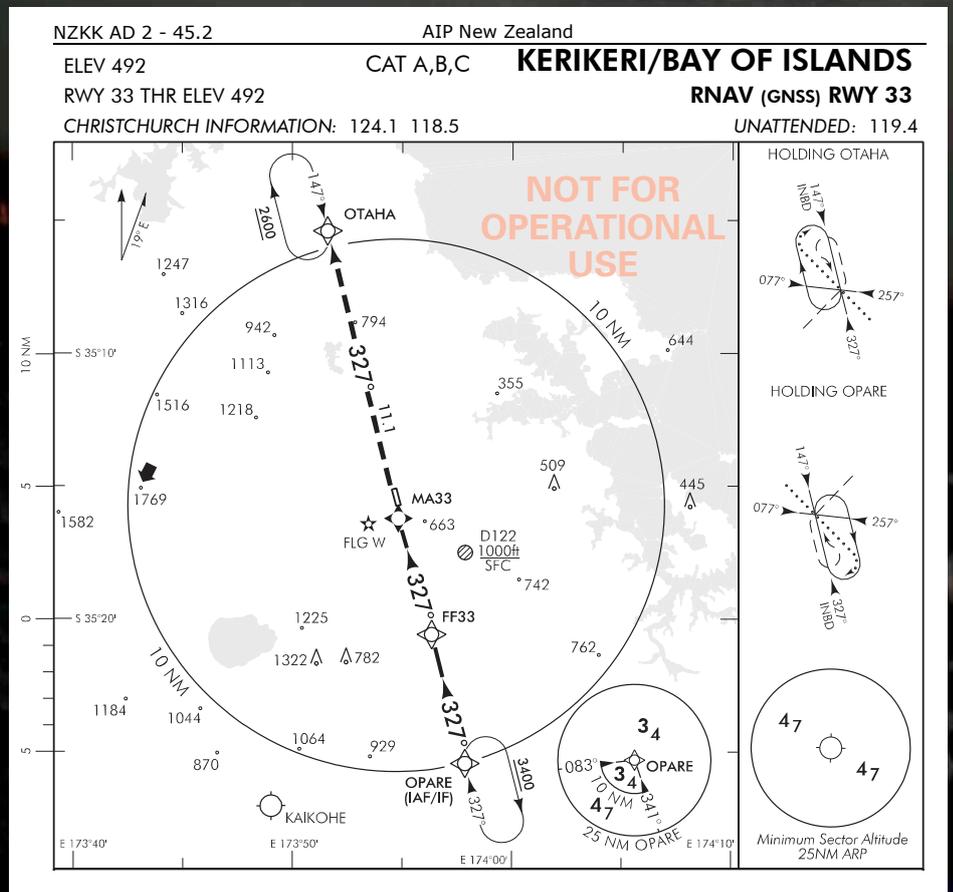
MISSED APPROACH: Climb to enter OTAHA holding 2600

If there is no RNAV arrival procedure to take you from the waypoint at the end of the missed approach back to the IAF – what do you do?
