vector

In this issue...

The Communications and Safety Education Unit of the Civil Aviation Authority of New Zealand, PO Box 3555, Wellington 6140.

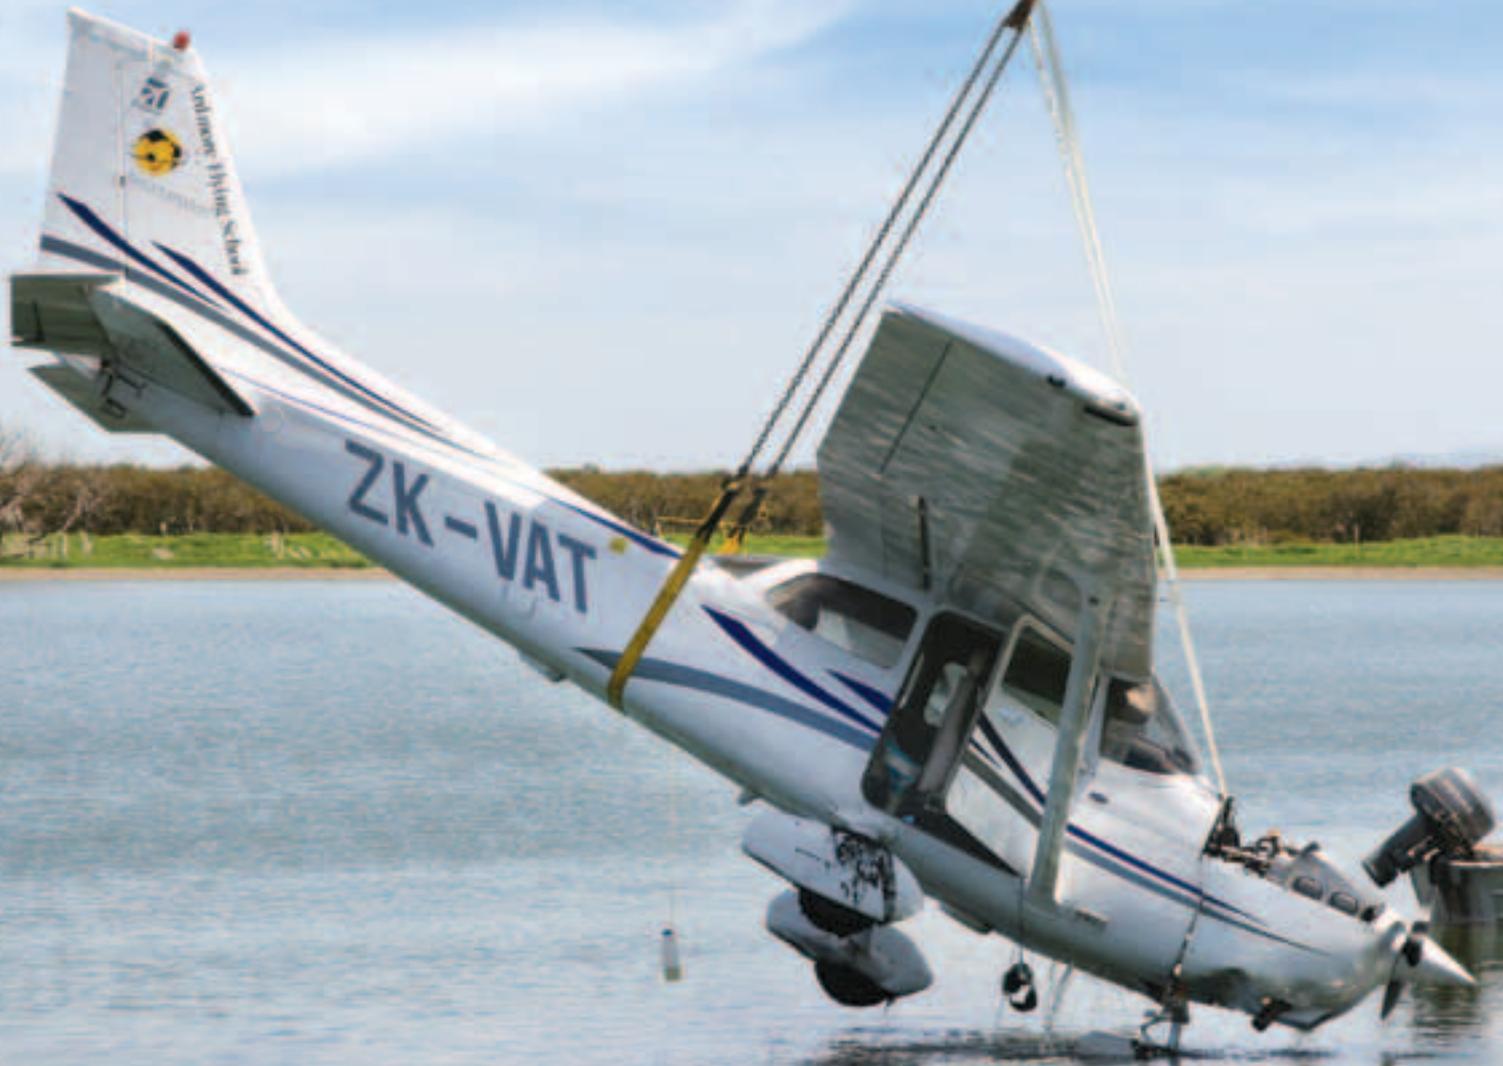
Cover photo: Get-there-itis contributed towards this C172 overrun accident at Thames Aerodrome. Photo courtesy of Graeme Giffney.

The Thames cess-pit is a good example of this. In the last six years, three Cessna aircraft have ended up in the sewage oxidation ponds at the end of Runway 14 at Thames Aerodrome, a C150, and two C172s. Two of these encounters show elements of get-there-itis.

The pilot of the first C172 was intending to carry out a touch-and-go at Thames, before continuing to Tauranga. A standard overhead join was made, and the pilot observed a light direct crosswind on Runway 14/32 from the south west, which was fluctuating between a head and tailwind for either runway choice. Since the pilot was heading to Tauranga next, he chose Runway 14 to expedite his departure on track.
