POINTING TO SAFER AVIATION

vector

March / April 2012

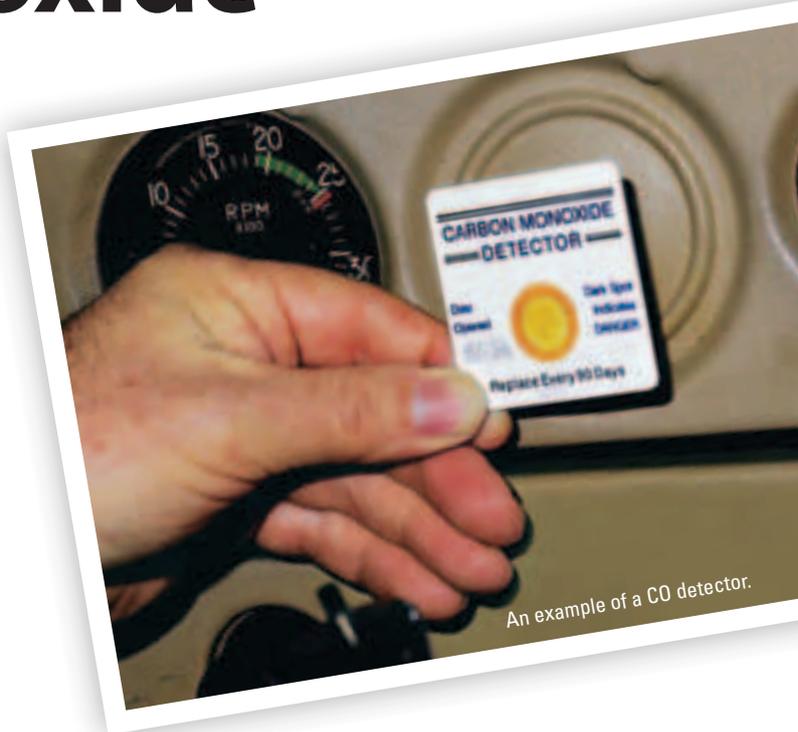
An example of a CO detector.

A twin-engine aeroplane was on a routine flight when the pilot started to feel unwell. Suspecting that CO exposure might be the cause, the pilot checked the cockpit CO detector for confirmation. The detector was situated near the pilot's breathing zone and readily visible, but showed no signs of CO presence.

The detector was within its currency, being only six months into its 18-month life. The reason that it didn't indicate the expected presence of CO from the defective heater could not be determined. The concentration and duration of exposure to CO however, and airflows at the time around the detector, were considered to be potential factors in its failure to register the probable presence of CO.

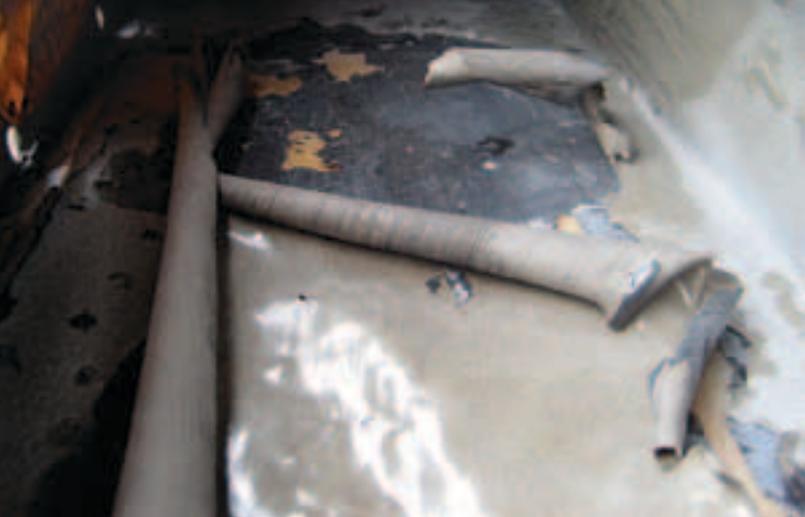
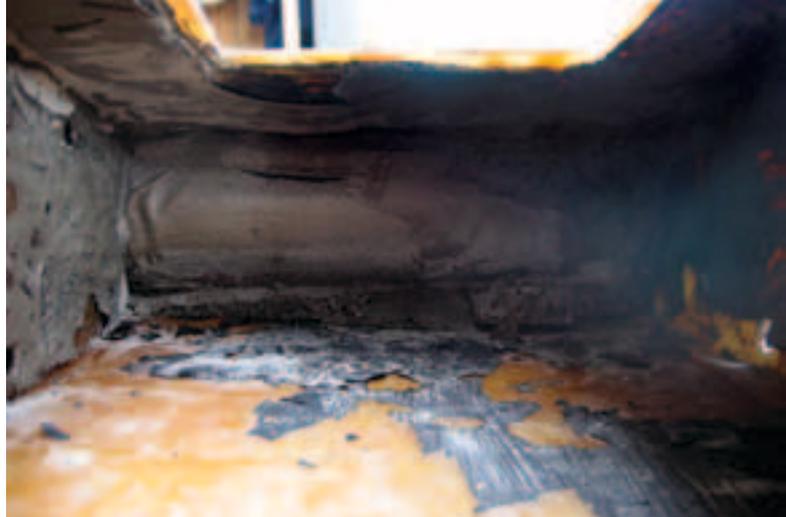
Photos courtesy of Dave Kenny

The aircraft was fitted with one fuel tank in the wing, which had developed a leak. In the process of rectifying the leak, Dave identified loose flaking material in the tank below the filler neck, so they decided to investigate further. After cutting access holes in the fibreglass tank, what they discovered came as a shock. Large sheets of sloshing compound had lifted from the tank walls, and large flakes were floating loose. Extensive delaminating of the sloshing sealant was evident throughout the tank.

Dave and the owner completely removed the sloshing sealant from the fuel tank, a major job, and repaired and resealed the tank with a fuel-resistant resin specifically designed for fibreglass. They also submitted a defect report to the CAA for follow-up.

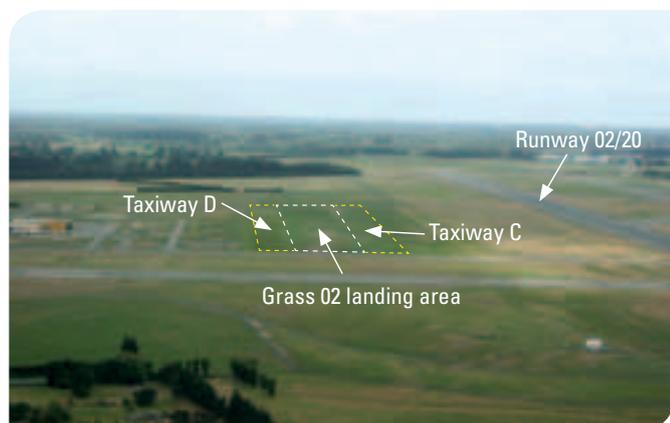
Turning final for Grass 02. Note the reduced width of the grass runway and consequent relocation of Taxiway C. Diagrams are indicative only.

NZCH AD 2-53.3. The Christchurch ground movements chart (3) shows the position of the grass runway, Grass Taxiways C and D, the holding points (Hold 1,2,3) on Taxiway E and the taxiways to the aero club and western GA areas.

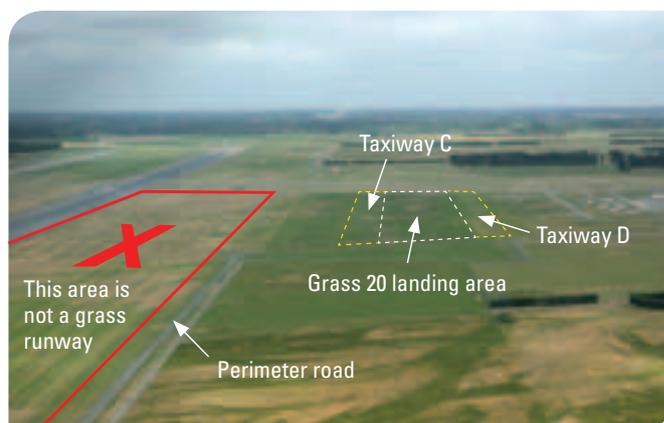
The perimeter road parallels sealed Runway 02/20 north of Taxiway C, and is on the same alignment to the south of Runway 11/29. When on final for either grass runway, keeping to the west of the perimeter road will ensure that you don’t land in ‘no-lands land’.

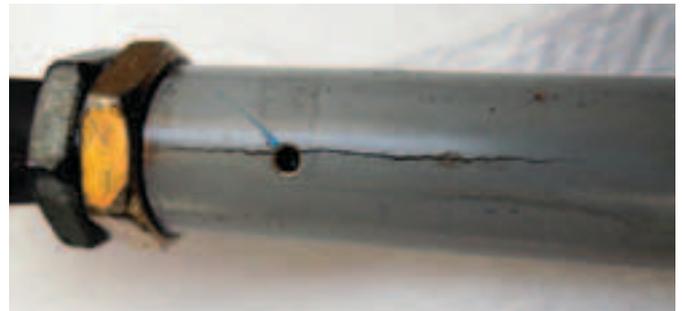
Tail rotor control push rod

Part Manufacturer: Robinson
Part Number: C343-1
ATA Chapter: 6400

During a scheduled 100-hour inspection, a lengthwise crack was seen at the witness hole in the end of the C343-1 tail rotor push/pull tubes. The tube is mounted vertically between the rear seats. Another aircraft was checked and found to have a similar but smaller crack. The FAA was informed, and the tubes were sent to the manufacturer.

They advised that this was a known problem due to stress corrosion in 2024-T tubes, from hoop stress caused by locking nut clamping forces. The FAA advised that it had been determined that a cracked tube could take operating loads but not certification loads. The manufacturer is currently developing a new part made from a different material specification 6061-T6. Both the FAA and the manufacturer are considering airworthiness action. Maintainers should use vigilance when inspecting this push/pull tube and report any defects found to CAA.
