vector

Classic Fighters 2013

The Right Frequency

Wind Shear for the Light Aircraft Pilot

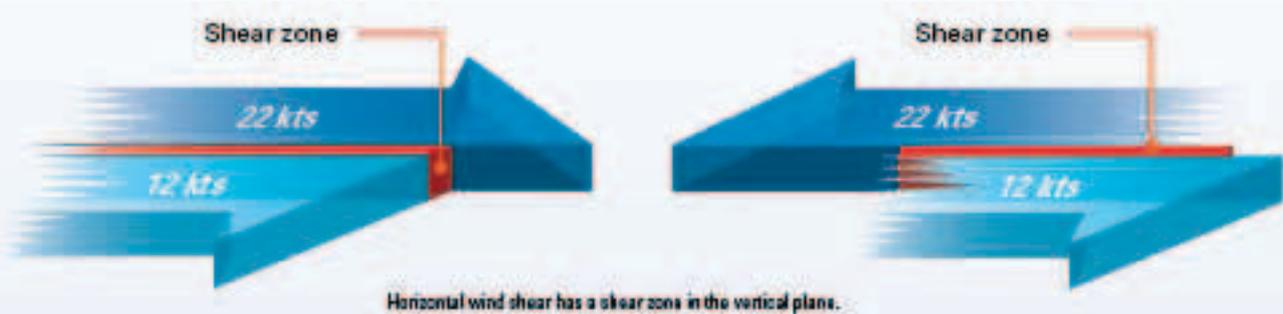
Horizontal wind shear

Wind shear is a sudden change in wind speed, wind direction, or both, encountered in flight. In New Zealand, there are nine reported incidents involving wind shear per year on average.

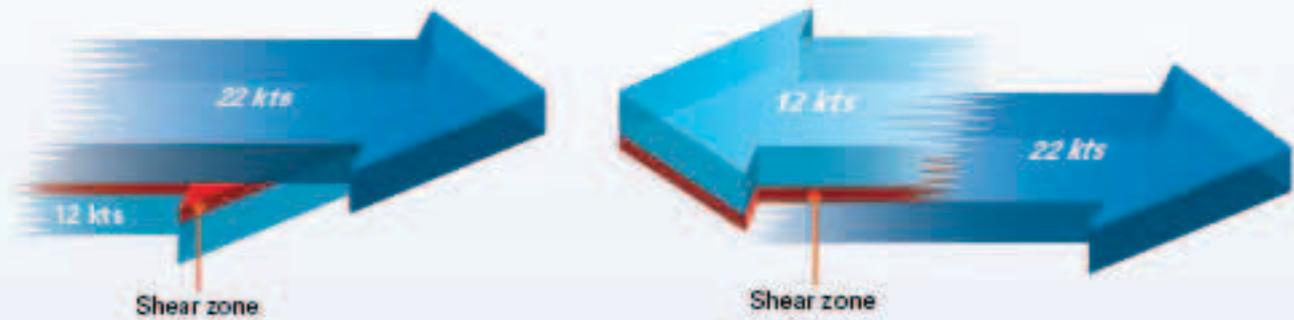
Vertical wind shear has a shear zone in the horizontal plane.

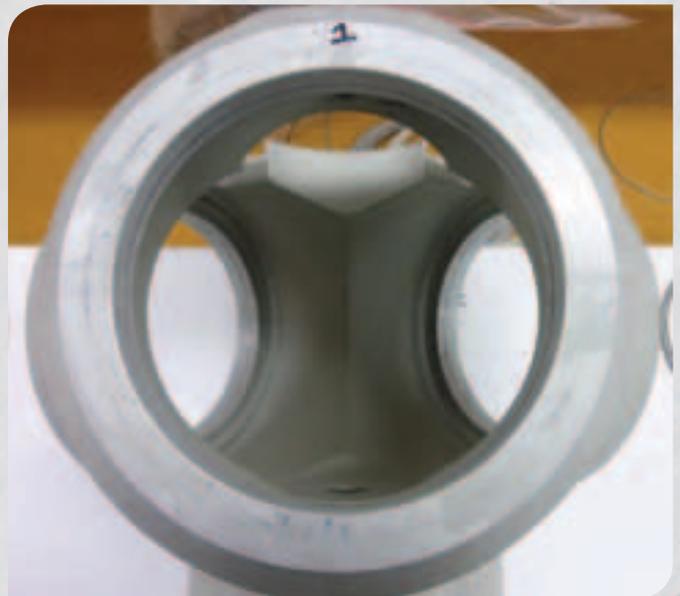
Corrosion damage to the hub face.

This year, another propeller was rejected during its initial 5-yearly inspection for the same reason – corrosion damage to the blade butt circlip grooves and the hub faces. Once again, there was no evidence of corrosion prior to disassembly. The owner was surprised, since he had been using a well-known “general aircraft cleaning product”. The propeller operator's manual states, “Use care when choosing a cleaning solvent to ensure that it does not contain any ingredients that could be caustic to aluminium”.

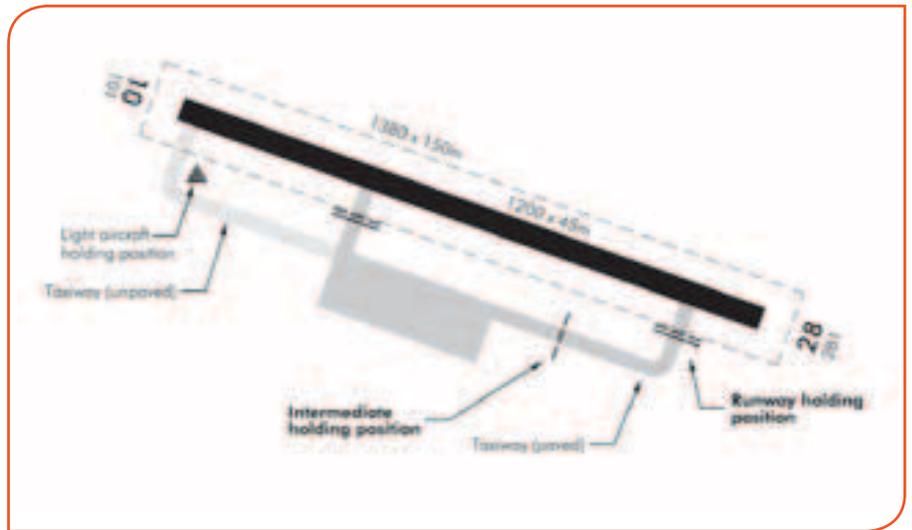
Currently, all holding positions are shown on the charts as two lines, one solid, one dashed, but this format will apply only to runway holding positions, ie, those at the entrance to a runway. This will distinguish them from intermediate holding positions, which will be shown as a single dashed line.

AIP Supplement recipients will have already noticed (in 183/12) a change in the way holding positions will be depicted on aerodrome and ground movements charts.
