Pointing to safer aviation

Summer 2022/23

# vector

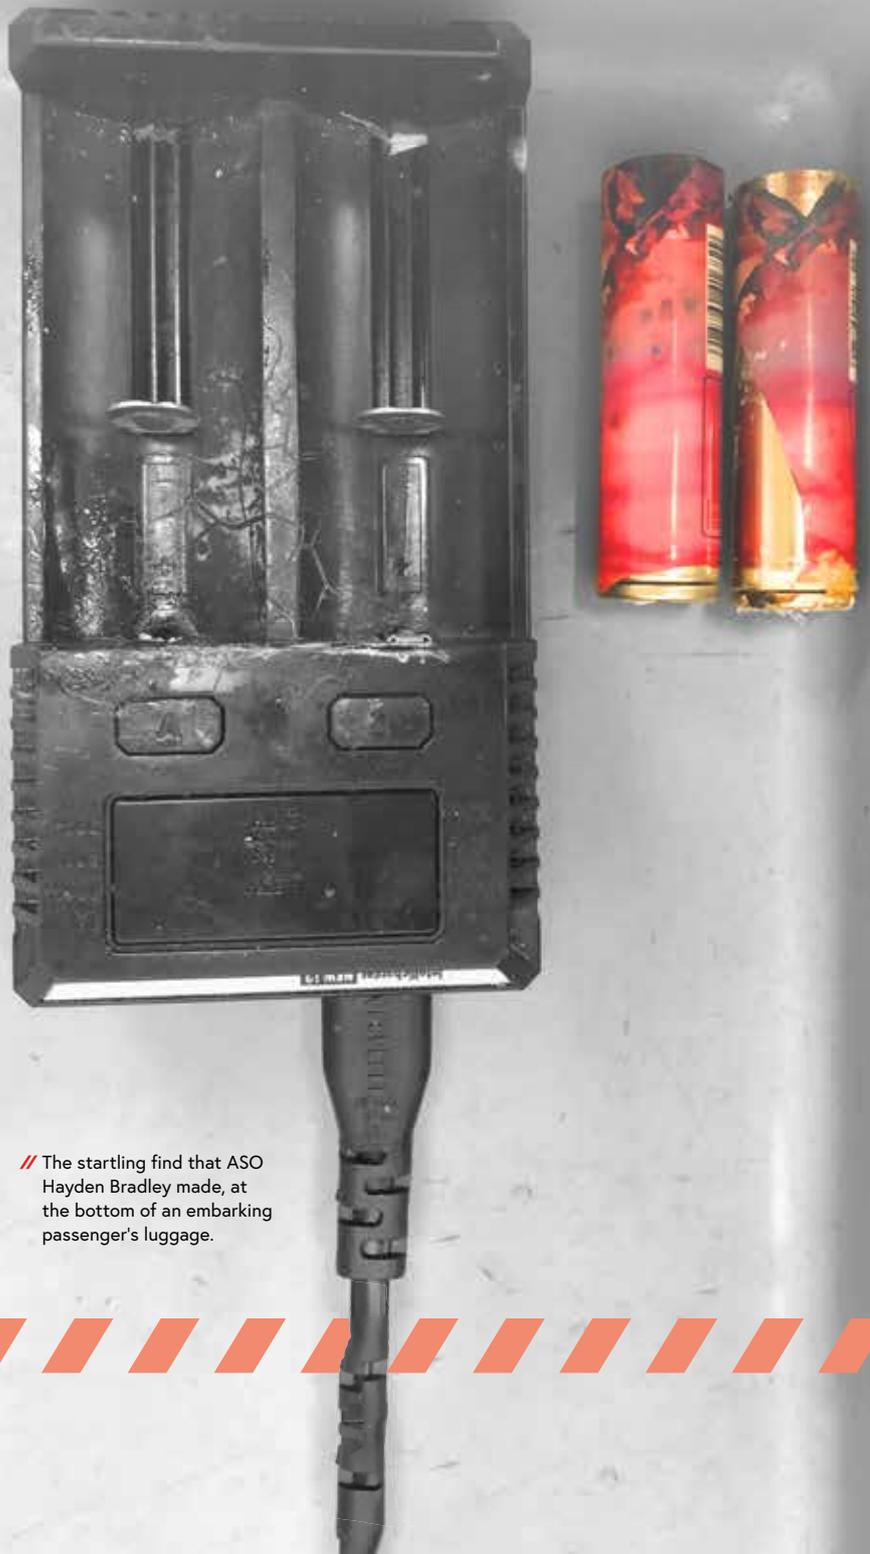
// The startling find that ASO Hayden Bradley made, at the bottom of an embarking passenger's luggage.

But, while scanning passengers' carry-on bags during the busiest part of the evening, the x-ray picked up four loose batteries, and two more in a charging device. Following protocol, Hayden re-checked the bag.

To his astonishment, there was smoke curling out of the bag, and underneath some clothes, he found a very hot and molten vape charger.

"I removed the batteries immediately to prevent further damage and to stop any ignition of the items. They were obviously extremely hot and melted through the PPE gear I was wearing.
